# BUGATTI

BUGCS037\_Turbocharger\_oil\_pipes\_replacement\_V2

Service Campaign

The four oil pipes associated with the turbochargers are to be replaced on 1600 HP engine.

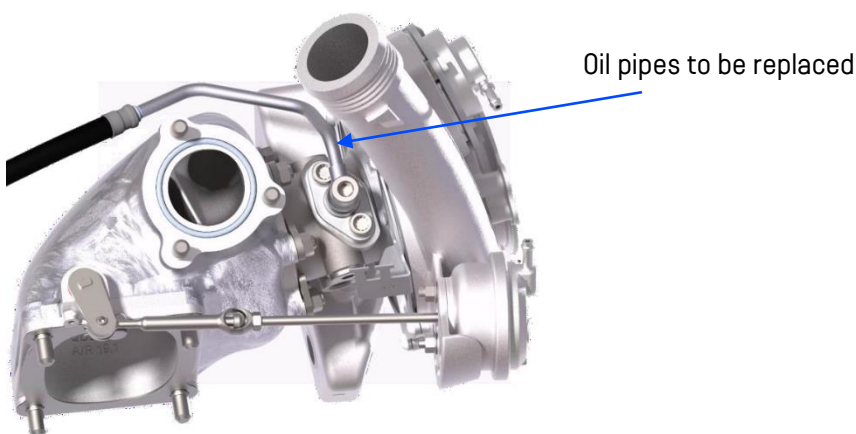
After internal verification, the turbocharger oil pipes are recommended to be replaced in order to increase durability.

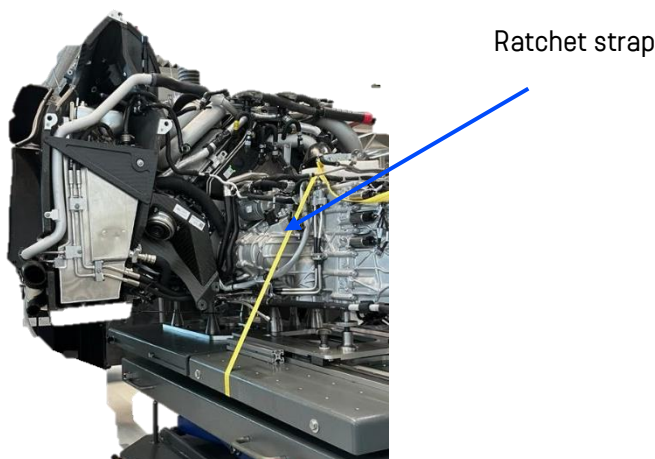
- Side panels L + R must be removed (Workshop manual — Body — Exterior).
- Rear Bumper must be removed (Workshop manual — Body — Exterior)
- Chassis must be split (Workshop manual - Installing and removing the direct-shift gearbox DSG).
- Powertrain + Rear chassis frame must be carefully installed on VAS 6131 equipped with BVK 098 100.
- Powertrain must be carefully attached to the VAS 6131 using ratchet strap.

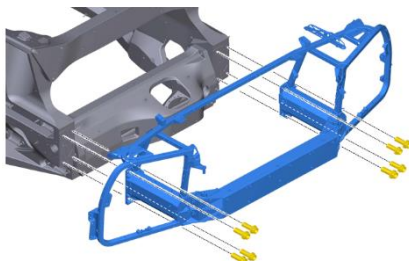
- Electrical connection must be disconnected from the E-boxes L + R.
- Complete Rear frame subassembly must be carefully removed.

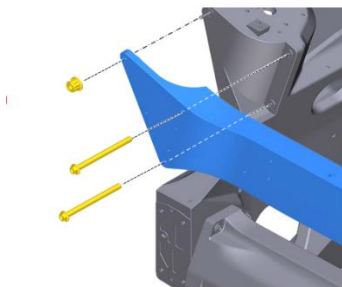
- Remove the rear left brake calipers + brake disc.
- Remove the rear left wheel shaft.
- Disconnect the subcomponents from the engine (Engine oil pipes, wires...)
- Remove Carbon air intake pipes.
- Carefully attach the rear left cross member using workshop crane.
- Remove the fastening screws and nut of the upper cross member.

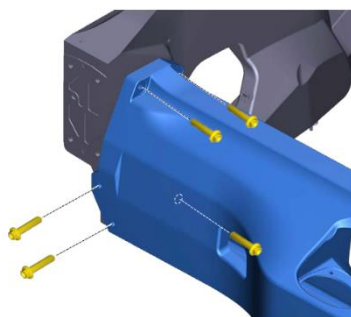
- Remove the fastening screws of the lower cross member.

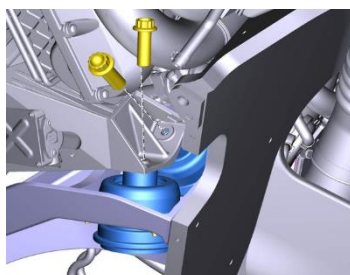
- Remove the fastening screws from the mounting element.

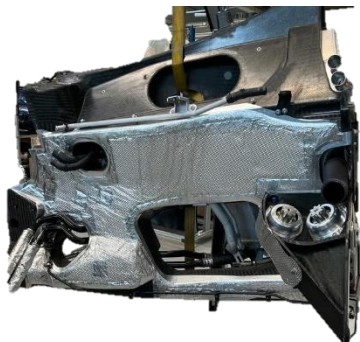
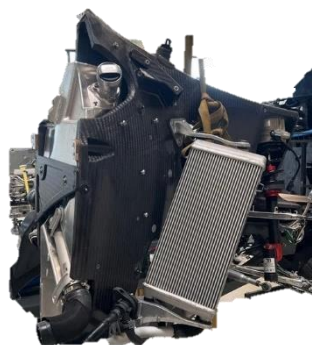
- Remove the rear left cross member with its subcomponents.

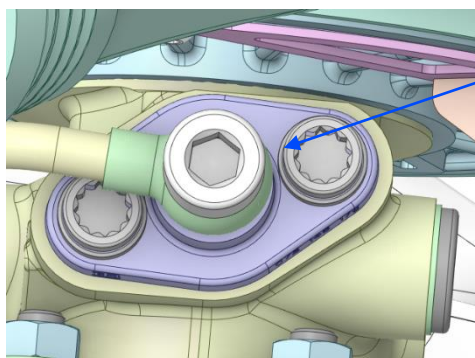
Banjo screw

- Heatshield behind the catalytic converter must be removed (Q1/Q2 & Q3/Q4).
- Fastening screws of the turbocharger oil pipes must be removed (M10).
- Remove the Banjo screws on the turbochargers (Q1 & Q2).

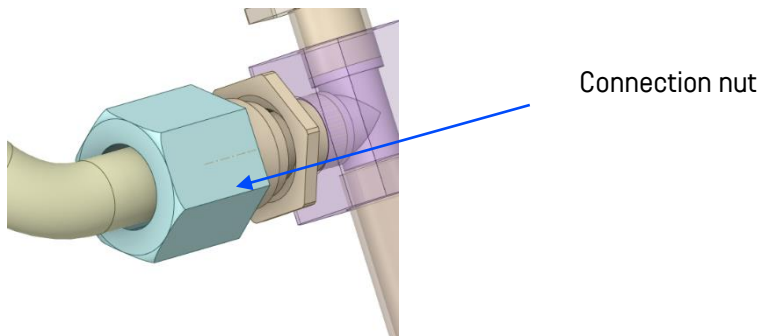
- Connection nut (M17) of the oil pipes must be unfastened.

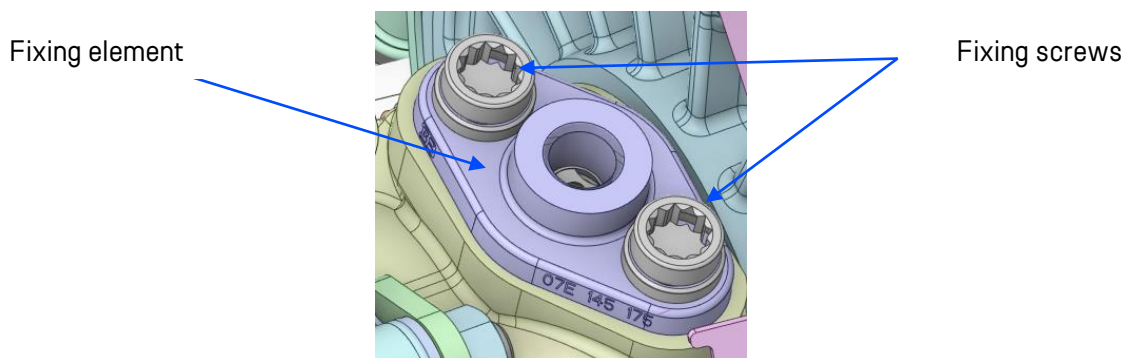
- Remove the turbo oil pipes.
- Remove the screws of the fixing element and remove it from the turbochargers (Q1 & Q2)

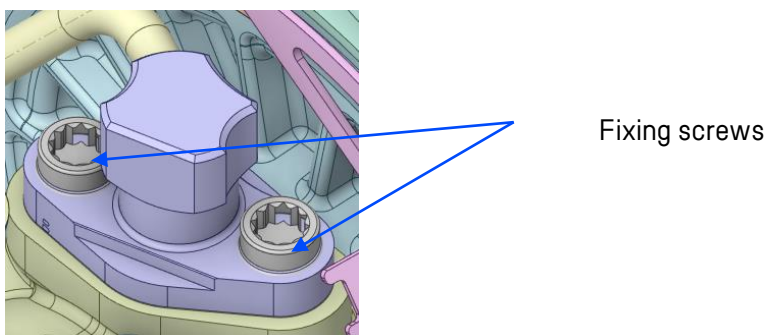
- Carefully clean the residual oil or foreign objects around the area.
- Carefully install the new valve check (Quad 1 & Quad 2).
- Carefully install the new turbocharger oil pipes (07E145140 L) and seals (07E145113).
- Screw the fastening screws of the oil pipes (M10)
- Install the new fastening screws (N 910 488 04 x4).

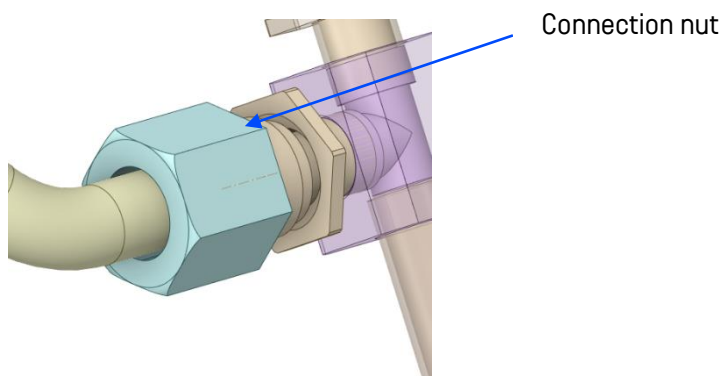
- Screw the connection nut.

- Tighten the turbocharger oil pipes to the appropriate torque.

| Designation | Part number | Quantity | Torque |
|---|---|---|---|
| Fixing screw (M10 x 20) | N 101 705 12 | 2 | 40 Nm +-4 Nm |
| Fixing screw | N 910 488 04 | 4 | 20 Nm + 90° |
| Connection nut | 07E145140 L | 1 | 35 - 3 Nm |

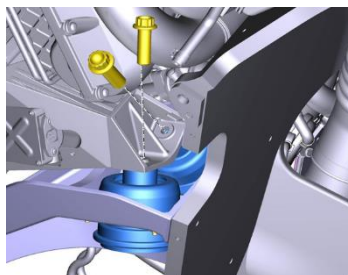
- Remove the fastening screws from the mounting element.

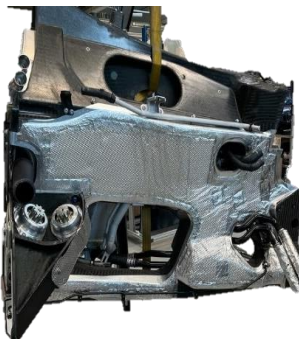
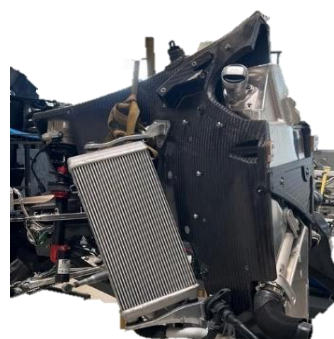
- Remove the rear right cross member with its subcomponents.

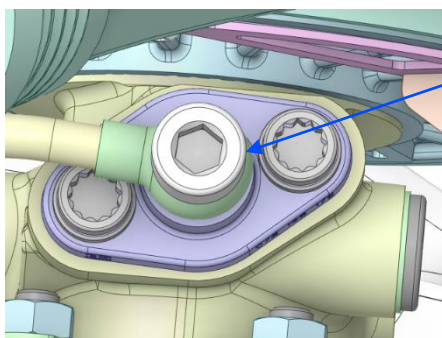
Banjo screw

- Fastening screws of the turbocharger oil pipes must be removed (M10).
- Remove the Banjo screws on the turbochargers (Quad 3 & Quad 4).

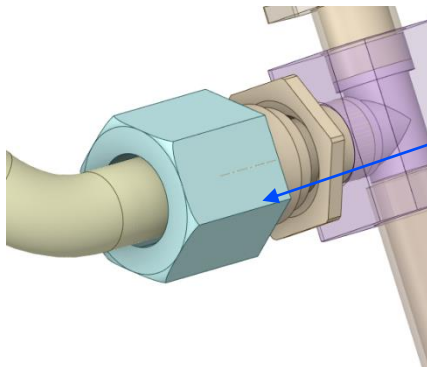
- Connection nut (M17) of the oil pipes must be unfastened.

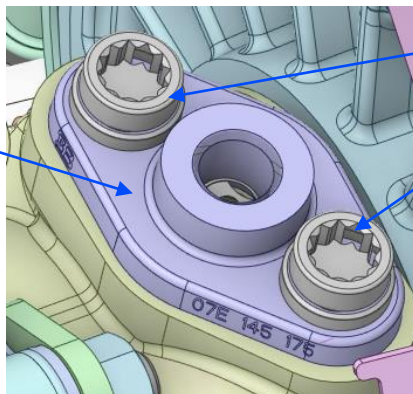
Fixing screws

- Remove the turbo oil pipes.
- Remove the screws of the fastening element and remove it from the turbochargers (Quad 3 & Quad 4)

Fixing element

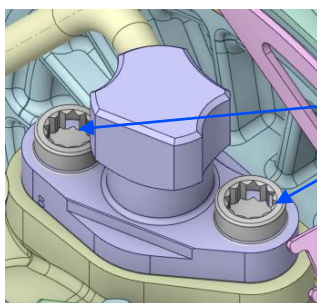
Fixing screws

- Carefully clean the residual oil or foreign objects around the area.
- Carefully install the new valve check (Quad 3 & Quad 4).
- Carefully install the new turbocharger oil pipes (07E145140 L) and seals (07E145113).
- Screw the fastening screws of the oil pipes (M10)
- Install the new fastening screws (N 910 488 04 x4).

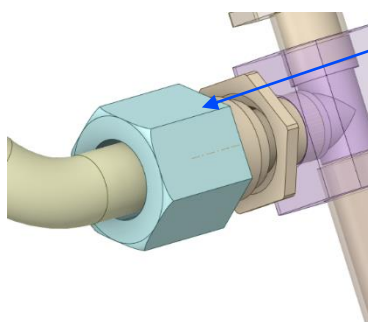
- Screw the connection nut.

- Tighten the turbocharger oil pipes to the appropriate torque.

| Designation | Part number | Quantity | Torque |
|---|---|---|---|
| Fixing screw (M10 x 20) | N 101 705 12 | 2 | 40 Nm +-4 Nm |
| Fixing screw | N 910 488 04 | 4 | 20 Nm + 90° |
| Connection nut | 07E 145 141 L | 1 | 35 +- 3 Nm |
