Technical Instruction TI – NA026

Enviro200 Change of Brake Calliper Dust Caps

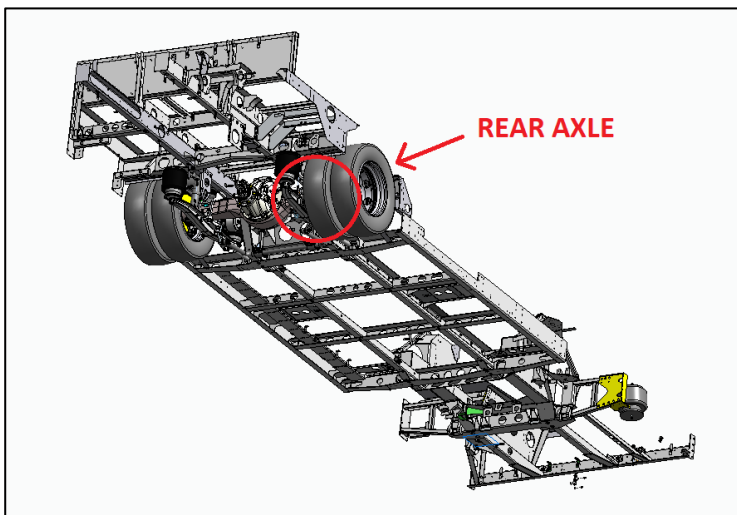
Problem Location

- A fouling condition has been discovered between the spring beam and the lower brake calliper dust cap for the slider pins, occurring when brake pad wear reaches approx. 50%.
- As the brake pad continues to wear beyond this level, the dust cap is deformed by the lug on the spring beam, with the paint finish on the spring beam also affected to a minor degree.
- There are 2 sizes of dust caps available for the callipers, with the larger (5/8”) cap fitted by default. However, on the lower slider pin, the shorter (1/8”) cap can be fitted as there is no protrusion in this area (i.e., the cavity offered by the larger cap is not required).
- This does not have a noticeable impact on the functionality of the brake callipers and was discovered through visual inspection only. The damage to the spring beams is negligible and of no concern.

Please refer to the below images showing the affected location on the vehicle:

IMPORTANT: This issue affects both the off-side and near-side brake callipers.

Replace the 5/8" dust cap on the lower calliper slider pin with the 1/8" one supplied in the repair kit, and discard the cap taken off the calliper. Retain the larger cap from the kit for potential future use.
