SS 288TBB HDX / EFX front lighting replacement

Rear stop/ tail / turn signal lights no longer available from the vender

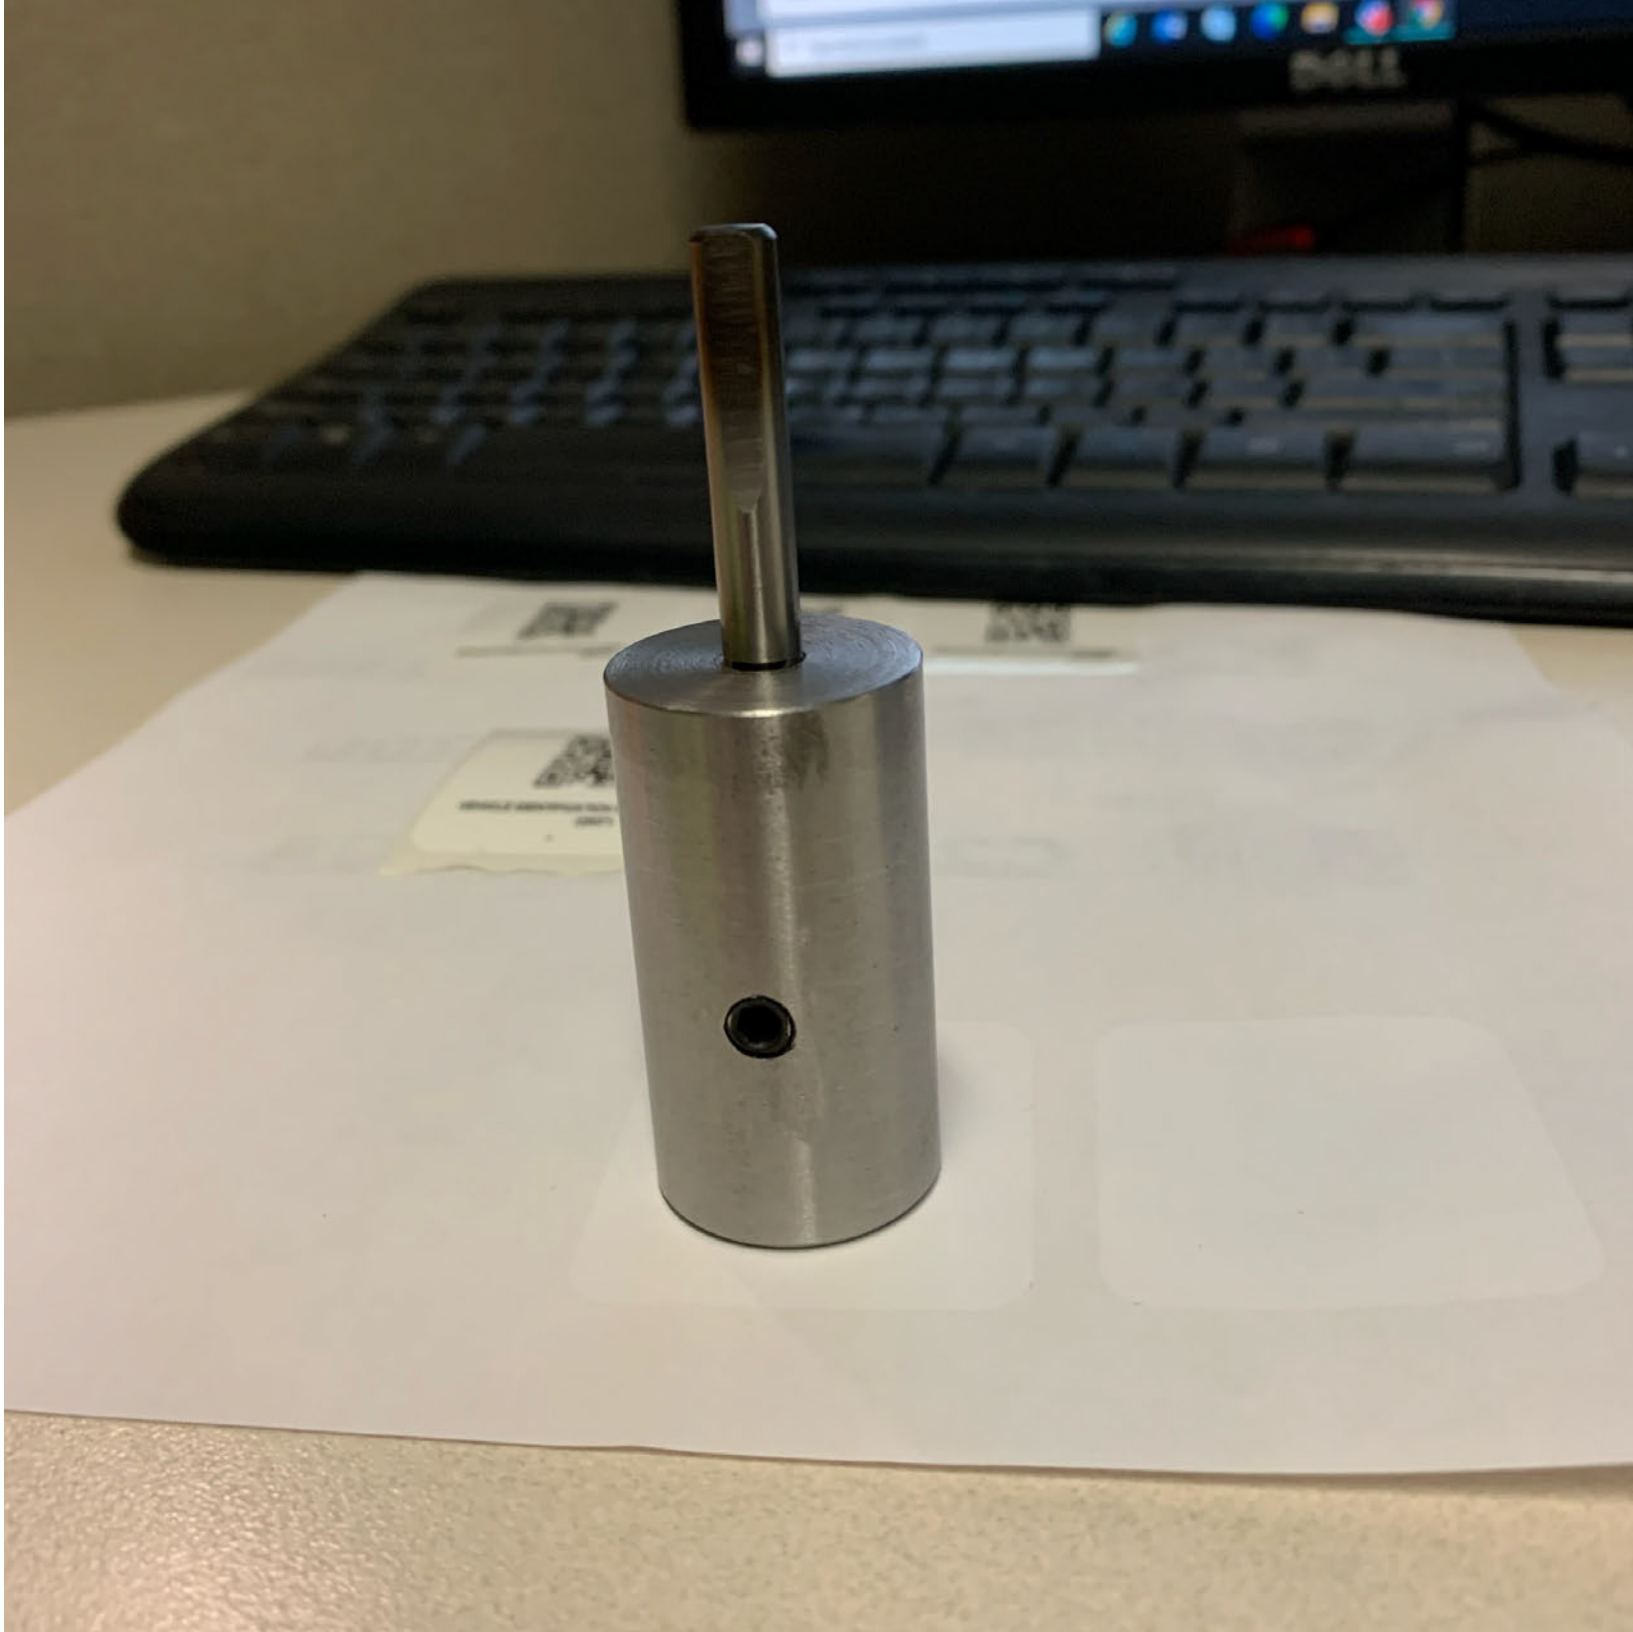
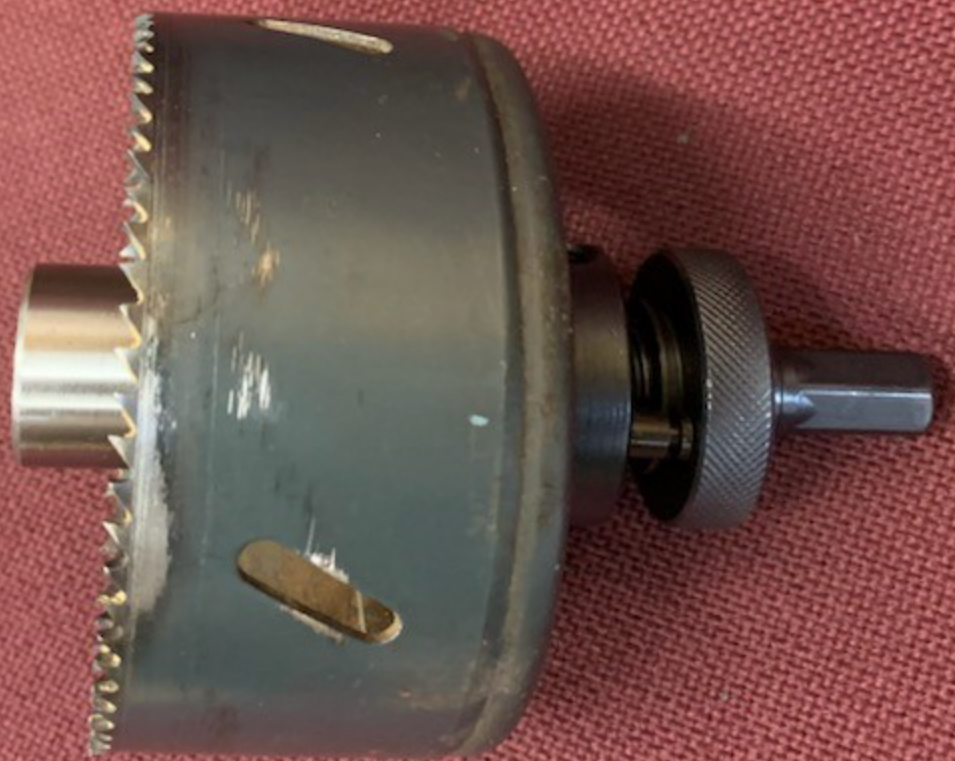
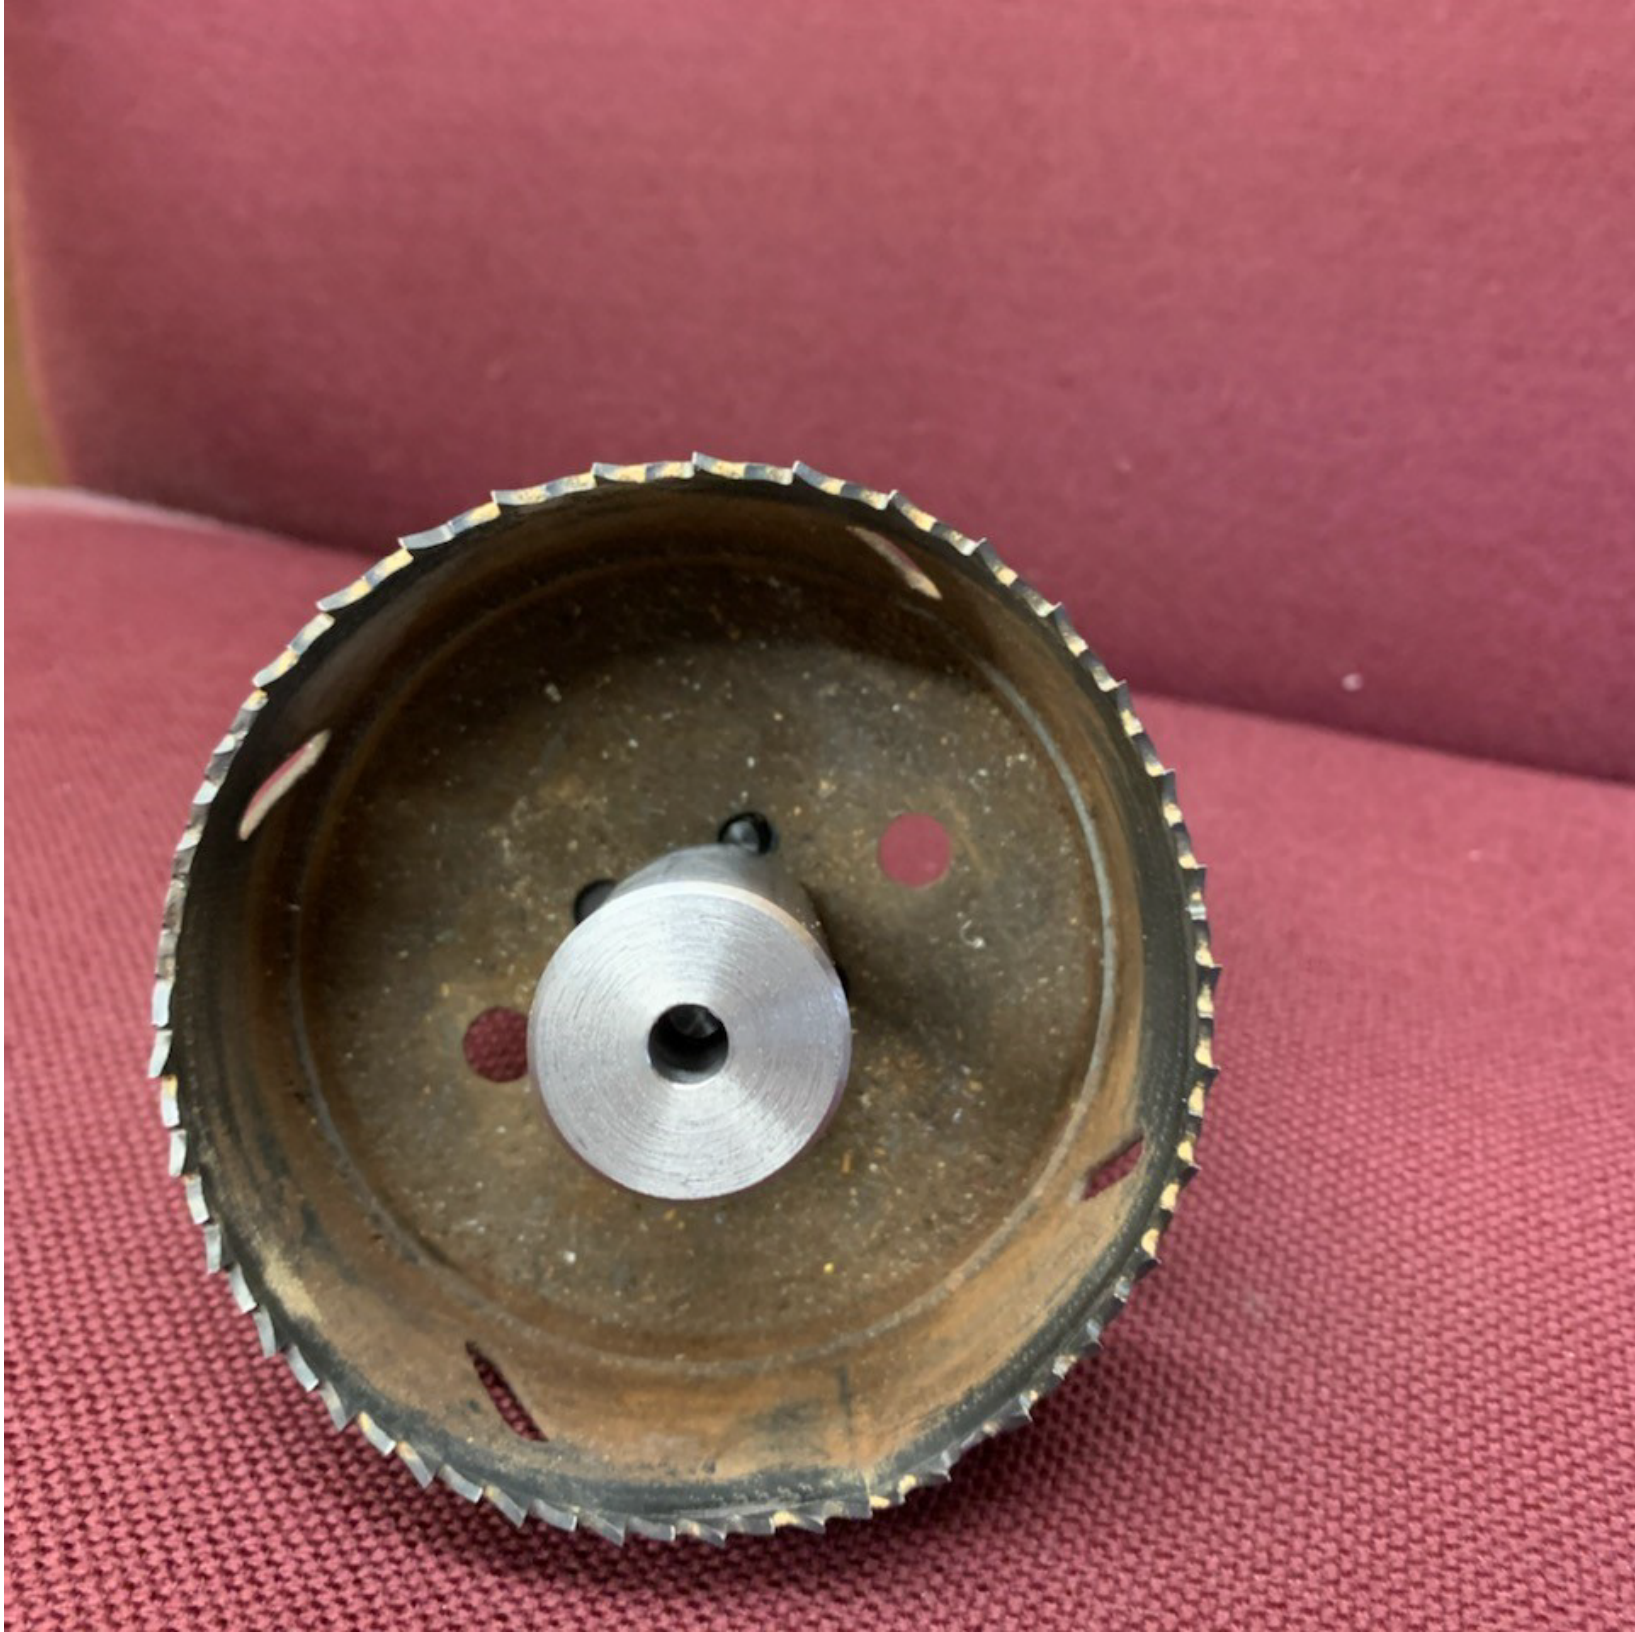
Attach is the spreadsheet for which light is replaced with the new light assembly. Depending on your unit some modification is needed. The Old light the wiring pass thru was one inch. The new light a 3 inch hole is needed. Attach photo example of a tool that can be made, not purchase from TBB to help on the process
