PRODUCT CAMPAIGN BULLETIN

APPLICABILITY: 2025MY Forester

NUMBER: WRB-25

SUBJECT: Safety Recall and Stop Sale – Incorrect Wheel Lug Seat Surface

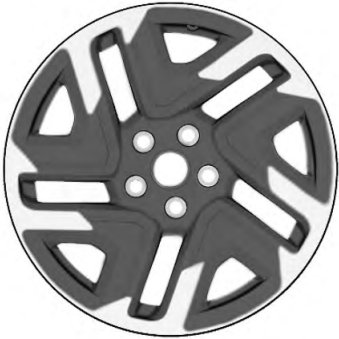
Part Name		Part Number	Qty	Image
DISC WHEEL AL 18 NOTE: See below for information on placing part orders		28111SL0409S	As Needed

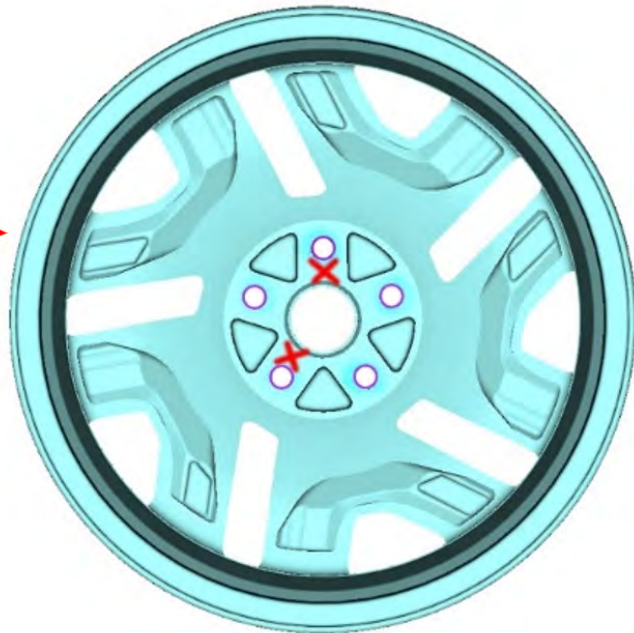
This EXAMPLE image shows a wheel with two failing lug holes.

Send an email to the Parts Information Coordinators (PICs) at Picemail@subaru.com. The subject line of the email should include reference to the WRB-25 recall, your 6- digit retailer code, the last 8 characters of the vehicle identification number (VIN) requiring the wheel replacement, and the number of wheels needed (Example: WRB-25- 030291- SH123456- 1 wheel). In addition, clear photos of the wheel(s) will be required. The EXAMPLE image below provides clear instructions on how to mark the holes on wheels that fail inspection. Clear photos of the wheel(s) with these markings must be attached to the email that is sent to the PICs. To ensure efficient review and order placement, please be sure to include the requested photo in a .jpeg format.

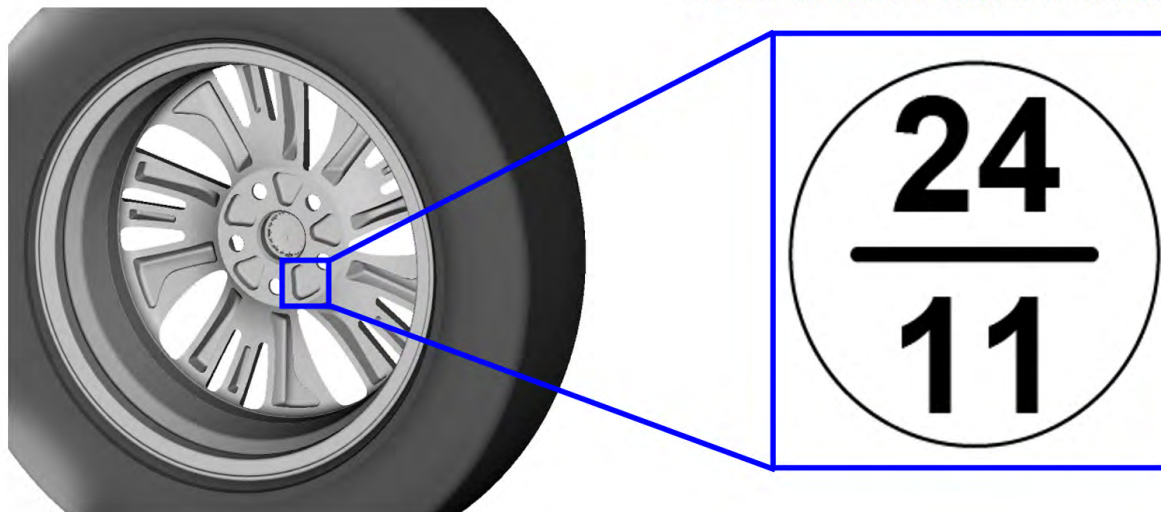
IMPORTANT: All 18-inch aluminum alloy wheels manufactured in November 2024 and after are shipped with the countermeasures. One of the five triangular indentations on the back of the wheel is stamped with the year and month of manufacture. Any 18-inch aluminum alloy wheels that were purchased as spare parts before and are subject to inspection.

EXAMPLE: Manufactured in November 2024

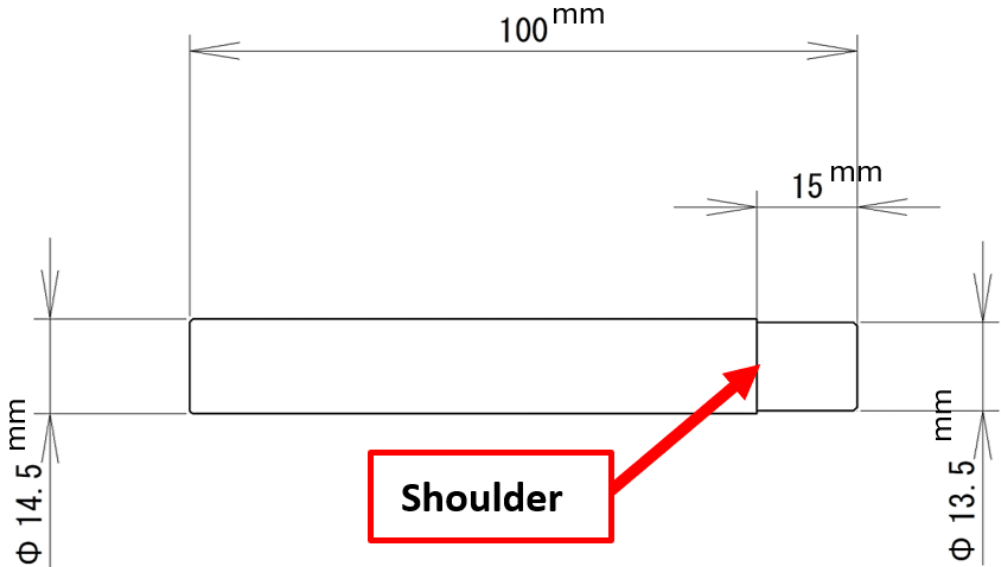
Part Name	Part Number	Image
WRB-25 Inspection Gauge	28199SL000

NOTE: One WRB-25 Inspection Gauge will be automatically shipped to all retailers at no cost.

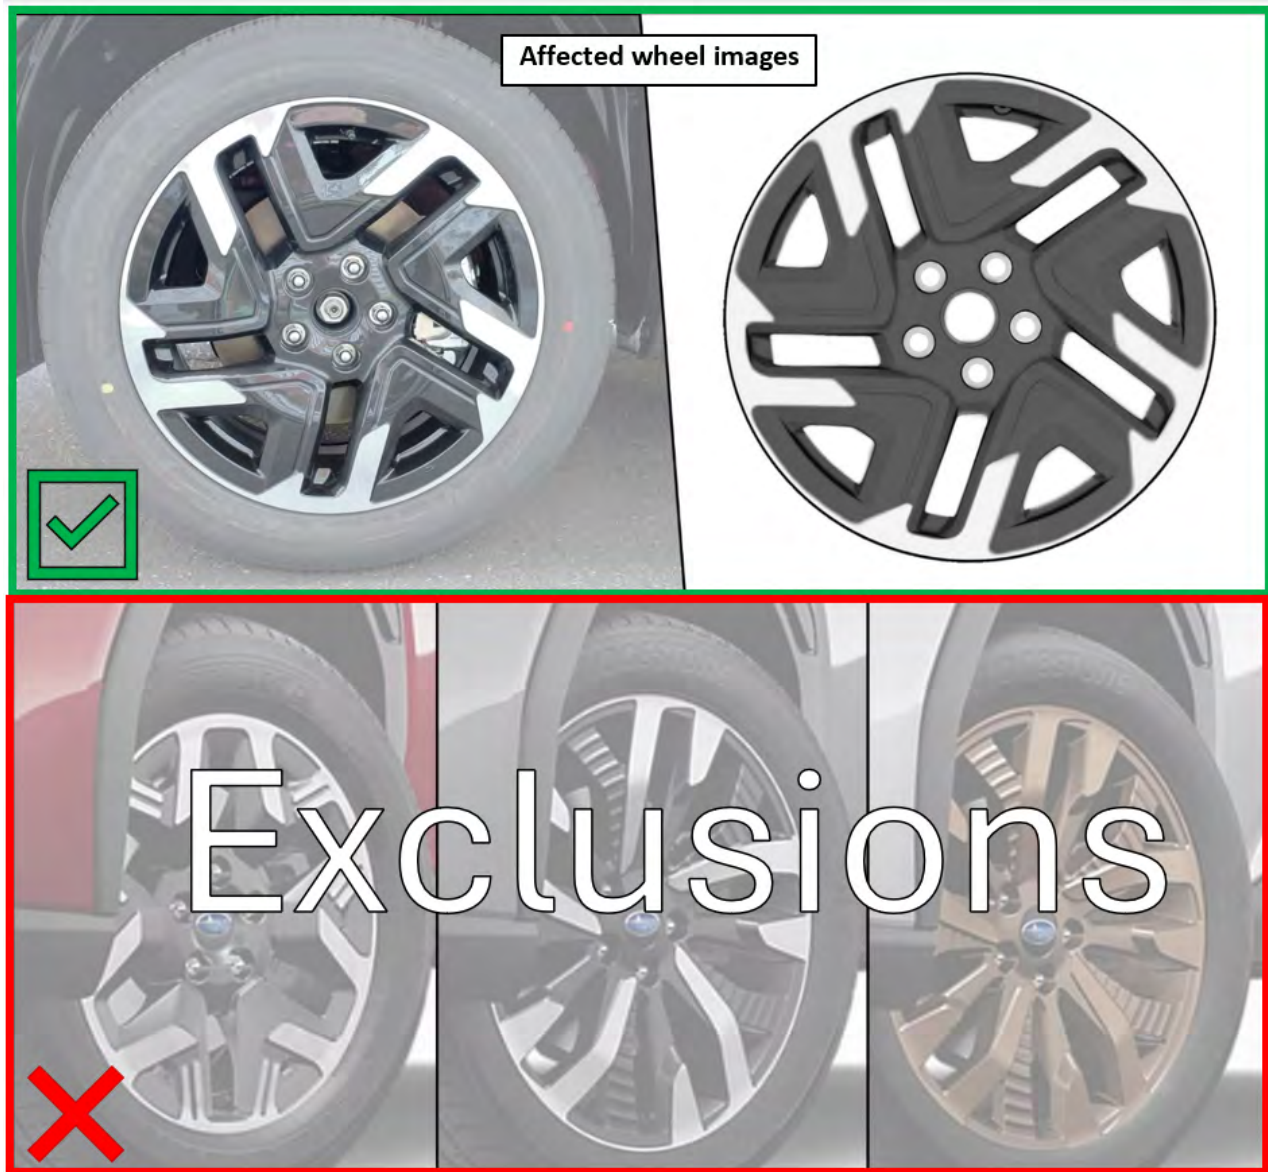
STEP 1: Confirm the affected wheels are installed on the vehicle. The applicable wheels are **ONLY** the 18-inch wheels (p.n. 28111SL0409S) shown below.

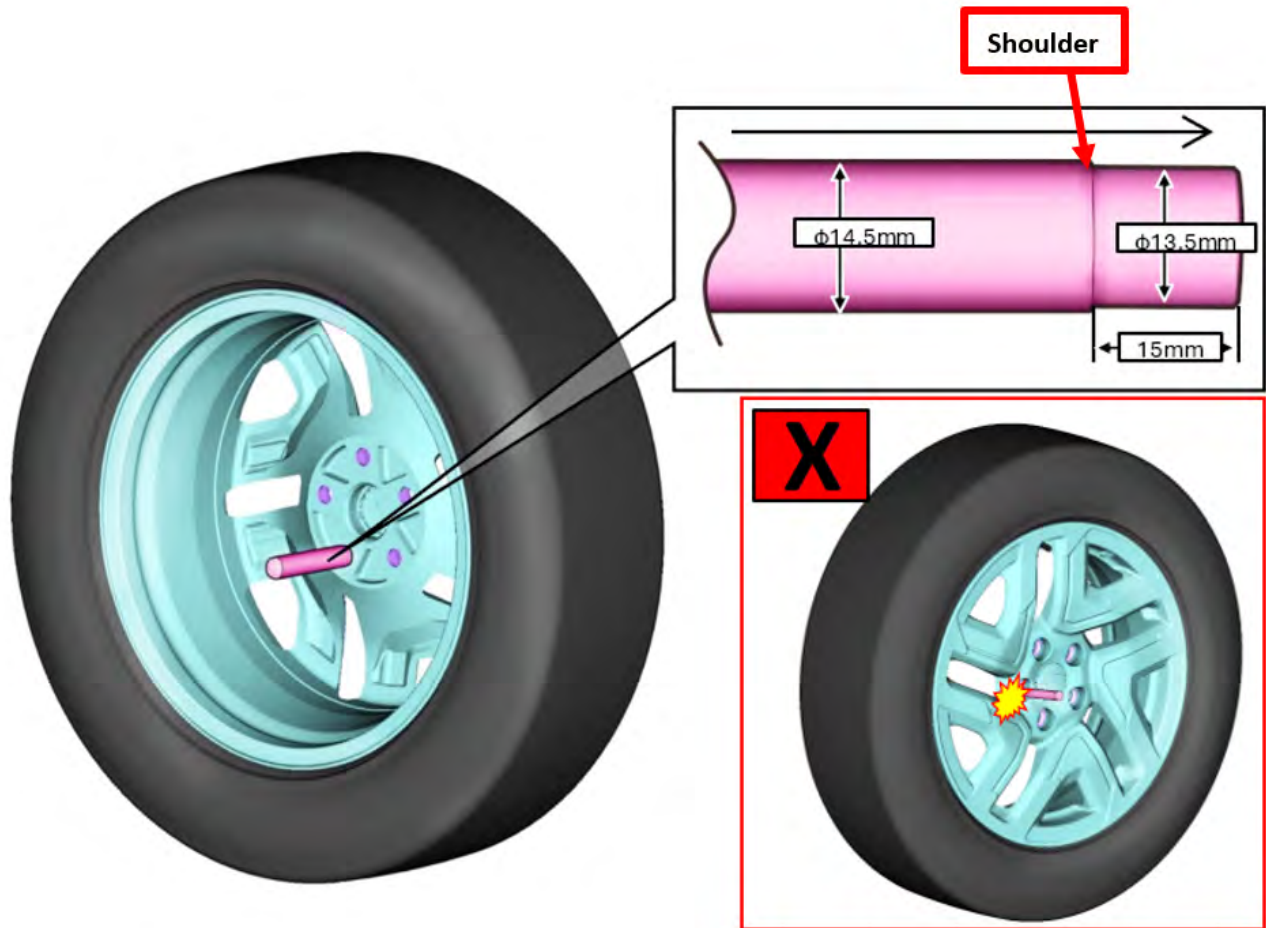
STEP 5: Slowly insert the WRB-25 Inspection Gauge into all five holes from the backside of each wheel. For a more accurate result, perform the inspection with the wheel positioned upright instead of facing down.

NOTE: The shoulder of the gauge is 13.5mm in diameter and 15mm in length.

CAUTION: DO NOT insert the inspection gauge from the front side of the wheel.

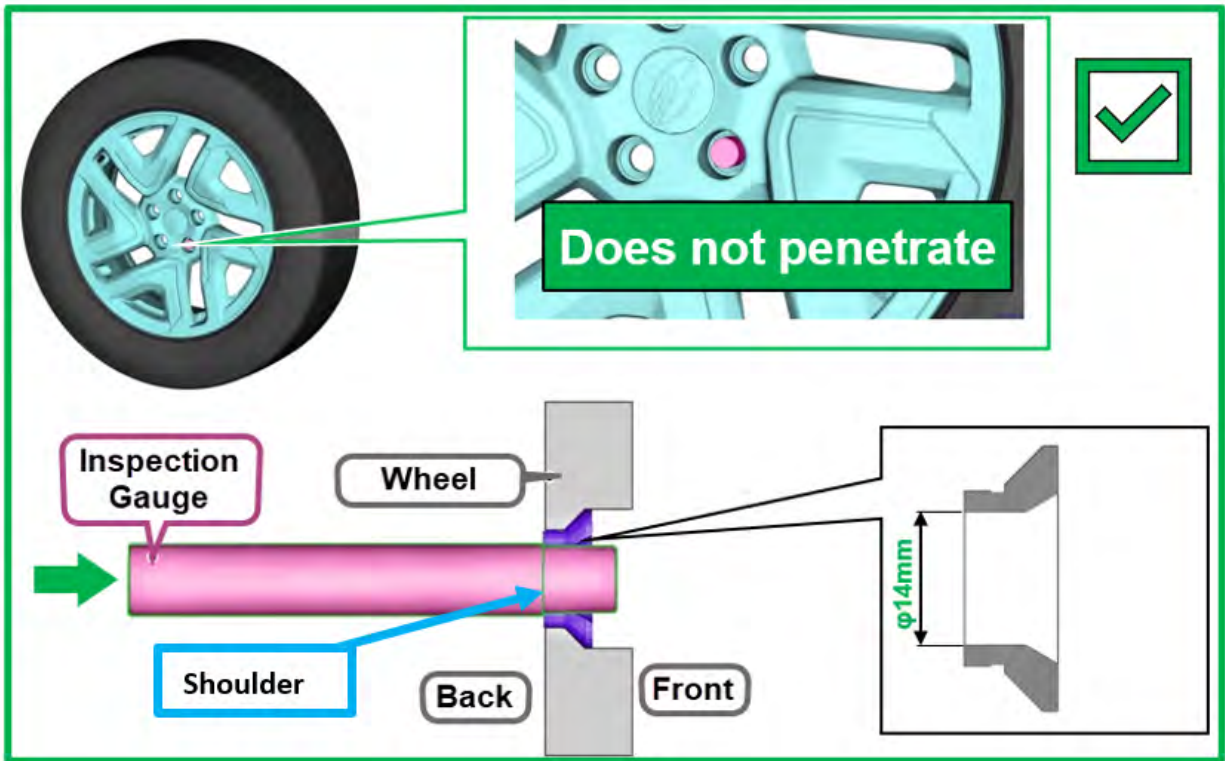
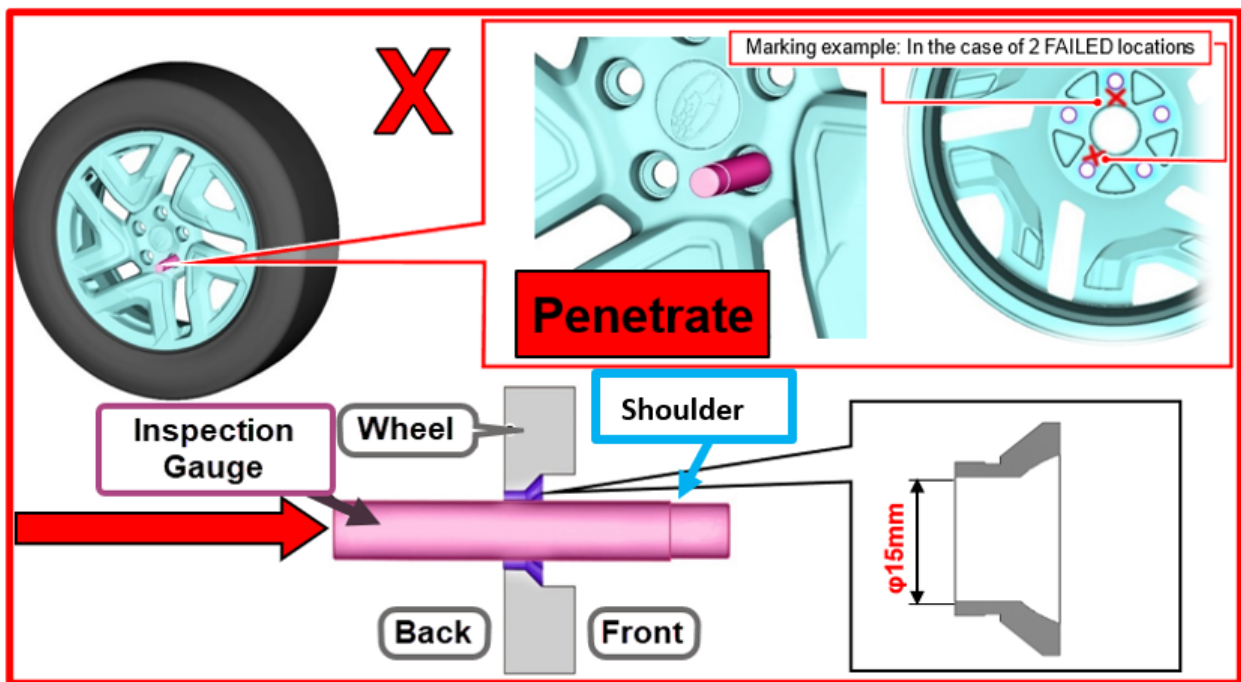
IMPORTANT: The inspection gauge will either stop at the 15mm shoulder or fully penetrate through the lug hole. Refer to the images below and additional information on the next page prior to proceeding.

Did the inspection gauge fully penetrate through any of the wheel lug holes past the 15mm shoulder?

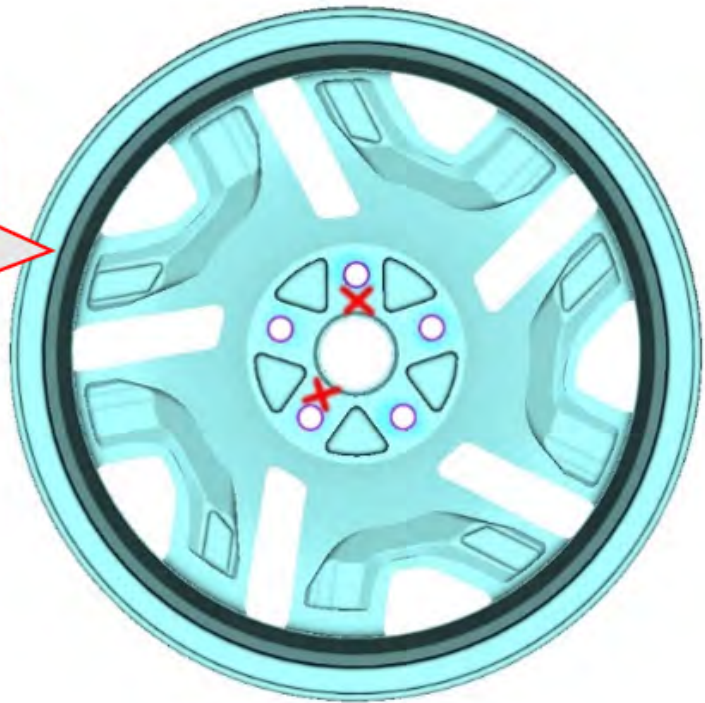
This EXAMPLE image shows a wheel with two failing lug holes.

YES: Using a permanent marker or paint pen, mark the failed inspection holes with an “X” on the back side of the wheel. This will prevent the failed wheels becoming confused passing wheels. Proceed to **STEP 6**.

STEP 6: Clear photos of the wheels will be required. The **EXAMPLE** image above provides clear instructions on how to mark the holes on a wheel that fail inspection. Provide clear photos of the affected wheels to your retailer’s parts department. The parts department can then refer to the information supplied on page# 4 of this bulletin for instructions on obtaining the necessary parts. Once all required parts are received, Proceed to **STEP 7**.

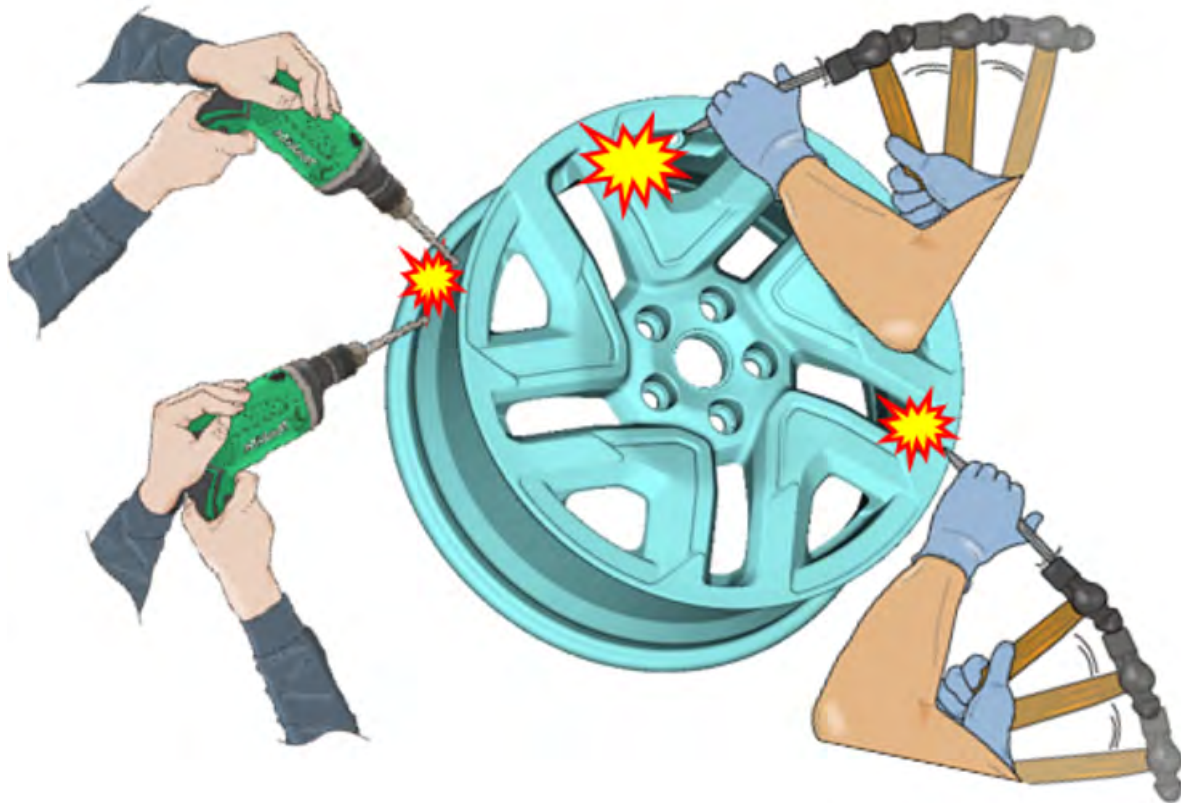
These methods will ensure the wheel(s) will not be able to hold any air preventing any possible re-use.

STEP 9: Wheels failing the inspection process **MUST** be destroyed and properly recycled. The wheels can be destroyed using any of the following three methods:

METHOD 1: Using a hammer and punch to deform the tire valve area.

METHOD 2: Drill a hole in the center of the wheel.

METHOD 3: Using a hammer and punch, puncture the center of the wheel.
