## Technical Service Bulletin

| <b>CAMPAIGN</b> | <b>25-01-019G</b> |
| <b>FEBRUARY 2025</b> | <b>G80 (RG3)<br/>G90 (RS4)</b> |

**SUBJECT:** A/C SUCTION AND DISCHARGE HOSE SEAL WASHER REPLACEMENT (SERVICE CAMPAIGN 911G)

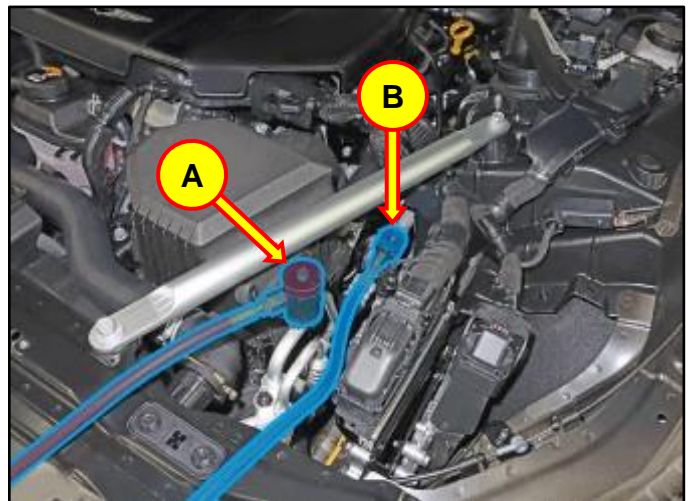
1. Refer to the shop manual to connect the refrigerant recovery/recycling equipment to the high-pressure service port (A) and low-pressure service port (B) and recover the refrigerant.

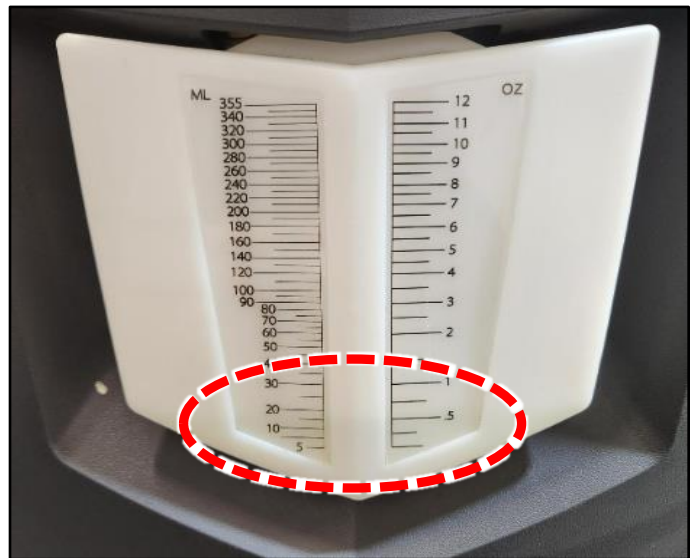
2. Measure the amount of PAG oil drained during recovery and record it so that amount can be injected later during the recharging process.

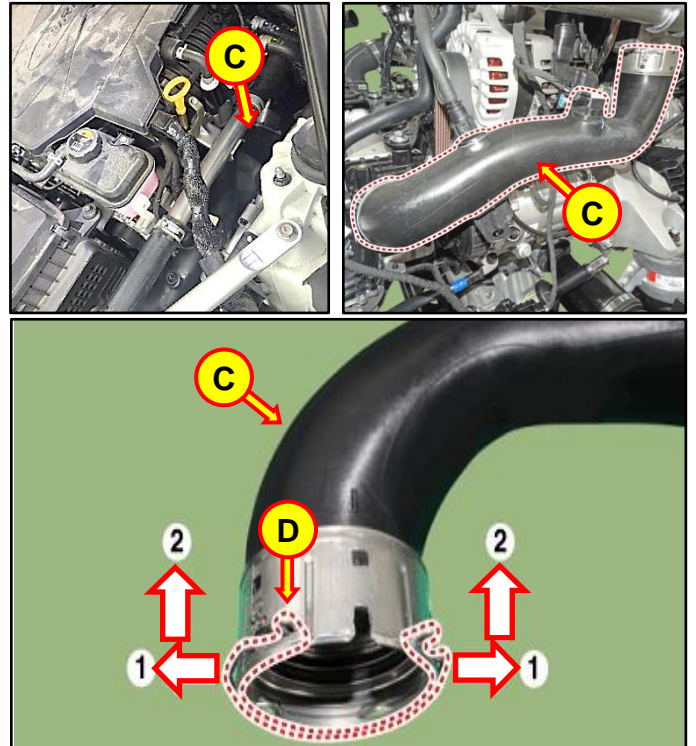
3. Record the guest's radio presets and then disconnect the negative battery (-) terminal.
4. Disconnect the intercooler hose (C) by pulling the sides (1) of the quick connector clamp (D) then remove the intercooler hose by pulling in the direction (2) as shown in the third photo.

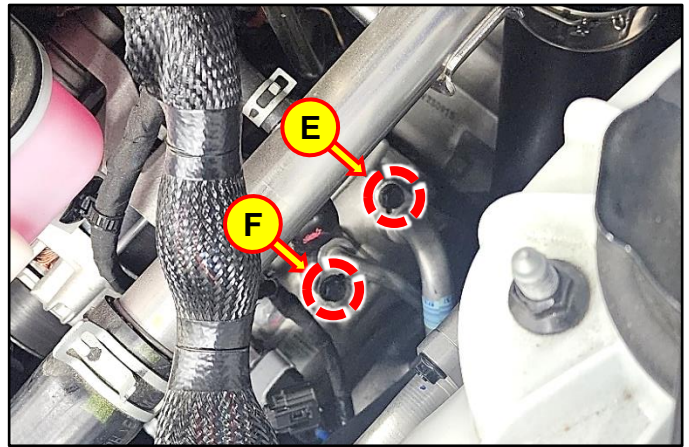
- Remove the fixing bolts and remove the A/C suction hose (E) and discharge hose (F).

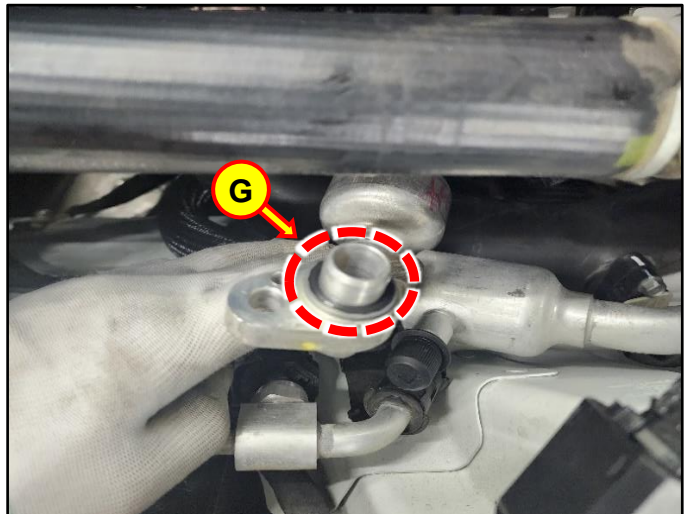
- Remove the suction hose seal washer (G).

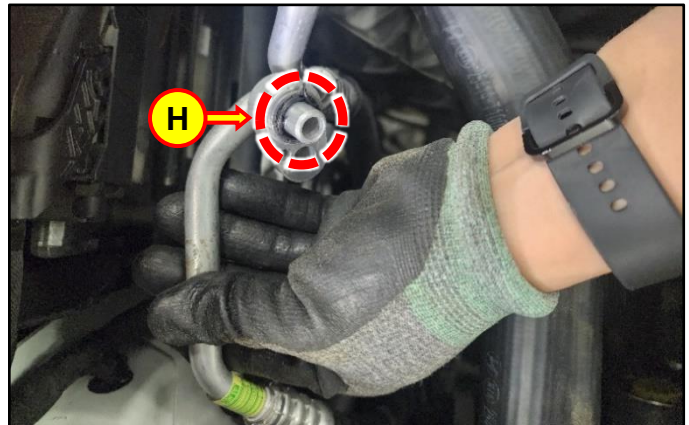
- Remove the discharge hose seal washer (H).

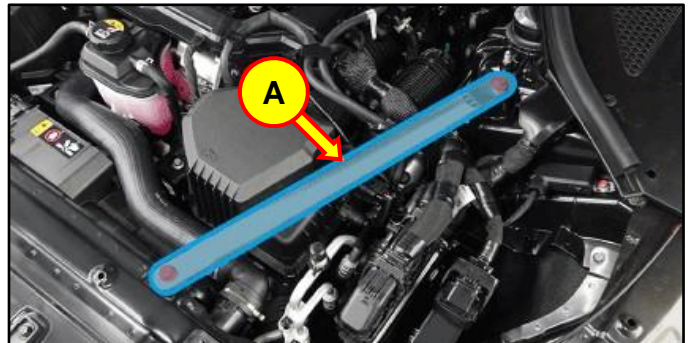
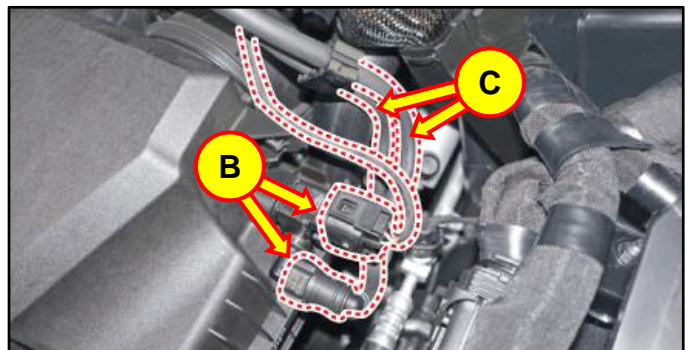
1. Record the guest's radio presets and then disconnect the negative battery (-) terminal.
2. Remove LH strut bar (A).
3. Disconnect the dual purge connectors (B) and dual purge hoses (C) on the air cleaner assembly.

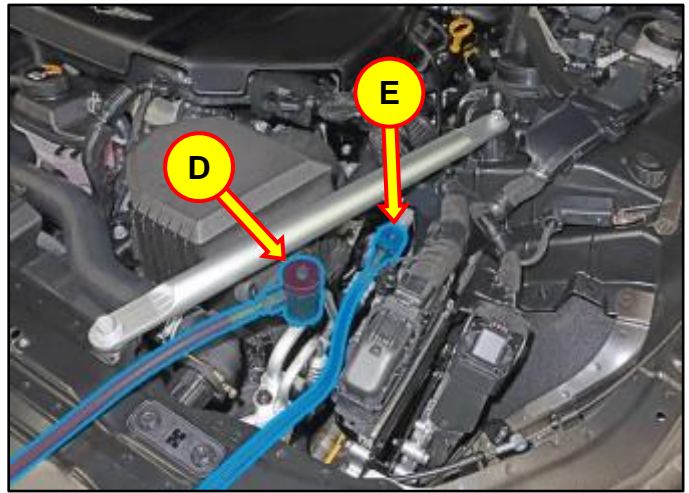
4. Refer to the shop manual to connect the refrigerant recovery/recycling equipment to the high-pressure service port (D) and low-pressure service port (E) and recover the refrigerant.

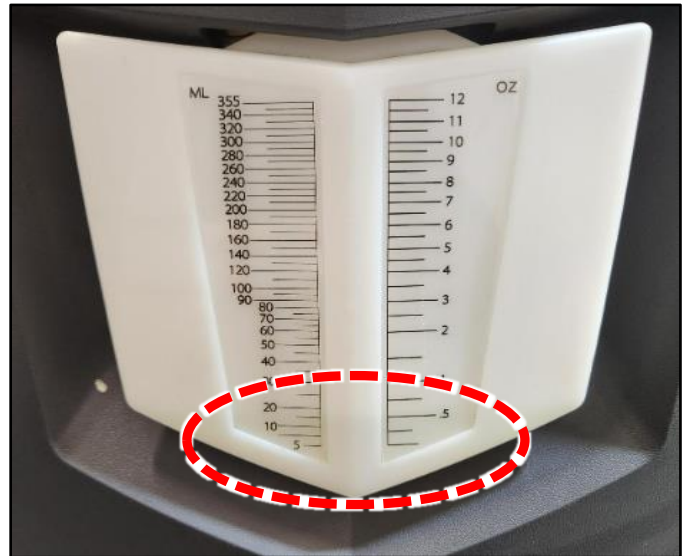
- 5. Measure the amount of PAG oil drained during recovery and record it so that amount can be injected later during the recharging process.

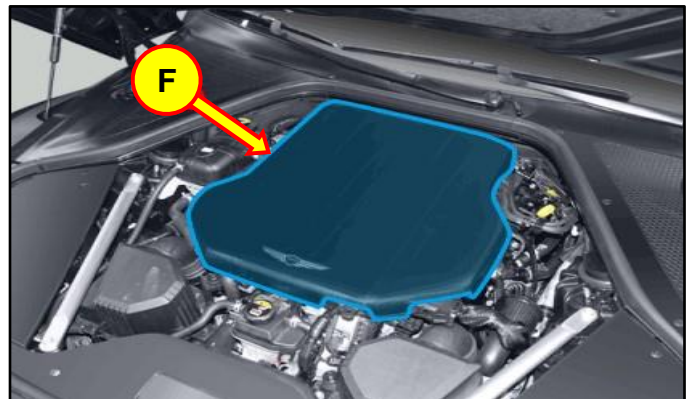
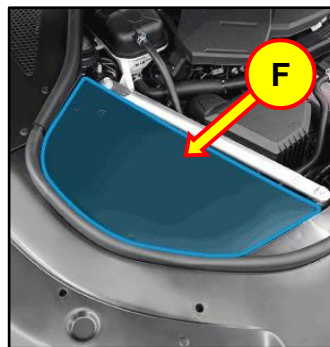
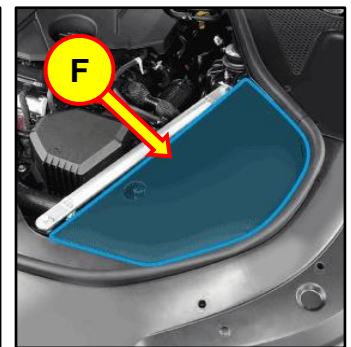
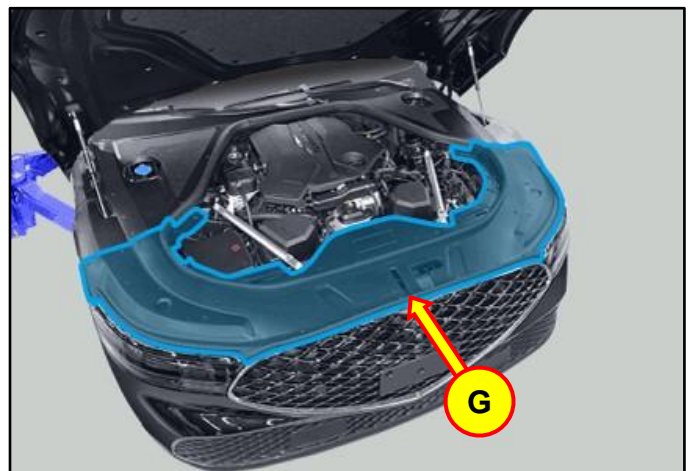
- 6. Remove the engine covers (F) and engine room cover (G).

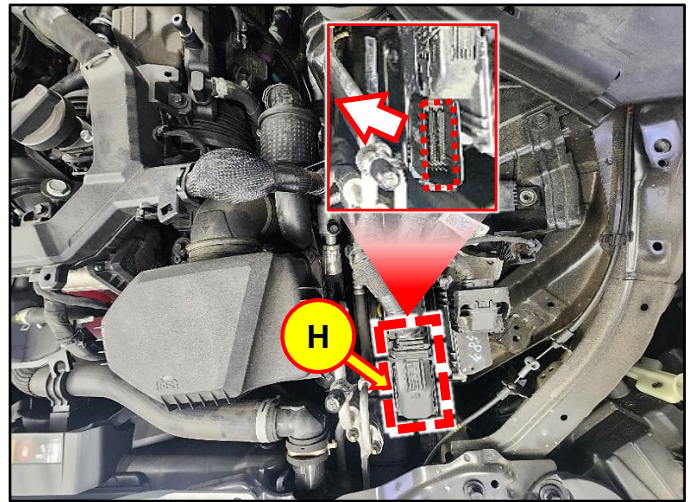
7. Disconnect the ECM connector (H) and place it in the direction of the white arrow as shown.

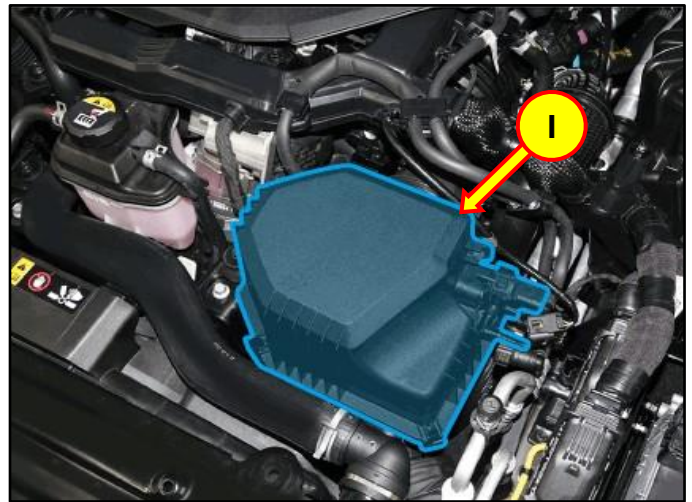
8. Remove the air cleaner assembly (I).

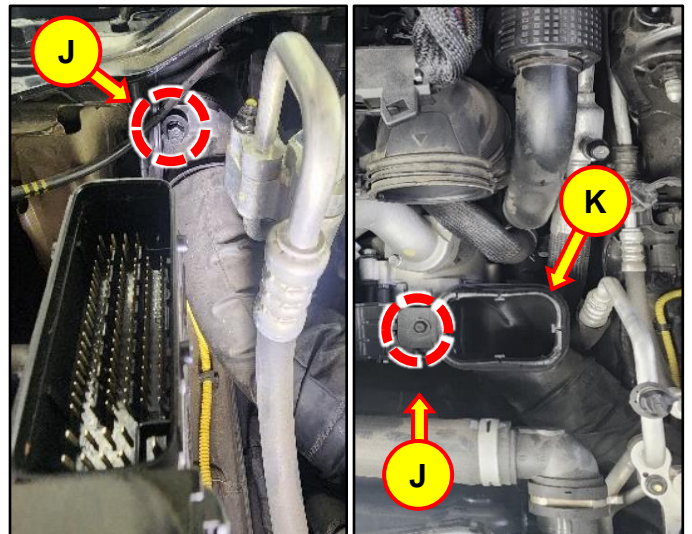
9. Remove the two fixing bolts (J) and remove the air duct (K).

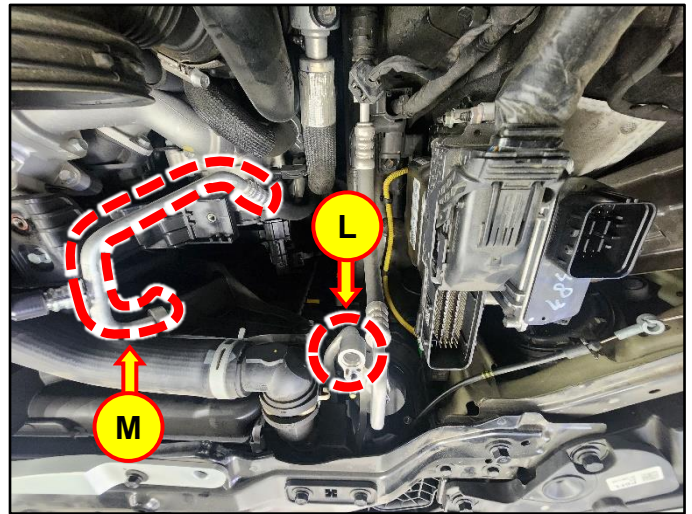
10. Remove the mounting nut (L) and disconnect the discharge line (M).

Do **NOT** remove the suction line mounting nut directly next to the discharge line.

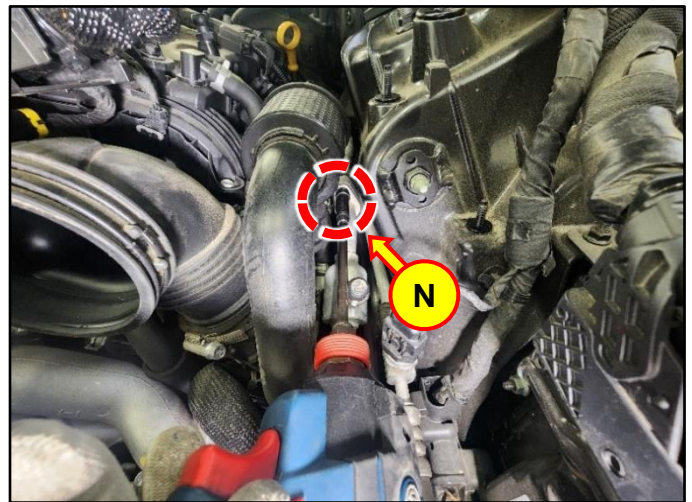
11. Remove the suction line mounting nut (N) and disconnect the suction line.

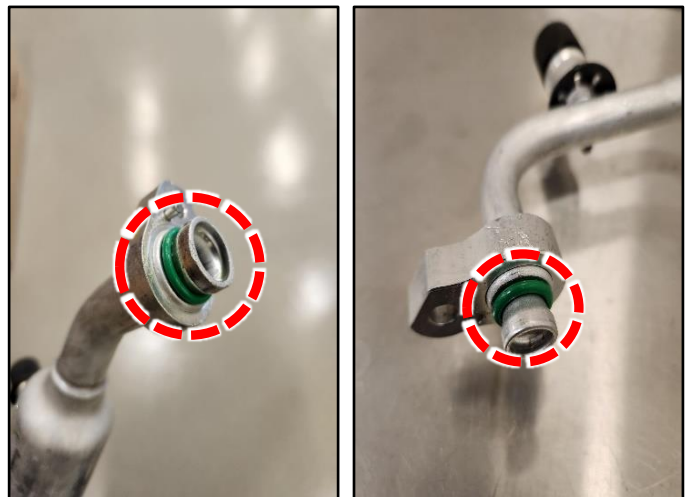
12. Remove the suction and discharge line O-rings.

Do **NOT** re-use the green suction and discharge line O-rings.

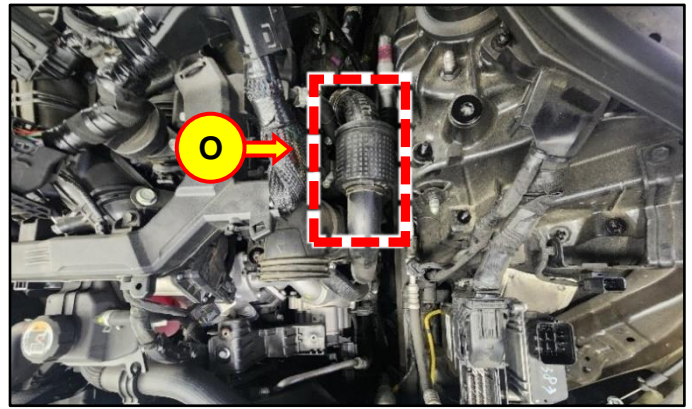
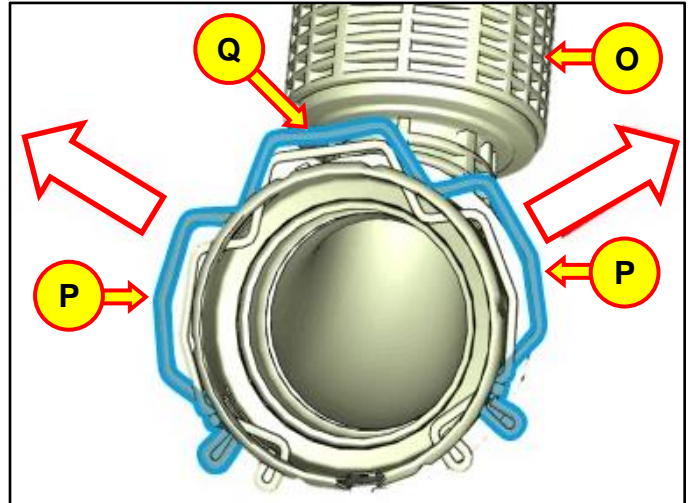
13. Disconnect the intercooler hose (O) from the quick connector clamp by pulling the sides (P) and top (Q). Remove the intercooler hose.

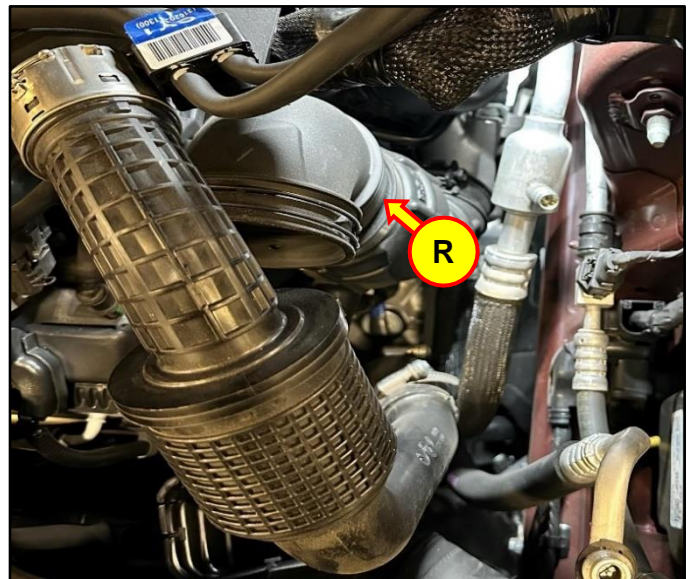
14. Loosen the fixing clamp and remove the air intake hose (R).

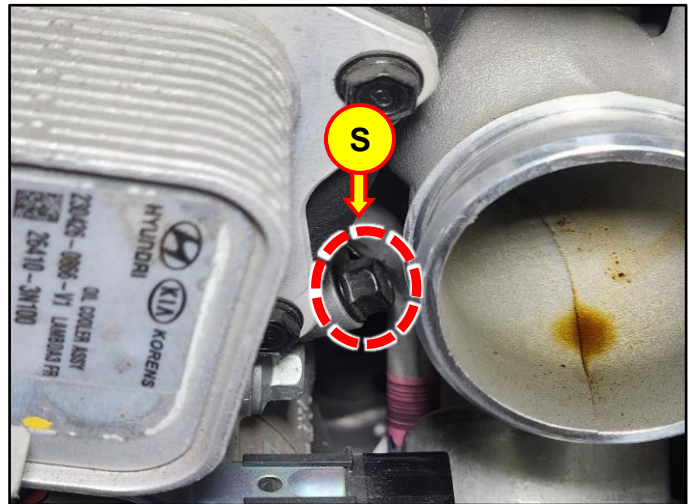
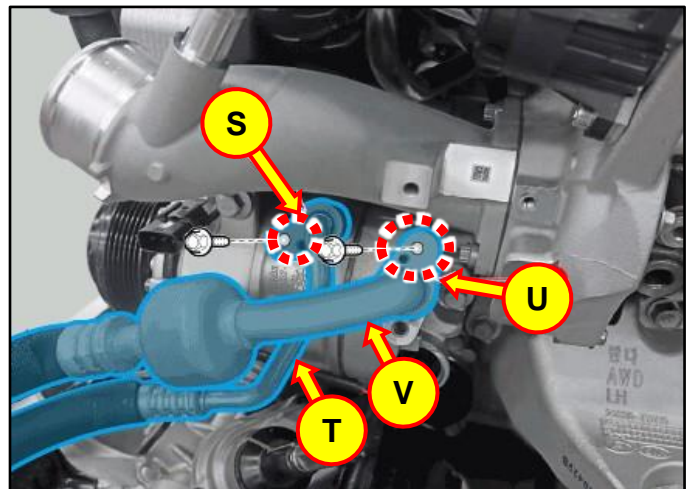
15. Remove the mounting bolt (S) then disconnect the discharge hose (T).

Remove the suction hose bolt (U) and suction hose (V).

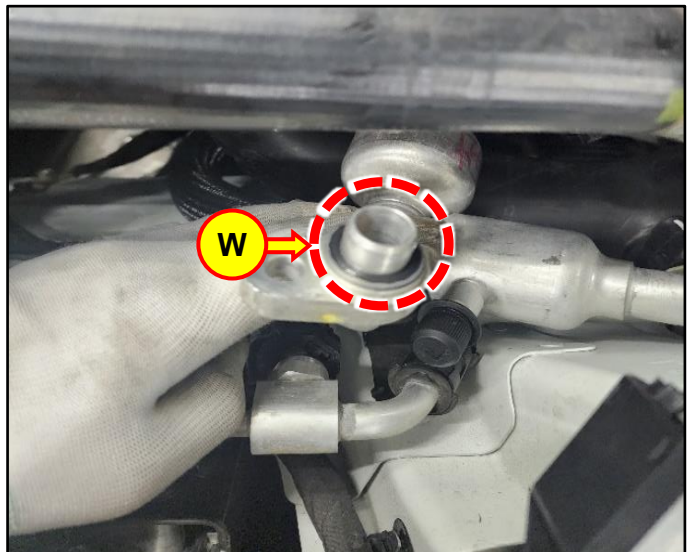
16. Remove the suction hose seal washer (W).

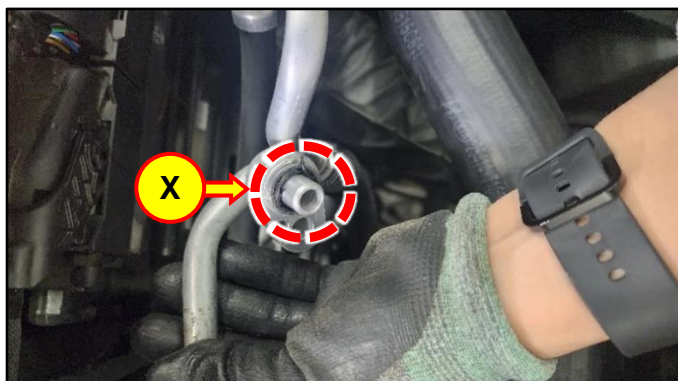
17. Remove the discharge hose seal washer (X).

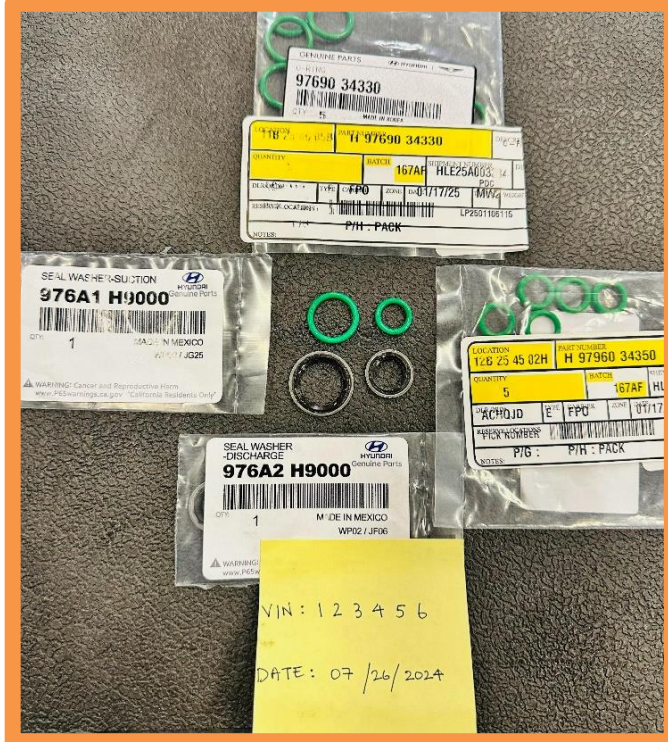
Using STUI, take a photo of the OLD discharge and suction seals and O-rings removed next to the NEW discharge and suction seals and O-rings in the bag with the last 6 digits of the VIN and the date of repair on a piece of paper.

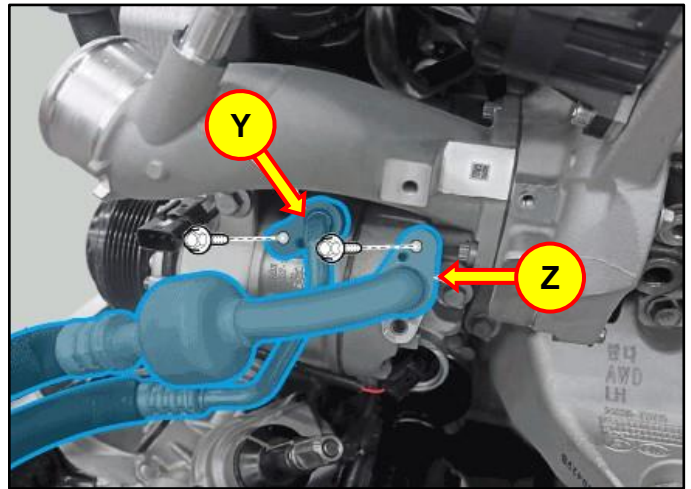
20. Reinstall the discharge hose (Y) onto the compressor assembly, then the suction hose (Z).
