**Title:** Next Gen Bus Top Step Tread Nosing Repair

**Applies To:** Next Gen Bus, PB11000 and PC11000

This document will guide the user through repairing a loose or raised top step nosing for Next Gen Bus.

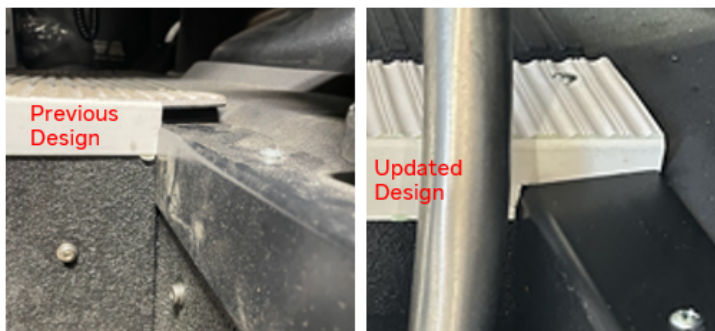
**Note:** There has been a design change to the top tread step nosing that minimizes the gaps on the forward side of the tread step nosing (see below). A gap can be seen in the previous design that can be identified from outside the front door, looking towards the top step inside. Updated Step Tread Part Numbers: 4630982C1(white), 4630983C1 (yellow).

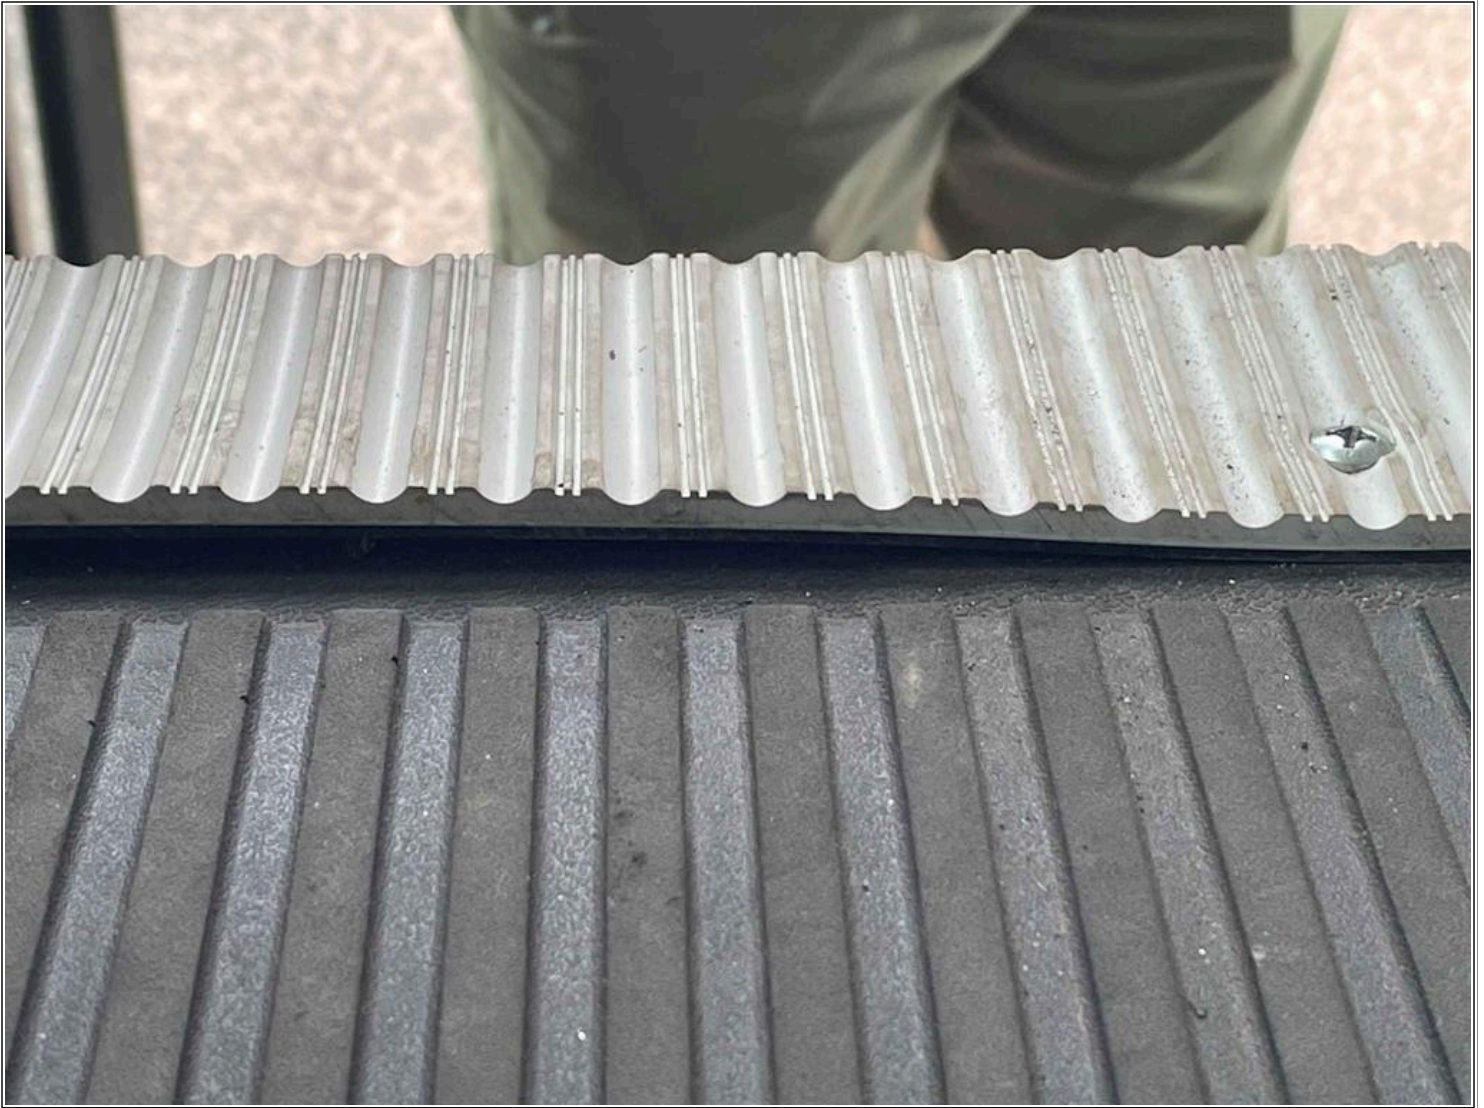
**Figure #1: Step Tread Nosing Gap Example**

Step nosing is loose, wavy, or does not sit flat to the step surface; see Figure 1 below. The gap can be seen from the driver's seat, looking towards the top step tread nosing.

Notice that the tread step nosing is not sitting flush to the floor.

| Step | Action | Decision |
|---|---|---|
| #1 | <b>DIAGNOSTIC:</b><br><br>Is the top step nosing raised or not flush to the floor, as shown in Figure 1? | <b>Yes.</b> Go to Repair Section and install additional screws to secure the top step nosing to the floor |

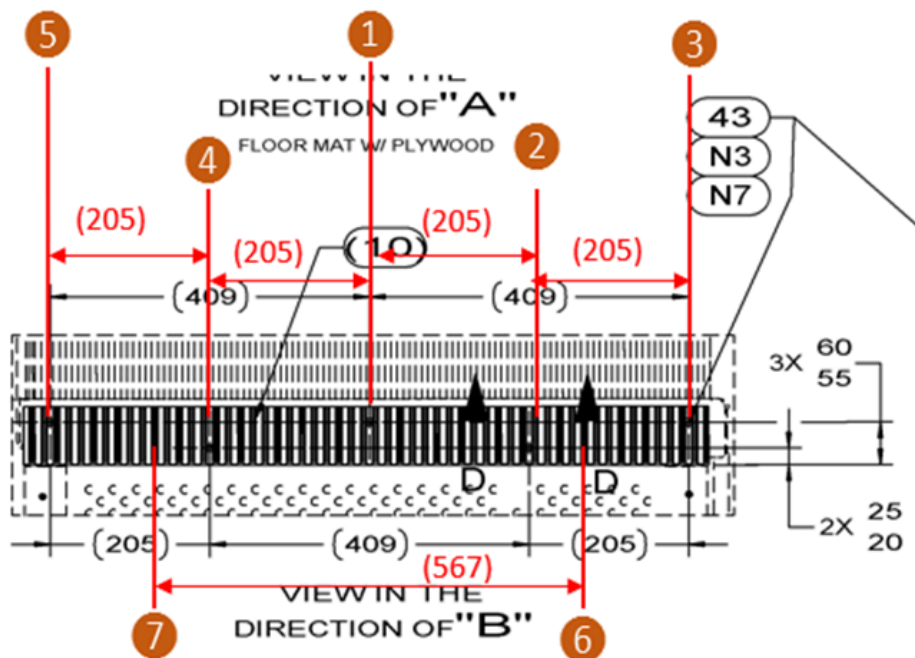
1. If not replacing nosing, then add 2 additional screws to be installed in positions 4 & 2 in the above graphic
2. If replacing nosing, Install the updated top tread step nosing with 7 screws in the locations as shown in the graphic above

- 1 a.) If not replacing step tread nosing, continue to Installation Procedure  
b.) If you are replacing step tread nose trim, remove the 5 screws fastening the top tread step nosing to the top step
2. Remove the top tread step nosing
