Front Suspension Noise While TurningSupersedes 23-094, dated November 7, 2023, to revise the information highlighted in **yellow**.**AFFECTED VEHICLES**

Year	Model	Trim Level	VIN Range
2021– 25	Accord	ALL	ALL
2022–25	Civic	ALL except Type R	ALL

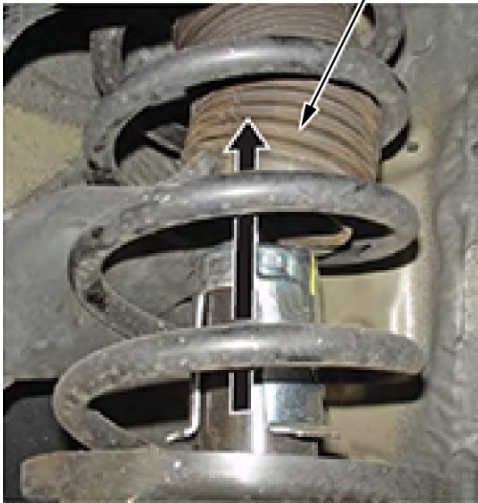
DAMPER DUST COVER

1. Raise the vehicle.
 - Accord – [Lift and Support Points](#)
 - Civic – [Lift and Support Points](#)
2. Remove the front wheels.
3. Lift the front damper dust cover to expose the damper shaft and the bump stop.

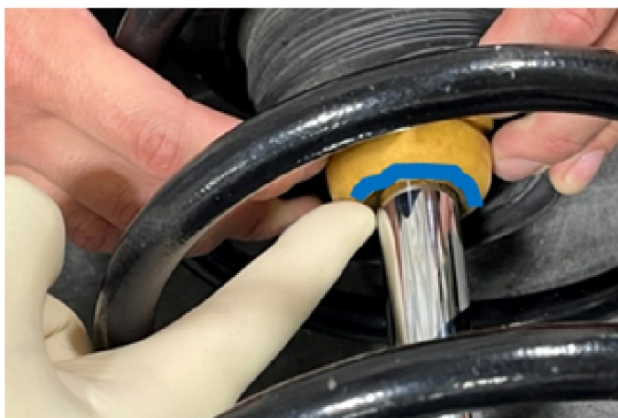
0.5 GRAM OF
SILICONE GREASE

4. Dispense approximately **0.5 g**, or about a finger-tip dab of Shin-Etsu silicone grease. Apply the grease around the bottom of the bump stop (shown in blue).

NOTE: Make sure to wipe off any grease from the shaft.
