Advanced Technical Information

9YA/9YB - 'Tail Light Faulty' Warning in the Instrument Cluster

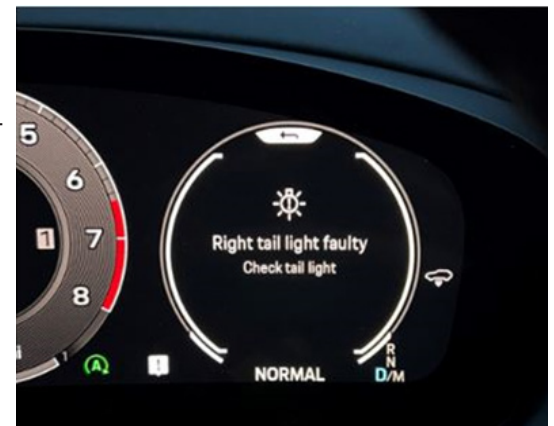
Figure 1

The customer receives a warning message in the instrument cluster indicating that a tail light is not working. (See Figure 1.)

Generally, however, the tail light does work as observed from outside the vehicle. The warning and faults are a false alarm.

- A) **False warning.** If the warning message is present and you observe that all the tail lights are illuminated, do nothing at this time. Assure the customer that the lights are visible to others on the road.
- B) **Actual tail light outage.** If the warning is present and any of the tail lights are not illuminated, replace that tail light as usual.
