ACCESSORY FIXED SIDE-STEP BRACKET CRACKED

- 21MY -On Discovery

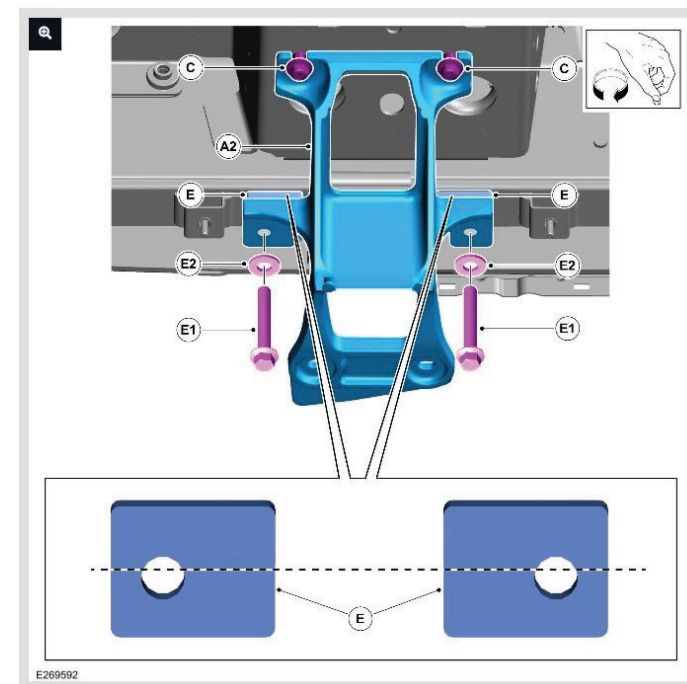
- During installation of the accessory fixed side steps (VPLRP0347 & VPLRP0530) the required spacers (kit VPLRP0487) was not installed on the front brackets as per the instructions.
- Failure to install the required spacers will lead to damage/ cracking of the front brackets.

- SSM76256 has been published to ensure that the correct spacers are installed during installation of the accessory fixed side steps.
