## 24 – 25MY Range Rover 2<sup>nd</sup> Row Seat “Bunny Hop” Latch release Procedure

Note: This procedure is an interim repair process for concerns where the 2<sup>nd</sup> row seat does not unlatch to allow the seat to tilt forward for 3<sup>rd</sup> row seat access while using the “bunny hop” feature. The seat only slides forward.

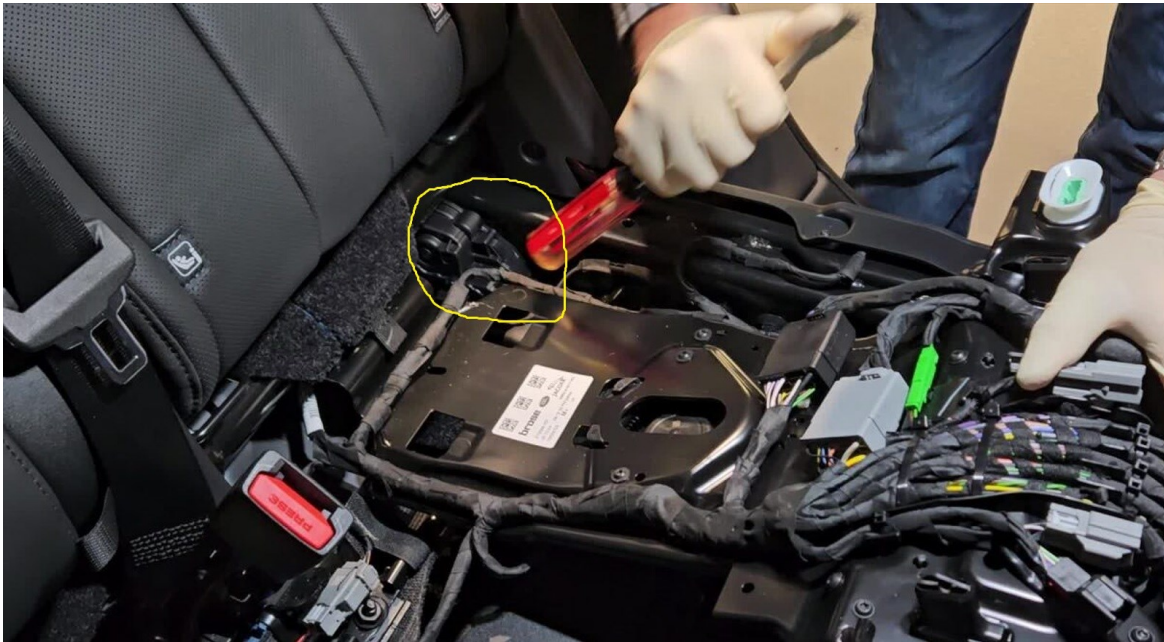
1. Confirm operation of the bunny hop feature on both 2<sup>nd</sup> row seats, follow the procedure below if either seat fails to tilt forward.
2. Remove the 2<sup>nd</sup> row seat base cushion assembly for access, refer to Workshop Manual section 501-10B: Seating – Vehicles with Core Seats, Second Row Seats > Removal and Installation > Second Row Seat Cushion – Vehicles with 7 Seats.
3. Locate the seat tilt feature latch assemblies under the seat cushion.

4. Using a suitable tool, like a medium large screwdriver handle, tap on the seat latch assembly as seen in the video. The vibration should cause the latch release motor to then move when operated to release the seat and tilt forward.

5. Once the seat is tilted forward confirm the seat latch claws move freely by closing and opening the claw with your finger.
6. Manually close both latch claws.

7. Place a suitable shop towel below the latch to protect the carpet.
8. Using a suitable PTFE dry film lubricant (Liquid Wrench Dry Film Lubricant Recommended) briefly spray the latch assembly by placing the nozzle above the latch claw, as seen in the video.

9. Manually flip the latch claw open and closed a few times, leaving the latch claws in the open position to operate the seat.
10. Operate the seat bunny hop feature 6 times then let the motors cool.
