This Service Information Bulletin provides technical, and repair procedure-related information.

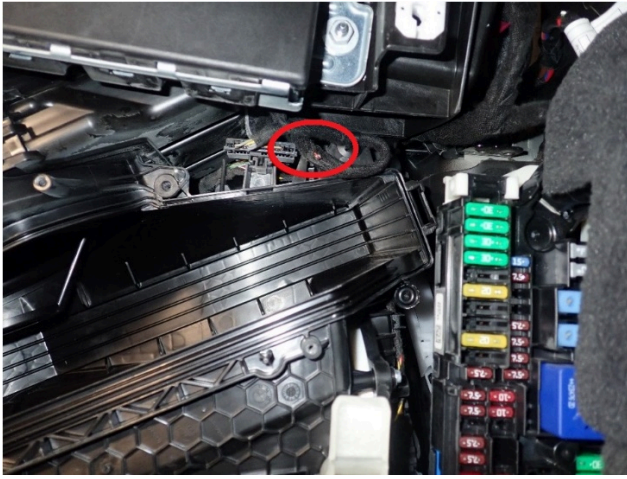
This is where the harness can be damaged when installing the cabin air filter cover screw.

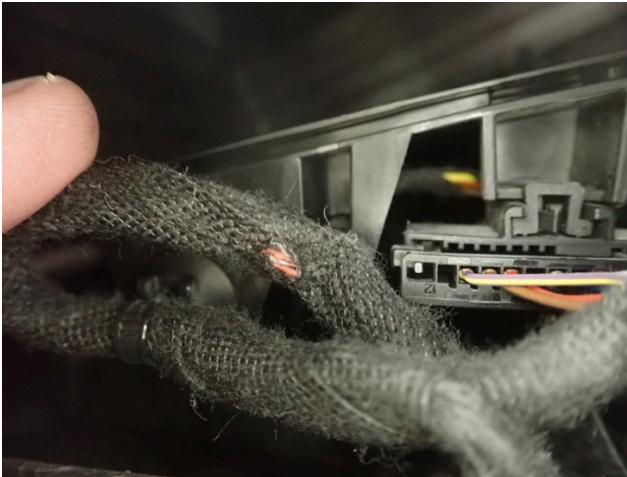
This shows the harness damage; the sheathing has been abraded.

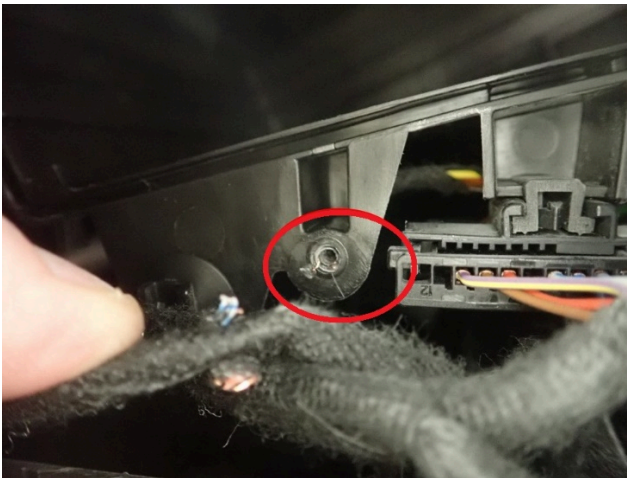
With the harness pulled out of the way, you can see the screw mounting hole for the cabin air filter cover.
