**SERVICE CAMPAIGN 75-06 T36B CHASSIS BATTERY DRAIN  
AFFECTED MODELS: 2024 SOLIS T36B**

# T36B Chassis Battery Drain

Run relay and battery mode control relay in B-post may be improperly wired causing chassis battery drain on T36B units built on September 19, 2024 – October 18, 2024.

Correct the Wiring Installation for the run relay and the battery mode control relay.

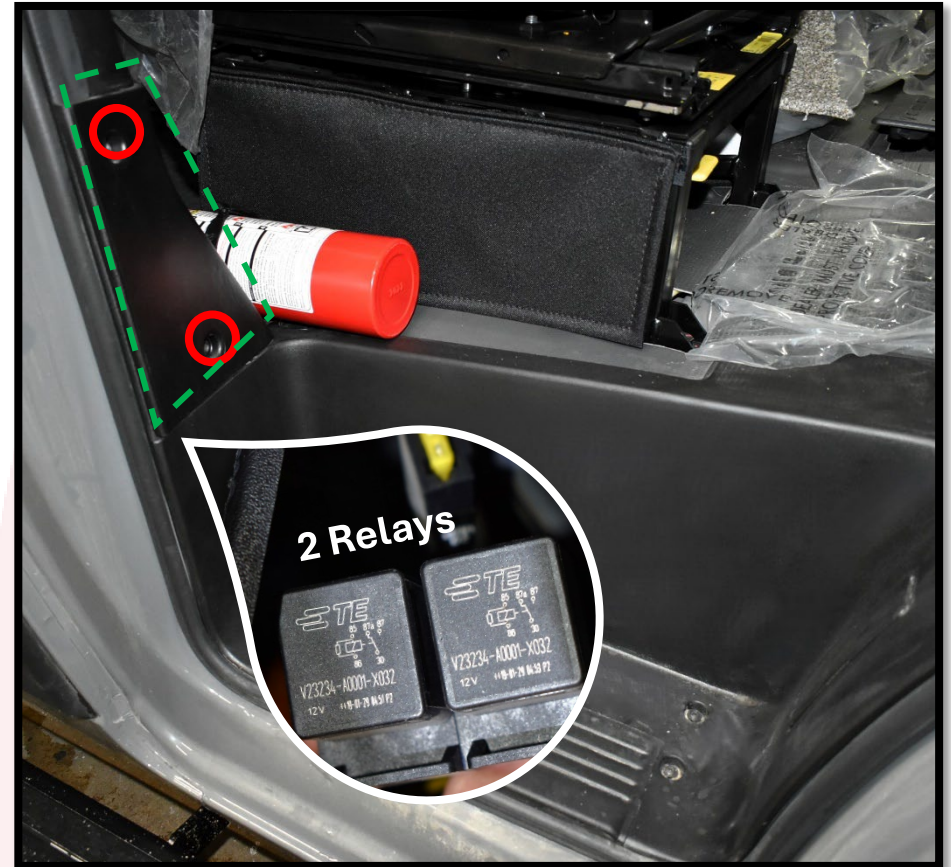
1. Ensure the vehicle is Turned OFF. ⚠
2. Open the Passenger door to locate the B-Post Cover. (See Figure 1 for Reference – Green Dashes)
3. Using a drill & a #2 drill bit, remove the 2 Screws on the B-Post Side Cover. (See Figure 1 for Reference – 2 Red Circles)
4. Remove the B-Post Cover and locate the 2 Relays. (See Figure 1 – White Call-Out)

**Note:** If the 2 Relays are NOT visible after removing B-Post Cover, Proceed to Step 2. (Disregard Step 2 if Relays were found in Step 1)
