Squeaking noise from the electric power steering

Topic number	LI46.35-P-076566
Version	3
Function group	46.35 - Electrical steering
Date	3/10/25
Validity	Model series 206 (Left-hand drive vehicle, with code M005) up to production 09/2023 Model series 214 (Left-hand drive vehicle, with code M005) up to production 09/2023 Model series 223 (Left-hand drive vehicle, with code M005) up to production 09/2023 Model series 254 (Left-hand drive vehicle, with code M005) up to production 09/2023 Model series 236 (Left-hand drive vehicle, with code M005) up to production 09/2023 Model series 232 (Left-hand drive vehicle) up to production 09/2023 Model series 294 (Left-hand drive vehicle) up to production 12/2024 Model series 295 (Left-hand drive vehicle) up to production 12/2024 Model series 296 (Left-hand drive vehicle) up to production 12/2024 Model series 297 (Left-hand drive vehicle) up to production 12/2024
Reason for change	Part numbers adapted
Reason for block	Results of endurance test still pending

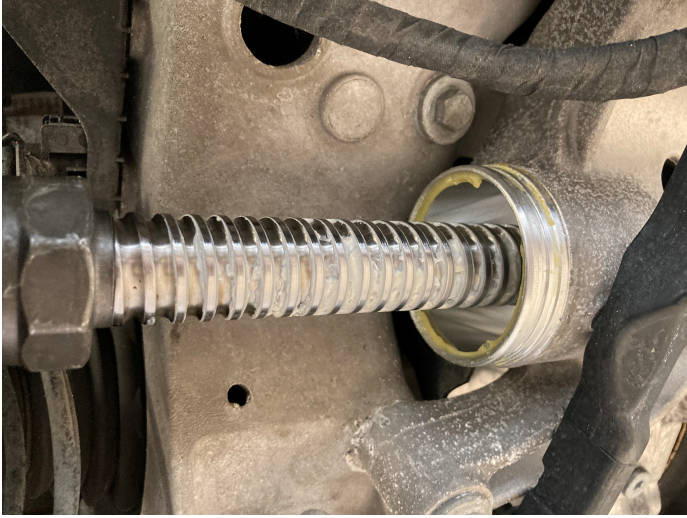
File	Description
Bild 1 Gewindetrieb.JPG	Picture 1, screw drive

3. Turn the wheels fully to the right. The screw drive of the rack-and-pinion steering becomes visible. See picture 1 of screw drive
4. Clean the screw drive with a clean cloth and remove the existing grease. See picture 2 of cleaned screw drive

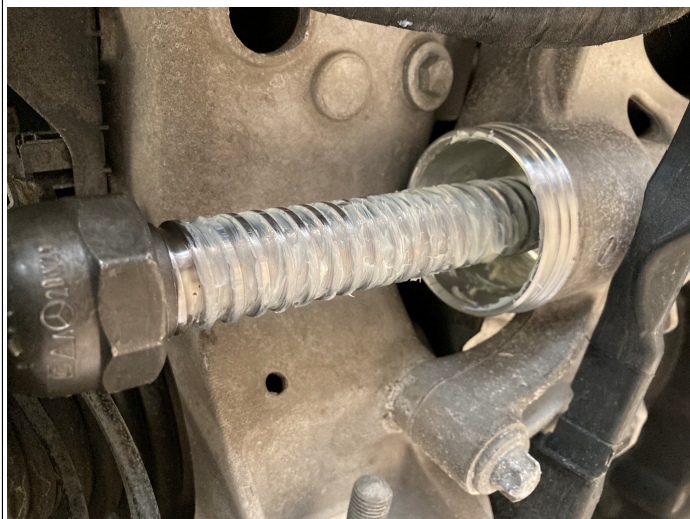
Picture 4, greased screw drive

6. Apply a sufficient amount of long-life grease (A001 989 84 51 09) to the screw drive of the toothed rack with the brush, making sure that this is applied evenly all around; see picture 4 of greased screw drive

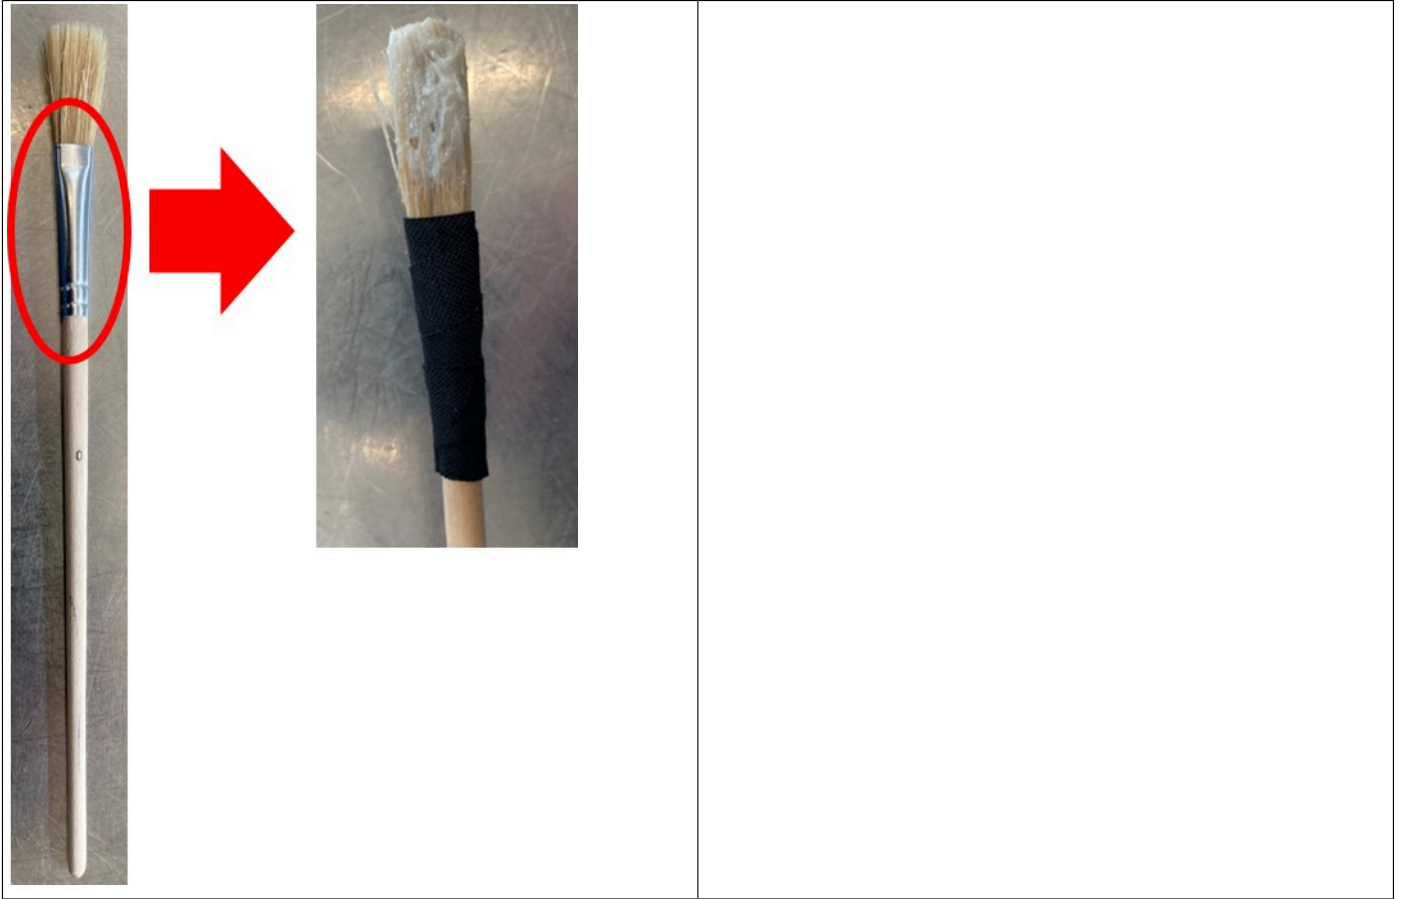
Picture 3, example brush

5. Prepare a clean brush for greasing the screw drive and, if necessary, mask off the metal sleeve of the brush or similar components to avoid damage to the steering housing or to the screw drive of the toothed rack. See picture 3 with example brush
