Technical Service Bulletin

Audi e-tron GT

57 Door seals discolored green

Transaction No.: **2076798/1**

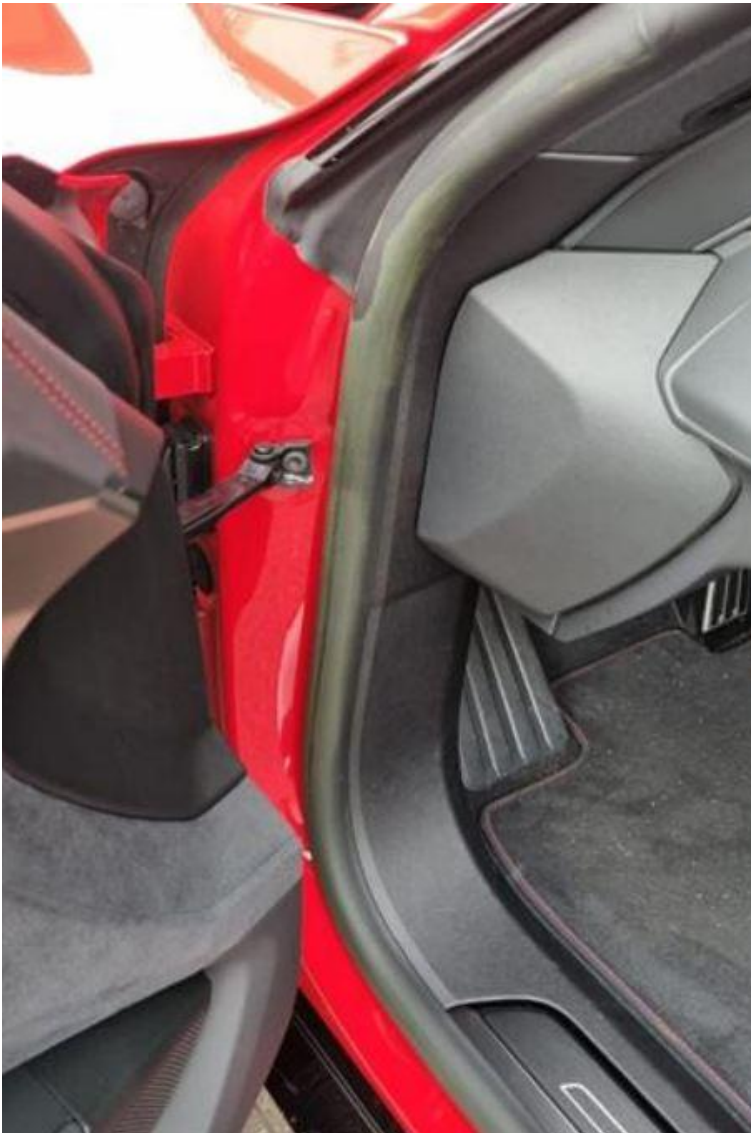
- The surface of the door seals is discolored green.

In unfavorable cases, vapor may come into contact with the door seal. The seal then turns green (Figure 1).

Figure 1: Door seal discolored green (example photo).

Please clean the discolored door seal. To do so, coat the affected areas on the door seal with cleaning solution D 009 401 04 (Figures 2 and 3).

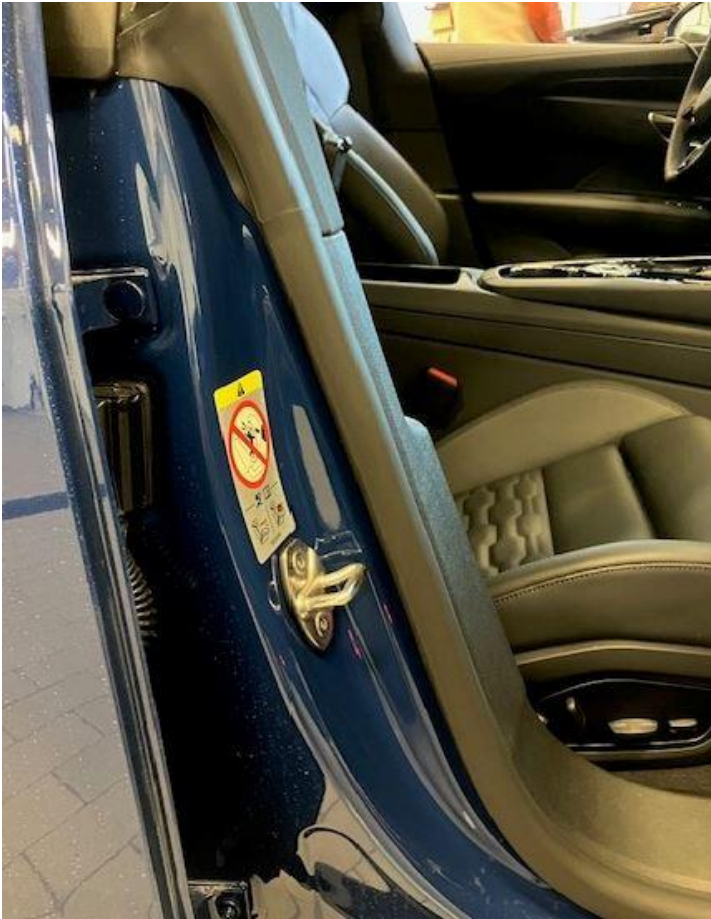
Figure 2. Discolored door seal.

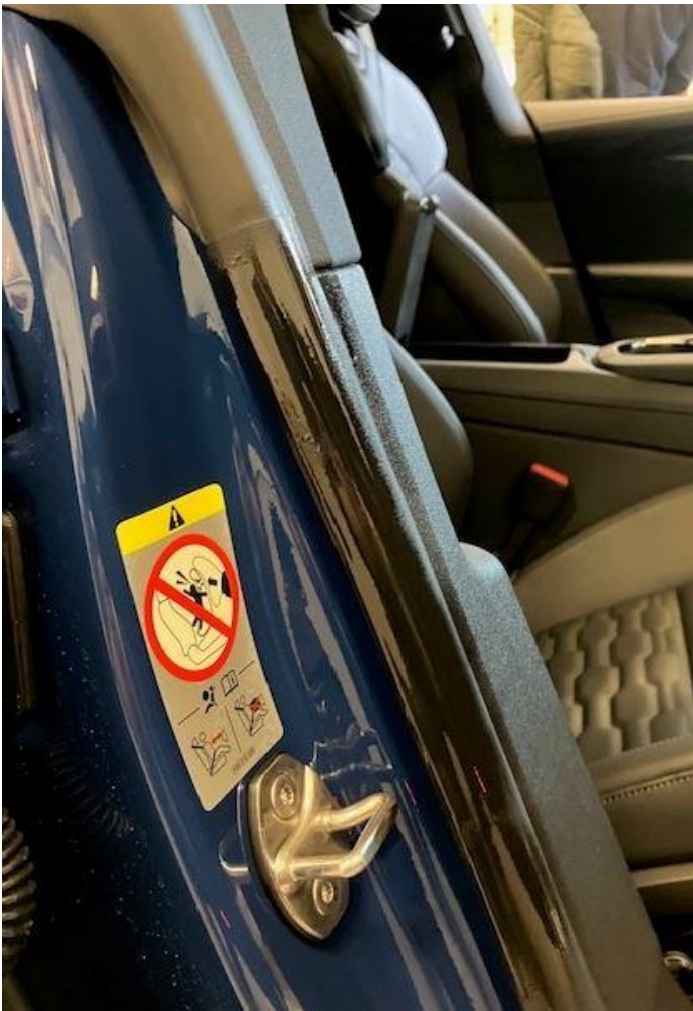
Figure 3. *Discolored door seal coated with cleaning solution.*

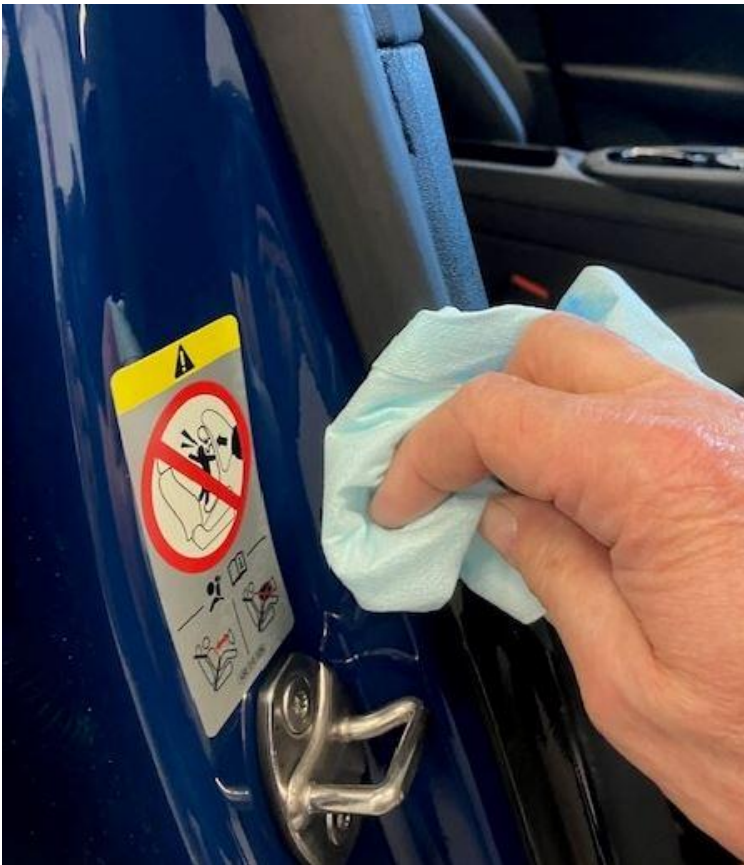
Figure 4. Immediately dry the door seal.

Immediately dry the door seal with a soft cleaning cloth after applying the cleaning solution (Figure 4).

This measure can remove all the discoloration.

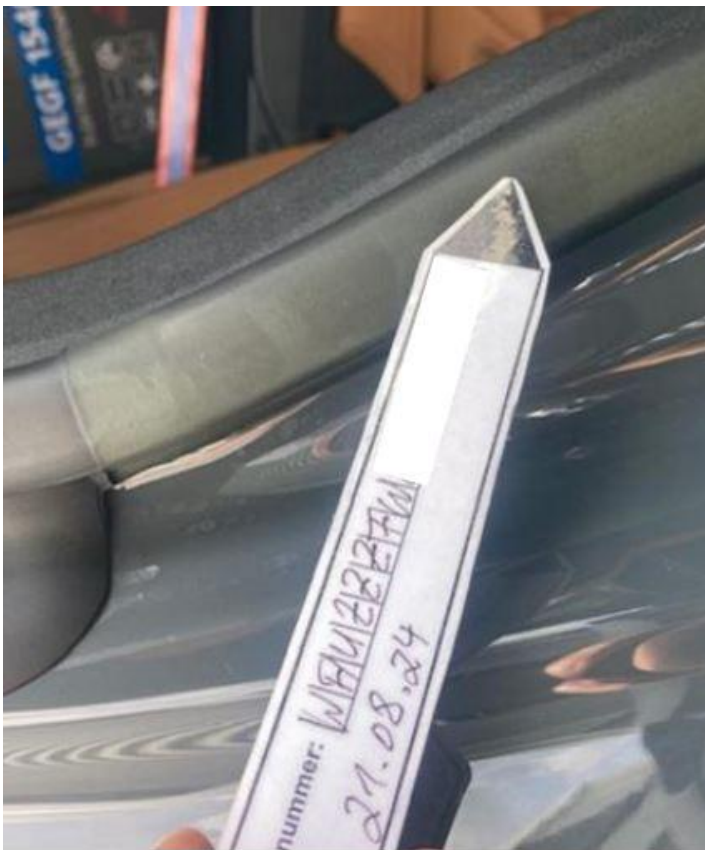
Figure 5. Indicate the VIN and of the photo as shown.

- Include the VIN and date (Figure 5).
- Must not be edited.
- Should be in focus and taken with sufficient light. A high resolution is not necessary.
