## Technical Service Bulletin

<b>Topic</b>	57 Bonded outer door seal coming loose from the door
<b>Market area</b>	United States 444 Volkswagen of America, Inc. (6444)
<b>Brand</b>	Audi
<b>Transaction No.</b>	2076939/1
<b>Level</b>	EH
<b>Status</b>	Released for publishing
<b>Release date</b>	Feb 17, 2025

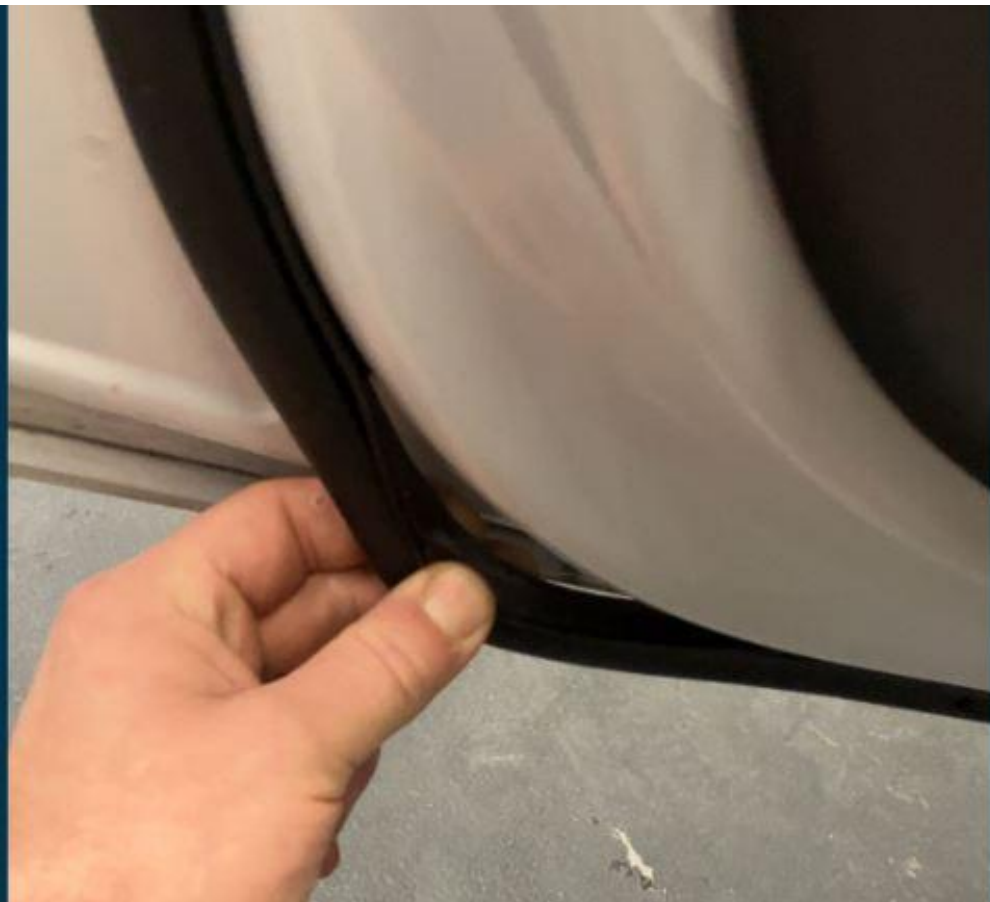
- The adhesive bond for the outer door seal has come loose from the door.

**Figure 1.** Door seal coming loose.

Replace affected door seals as described in Workshop Manual.

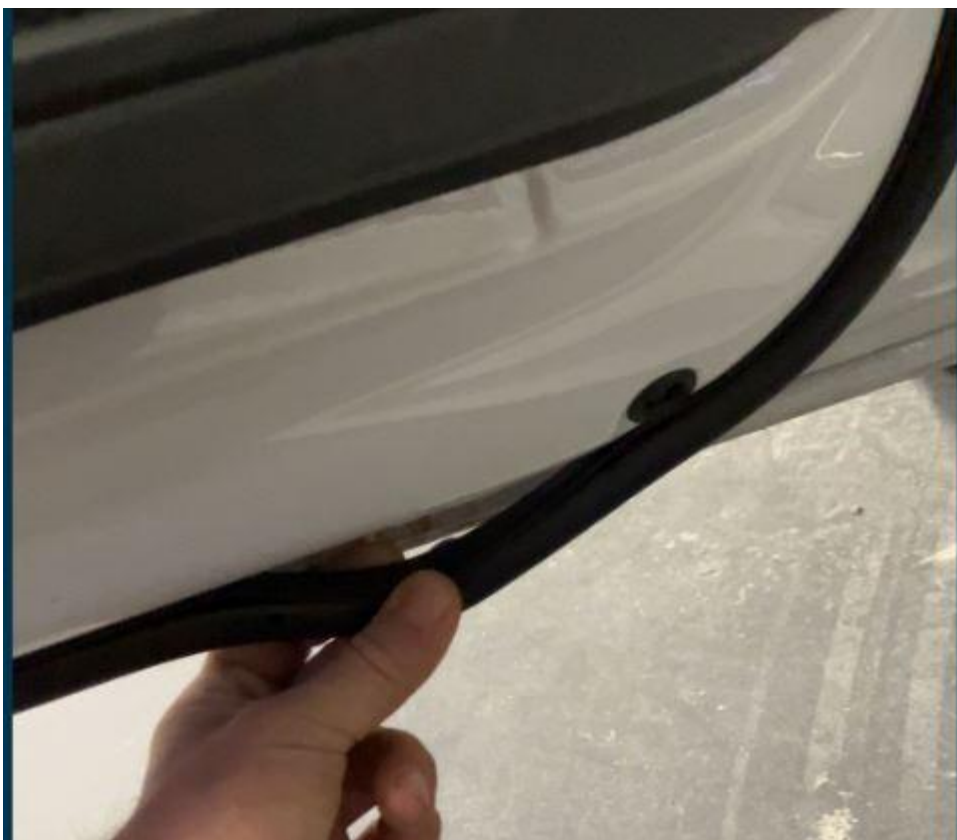
**Figure 2.** Door seal coming loose.

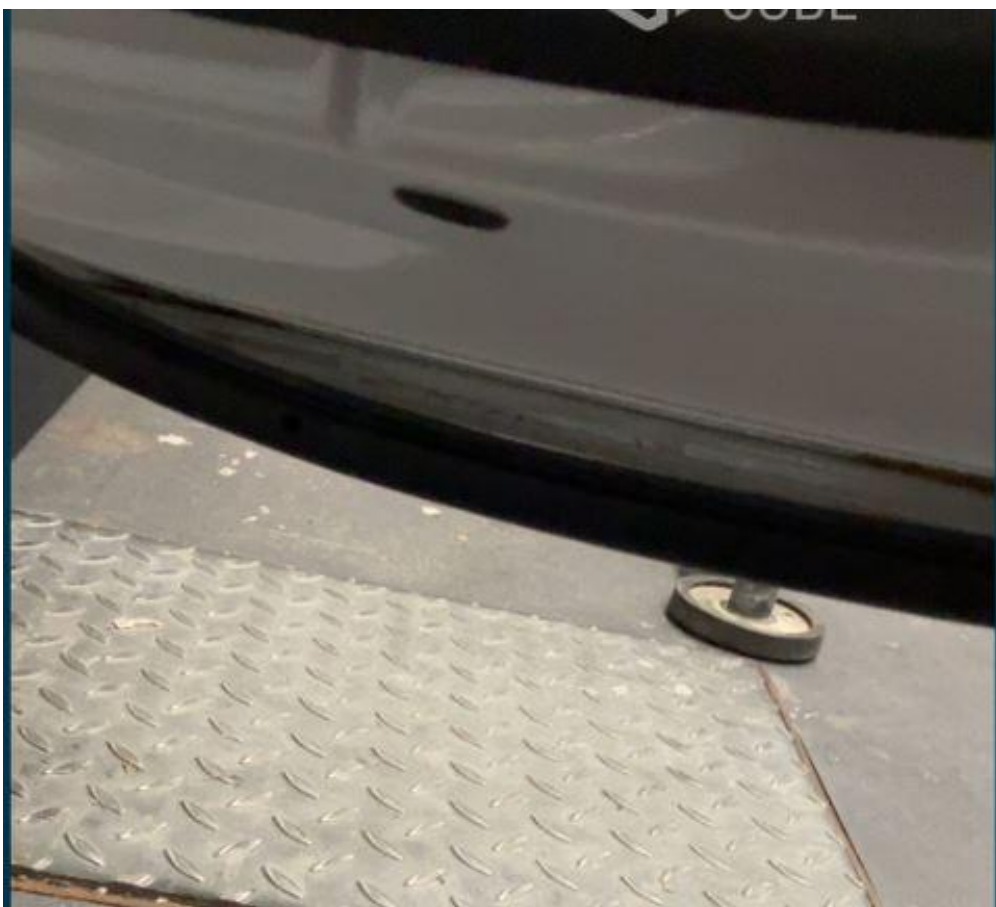
**Figure 3.** Door seal coming loose.

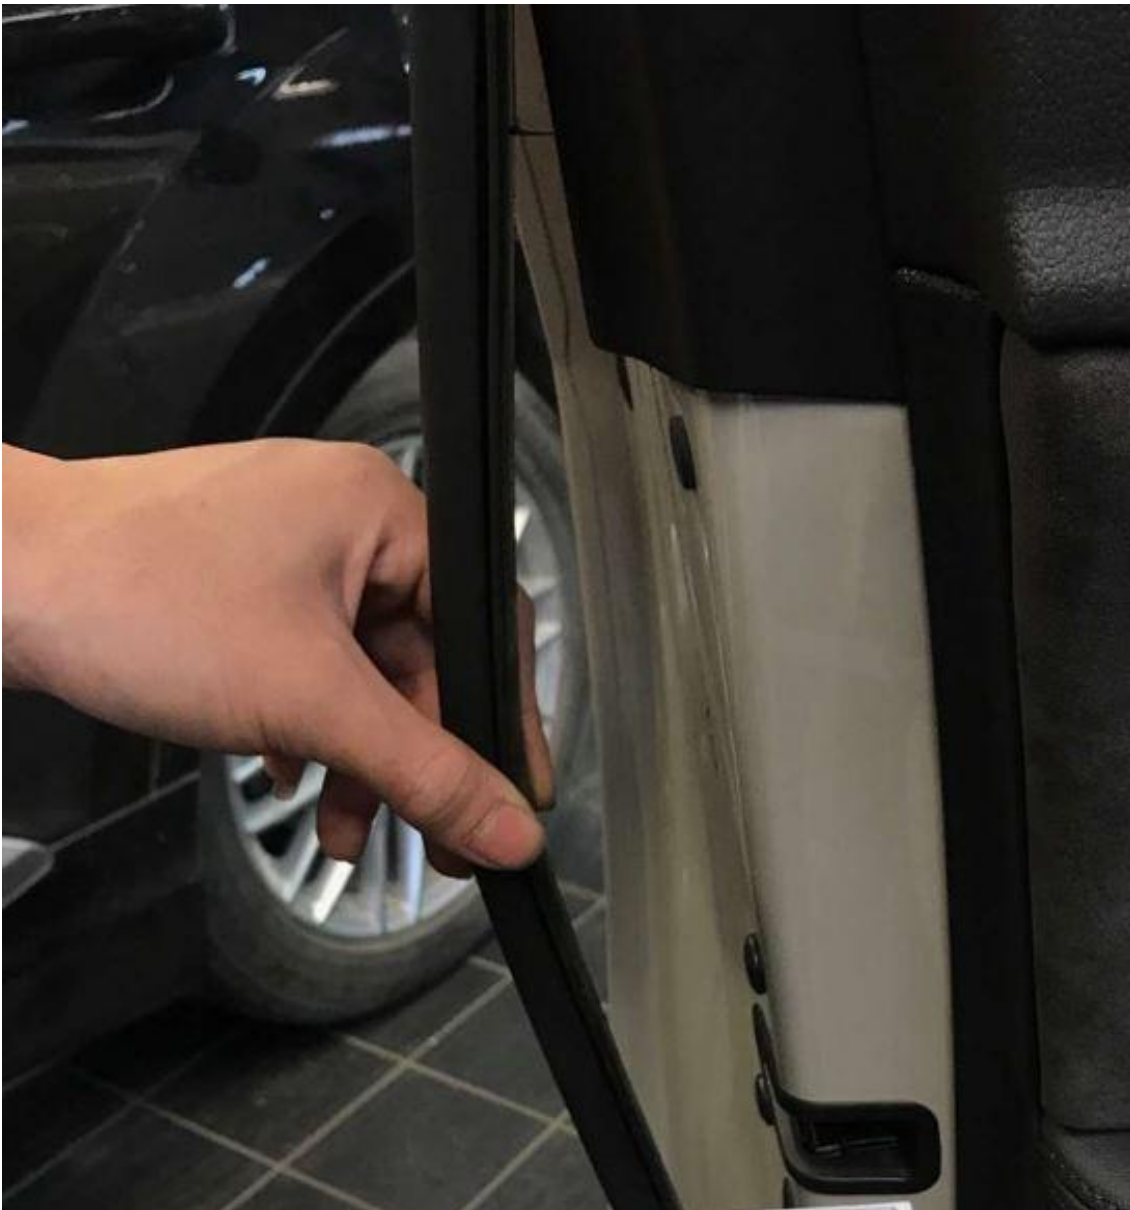
**Figure 4.** Door seal coming loose.
