MAS004385 MCL 25-12

Circular Letter

Serviceability of Crossover and Water Pump

MODELS: M156 Quattroporte, M157 Ghibli and M161 Levante (All MY)

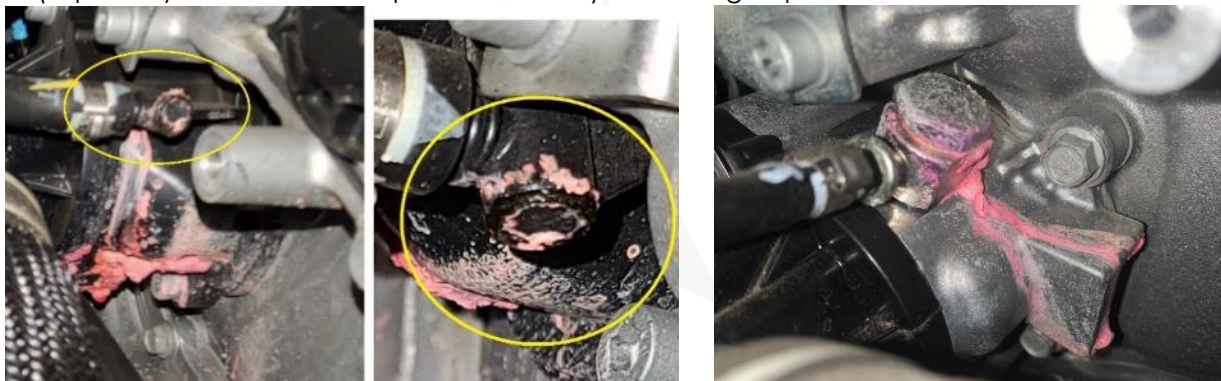
- 1) In some cases, an engine coolant leakage has been detected from the **Crossover** (especially for those built in plastic material) according to pics below:

Sample pics. of Crossover – Engine Coolant leak

From now on, each repair related to these specific issues and claimed in warranty (valid for ALL cost codes), must be performed by using the single Crossover and/or the Water Pump only and not the complete Timing System Front Cover as done up till today.

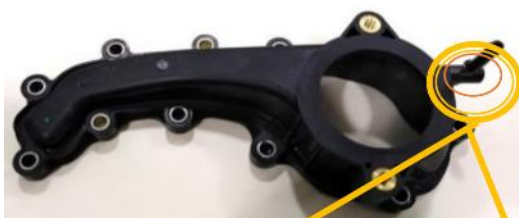
1) Sample pic. of Crossover built in Plastic Material (more frequent coolant leak area highlighted).

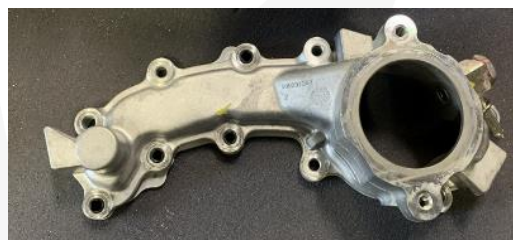
1) Sample pic. of Crossover built in Aluminum.

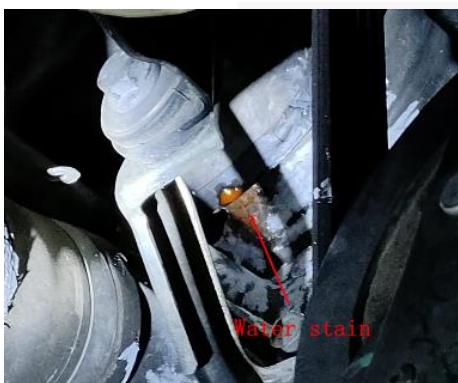
- 2) In a minor number of cases, an engine coolant leakage from the **Water Pump** has been detected, according to pics. below.

2) Sample pic. of engine coolant leakage from the Water Pump

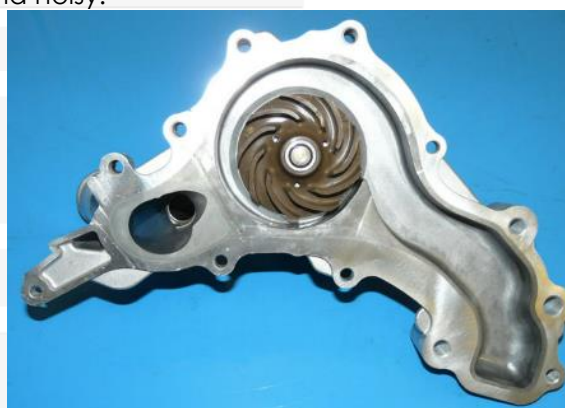
- 3) In some others the Water Pump has been found noisy.

2) Sample pic. of a Water Pump removed from the engine.

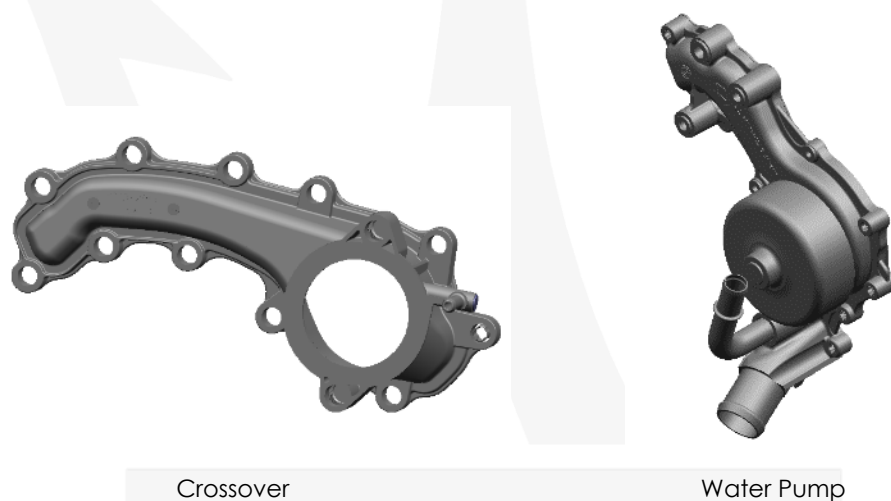
- **291773 – Crossover**
- **878648 – Water Pump**

Components that can be serviced and available as spare parts are represented in the pictures below:

Furthermore, due to the need of Crossover Gasket replacement during the Crossover replacement, a dedicated P/N is now available:

- **280912 – Crossover Gasket**
