Rattling Noise From Forward Recognition Camera Cover

Service Category Vehicle Interior

YEAR(S)	MODEL(S)	ADDITIONAL INFORMATION
2023 - 2024	Corolla

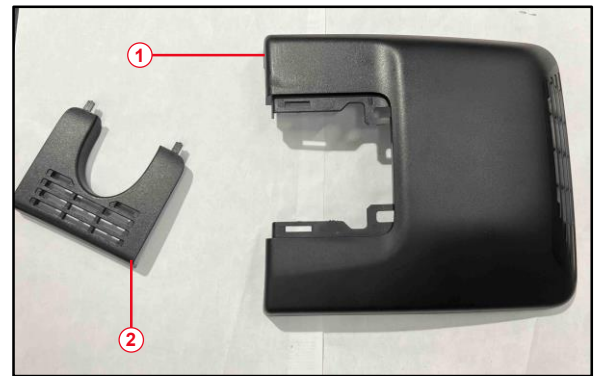
Figure 1.

2. Remove the No. 1 and No. 2 forward recognition camera covers.

1	Forward Recognition Camera Cover No. 1
2	Forward Recognition Camera Cover No. 2

3. Install the NEW No. 1 and No. 2 forward recognition camera covers.
