Technical Service Bulletin (TSB)
Various Models - Engine Valley Cap (Flywheel Side) - Oil Leakage - Service Solution

REFERENCE:	TSB: 09-005-25 GROUP: 09 - Engine	Date:	March 22, 2025	REVISION:	09-021-24
VEHICLES AFFECTED:	2020 - 2024 (BV) Jeep Renegade 2020 - 2024 (MV) Jeep Compass This bulletin applies to 2020 - 2023 BV and MV vehicles built on or before November 03, 2023 (MDH 1103XX) equipped with one of the following engines: <ul style="list-style-type: none">1.3L I4 Turbo MAir DI Engine w/ESS (Sales Code EYF).1.3L I4 Turbo MAir DI Engine (Sales Code EYH).1.0L I3 Turbo Engine w/ESS (Sales Code EKA). This bulletin also applies to 2020 - 2024 BV and MV vehicles equipped with the 1.5L I4 DOHC Turbo MHEV Engine (Sales Code EYP).			MARKET APPLICABILITY: <div><input type="checkbox"/> NA<input type="checkbox"/> MEA</div> <div><input type="checkbox"/> SA<input type="checkbox"/> IAP</div> <div><input checked="" type="checkbox"/> EE<input type="checkbox"/> CH</div>	
CUSTOMER SYMPTOM:	Customers may experience the following: <ul style="list-style-type: none">Oil leaks from the engine compartment, engine/transmission coupling.

CAUSE:	Oil leakage from engine valley cap

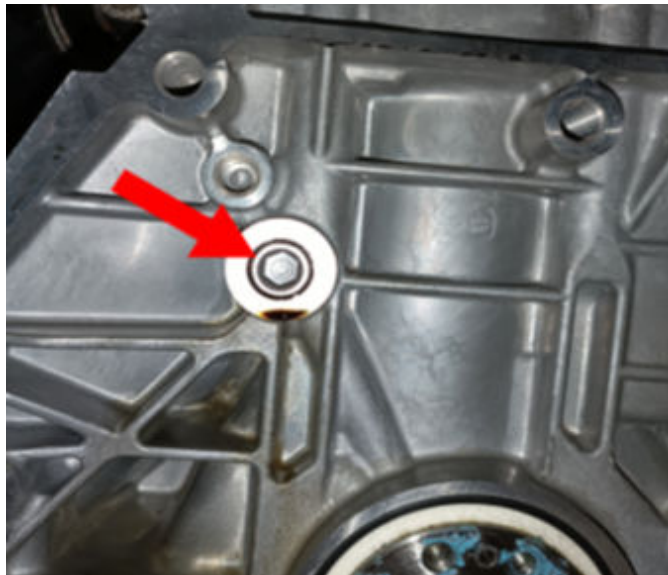
**Fig. 1**

5. Inspect the engine valley cap for evidence of an oil leak [Fig. 1](#).

Oil Valley Cap Leaking

6. Is there oil leaking from the engine valley cap in the oil line?
 - YES>>> Proceed to [Step 7](#).
 - NO>>> This bulletin does not apply. Proceed to [Step 11](#).

7. Remove and **DISCARD** the engine valley cap.
8. Thoroughly clean the engine valley thread.
9. Install a **NEW** engine valley cap and tighten to 27 N·m (20 ft. lbs.).

10. Clean any residual oil from the affected area.
11. Install the engine flywheel.
 - **For automatic transmission equipped vehicles:** Refer to the detailed service procedures available in DealerCONNECT/Service Library under: 1024B20 Engine Flywheel - R.R.
