# TECHNICAL SERVICE BULLETIN

Classification:	Reference:	Date:
EL24-015	NTB25-014	February 28, 2025

## REAR VIEW CAMERA IS INOPERATIVE OR "X" IS DISPLAYED WHEN SHIFTING INTO REVERSE

**APPLIED VEHICLES:** 2021-2023 Rogue (T33)

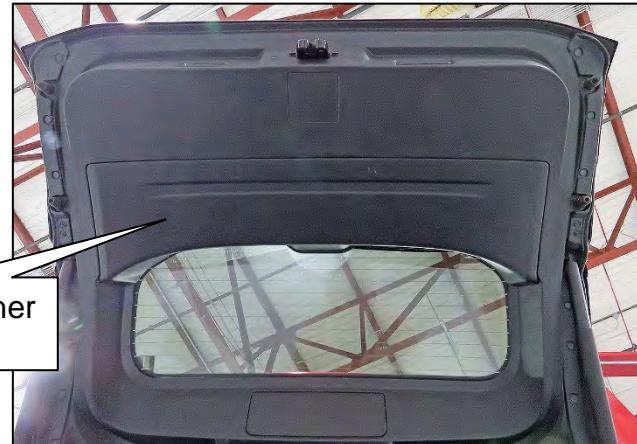
Figure 1

1. Open the back door.
2. Remove the Back Door Inner Finisher.

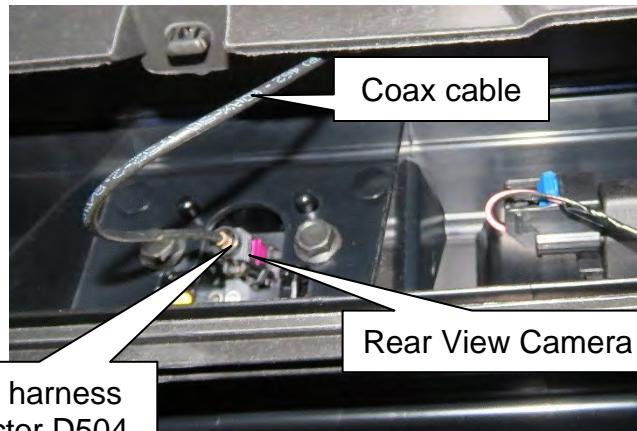
Figure 2

3. Disconnect the coax cable from the Rear View Camera.

There is corrosion at the Rear View Camera wiring harness connector D504 (Figure 2 on page 2).

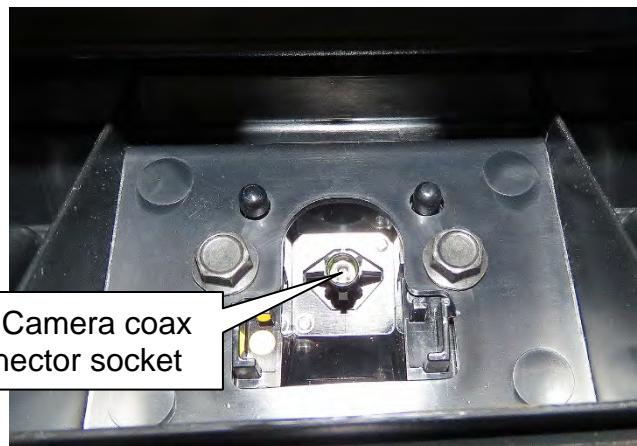
Figure 3

4. Inspect the Rear View Camera coax cable connector socket for corrosion.

5. Is corrosion present in the Rear View Camera coax cable connector socket?

**YES:** Replace the Rear View Camera, and then proceed to step 6.

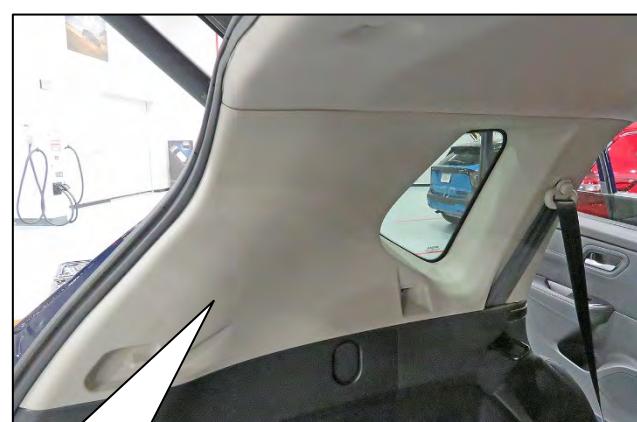
Figure 4

9. Remove the Luggage Side Lower Finisher LH.

Luggage Side  
Lower Finisher LH

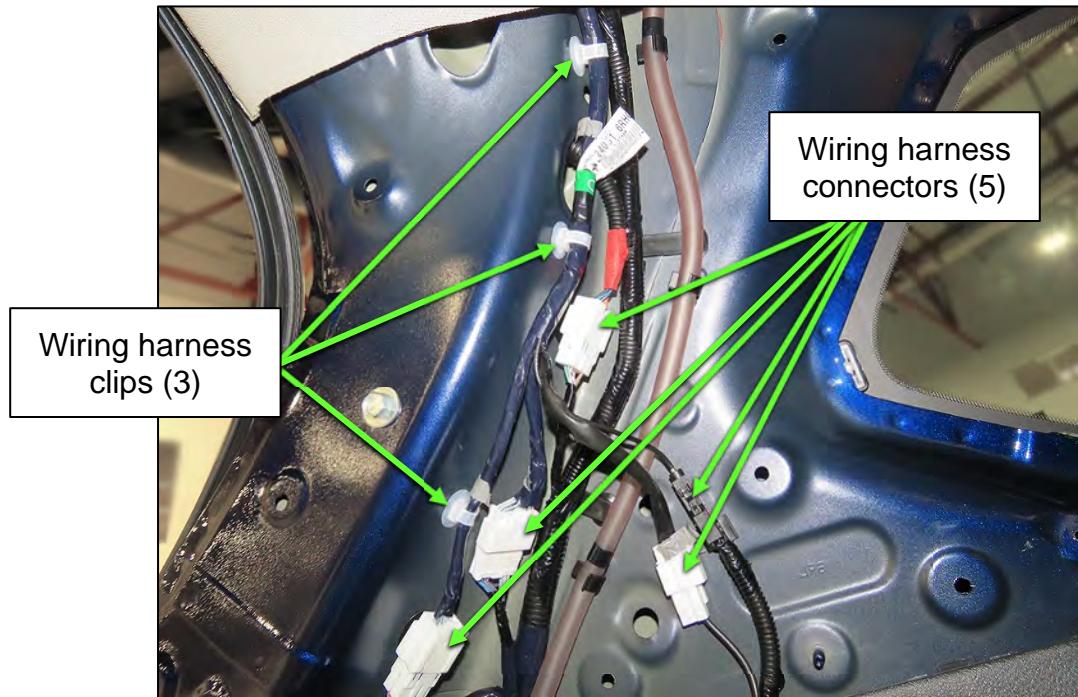
Figure 5

10. Disconnect the five (5) wiring harness connectors shown in Figure 5.

11. Detach the three (3) wiring harness clips shown in Figure 5.

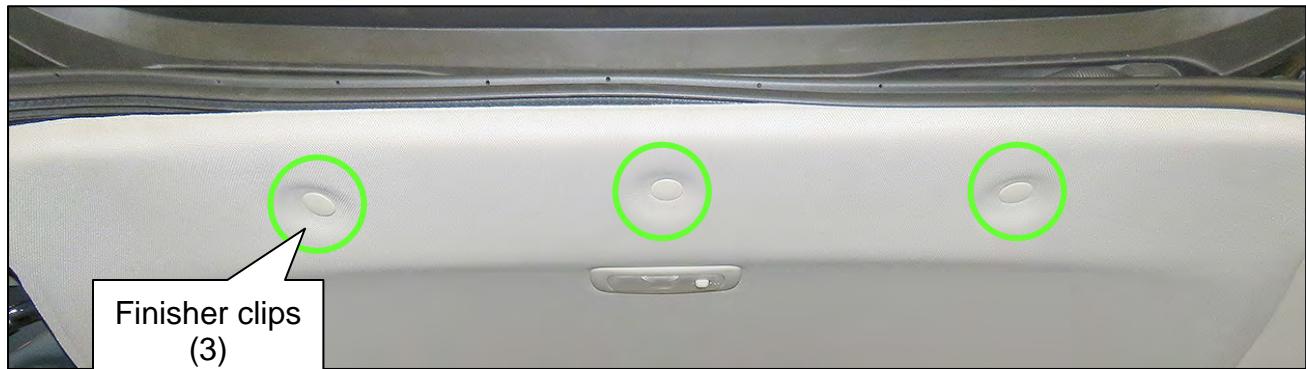
Figure 6

12. Remove the three (3) finisher clips that retain the rear of the headliner (Figure 6).

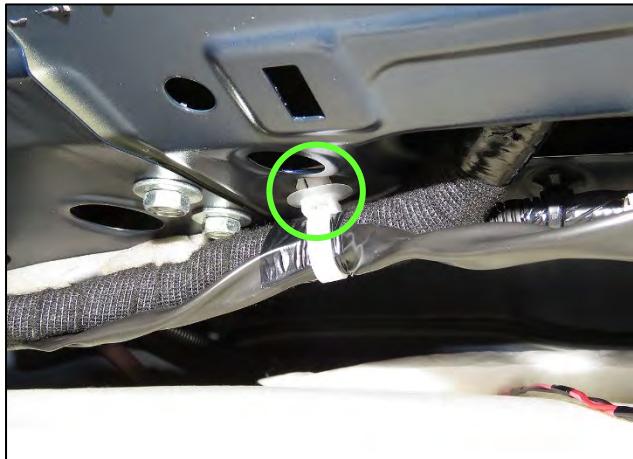
13. Detach the two (2) wiring harness clips shown circled in Figure 7 and Figure 8.

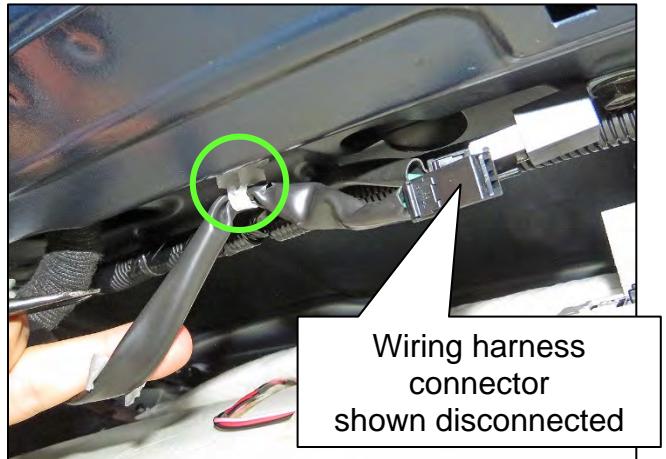
Figure 8

14. Disconnect wiring harness connector shown in Figure 8.

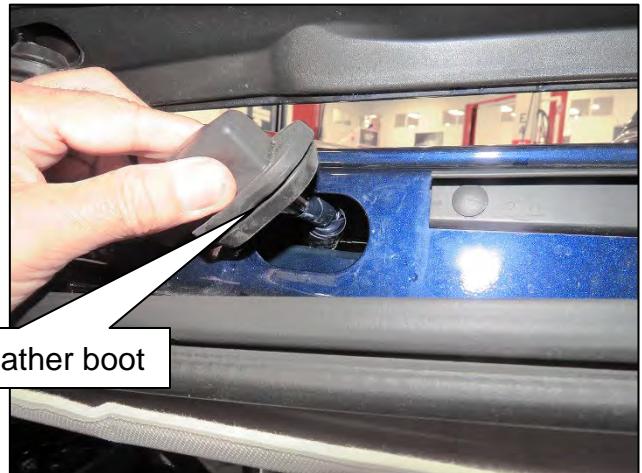
Figure 9

15. Detach the harness weather boot from the rear of the roof, where shown in Figure 9.

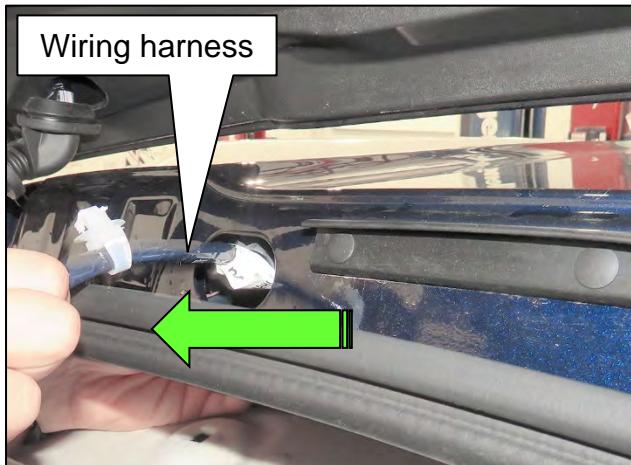
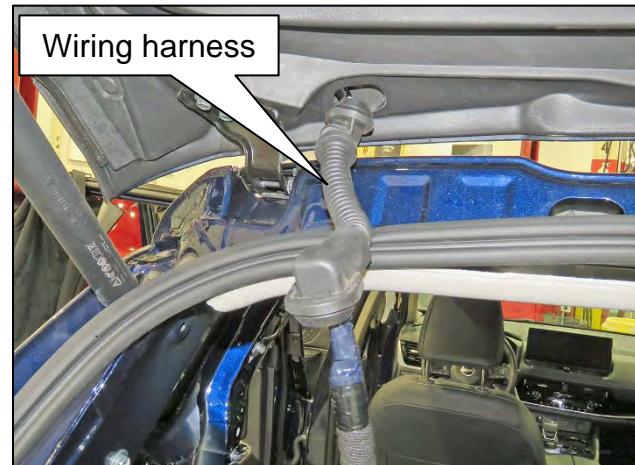
16. Using one hand on the inside and one on the outside of the vehicle, gently draw the disconnected wiring harness (Figure 10) completely out of the interior of the vehicle (Figure 11).

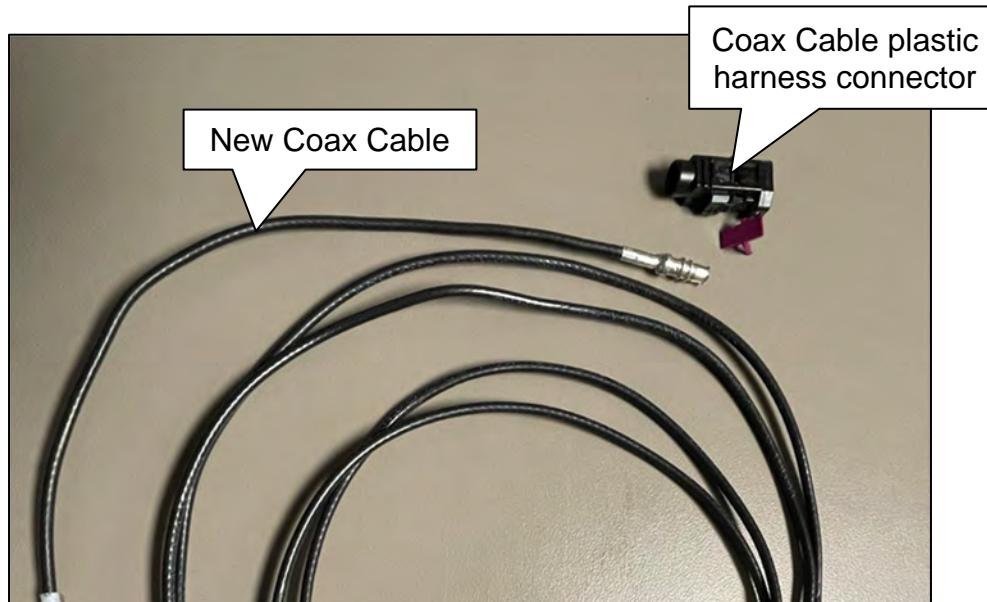
Figure 12

17. Remove a plastic harness connector (Figure 12) from one end of the new Rear View Camera Coaxial Cable (Coax Cable).

**HINT:** This will allow the Coax Cable to be easily pulled through the wiring harness weather pack

25. Reattach the plastic harness connector removed in step 17 (page 6) to the end of the Coax Cable.
26. Pull the Coax Cable through the weather boot until its length equals the preexisting Coax Cable (Figure 15).

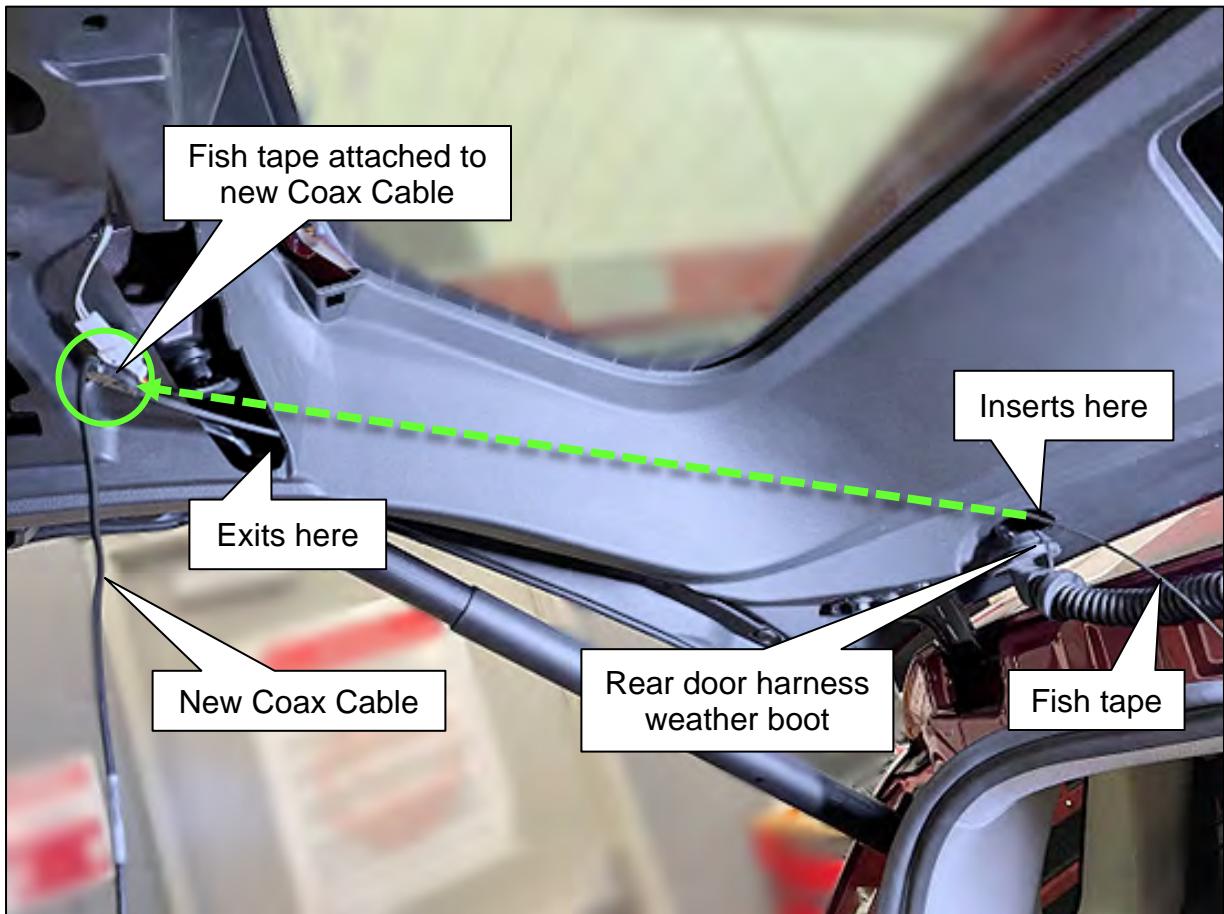
Figure 13

18. Detach the harness weather boot from the rear door, where shown in Figure 13.
19. Insert a fish tape into the opening that the harness weather boot was just detached from, and then guide it through the rear door and out where shown in Figure 13.  
**HINT:** If a fish tape is not available, a stiff piece of wire may be used.
20. Using black electrical tape, attached the end of the Coax Cable that the plastic harness connector was removed from (step 17 on page 6), to the end of the fish tape.

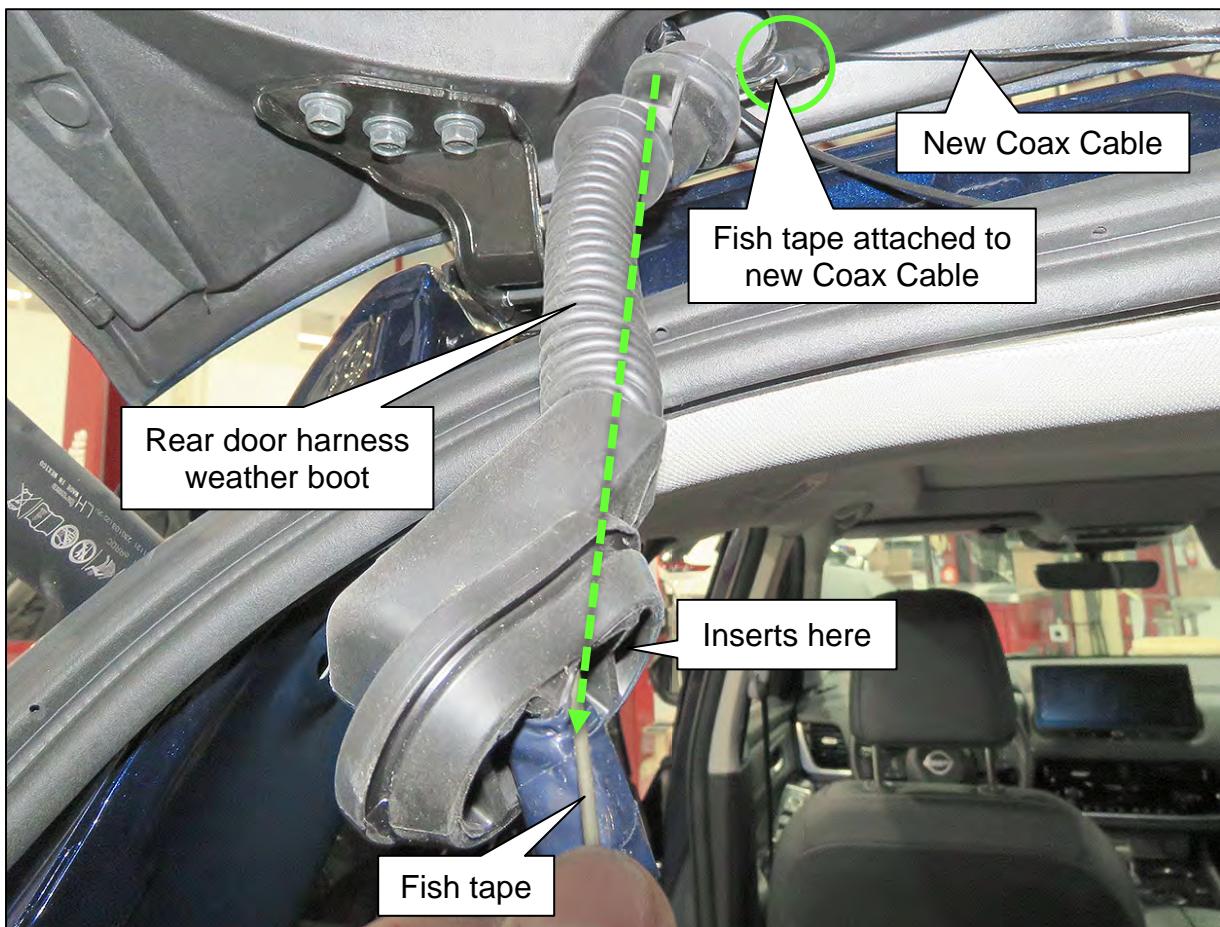
Figure 14

22. Insert a fish tape into the weather boot where shown in Figure 14, and then gently guide it through the weather boot to the other end.
23. Using black electrical tape, attached the end of the Coax Cable to the end of the fish tape.
24. Gently draw the Coax Cable through the weather boot in the direction indicated in Figure 14, and then remove the tape from the Coax Cable and fish tape.

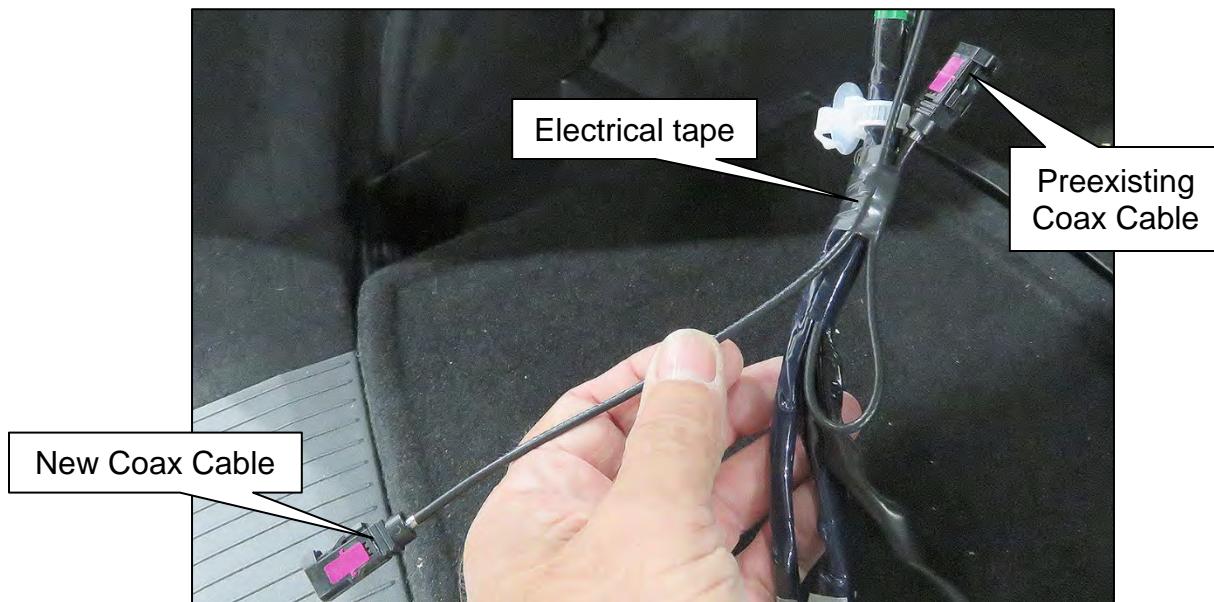
Figure 16

27. Fold the preexisting Coax Cable back over itself, and then tape it along with the new Coax Cable to the wiring harness near the first harness clip.

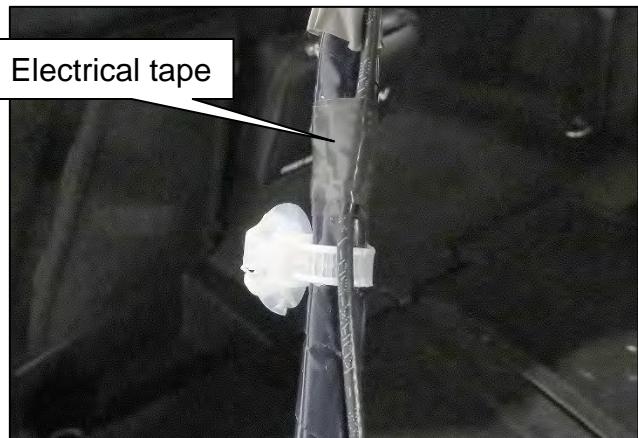
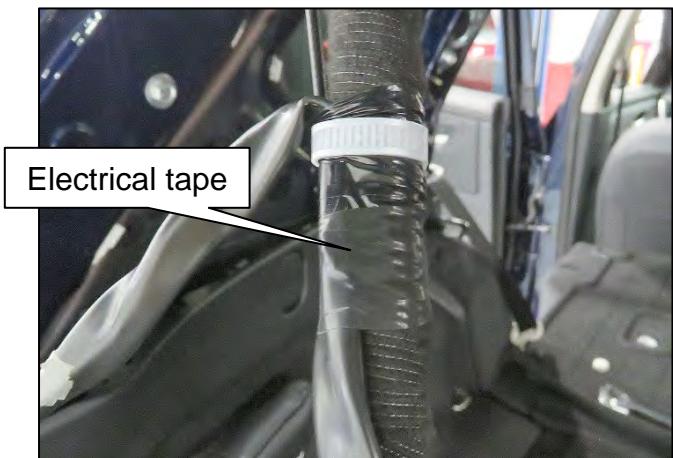
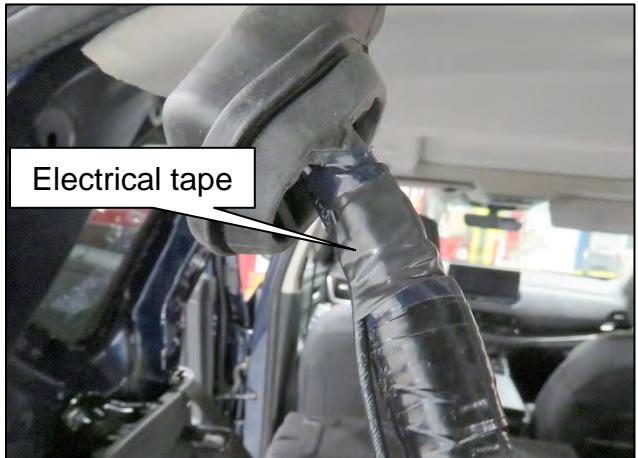
28. Tape the new Coax Cable to the wiring harness in three (3) additional places.

- Two (2) points next to the harness clips (Figure 17 and Figure 18).
- One (1) point where harness exists weather boot (Figure 19).

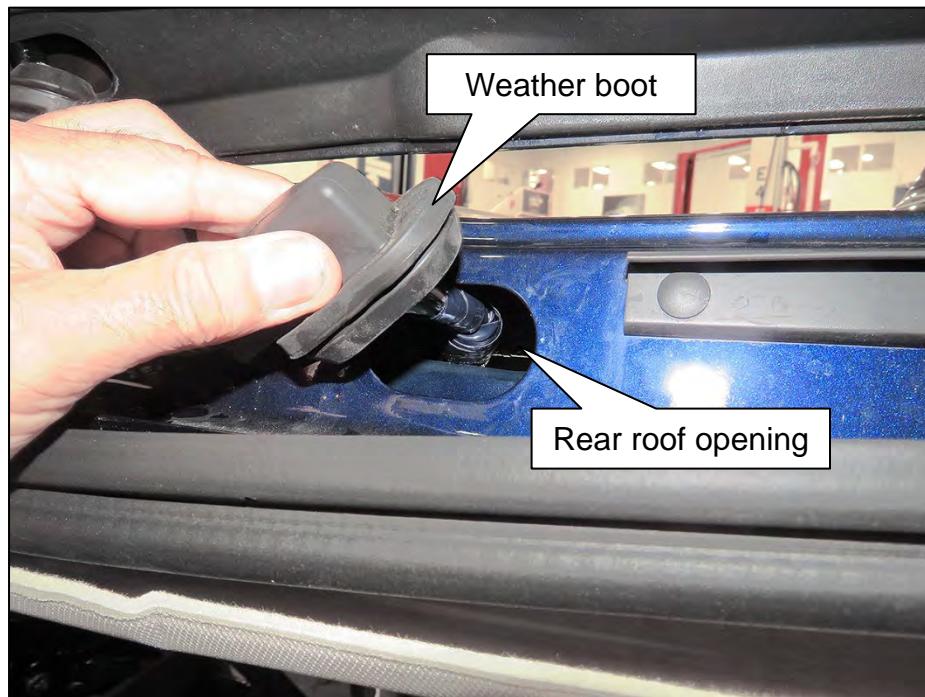
Figure 21

30. Reinstall the wiring harness through the rear roof opening, and then reattach the weather boot into the rear of the roof and the back door.

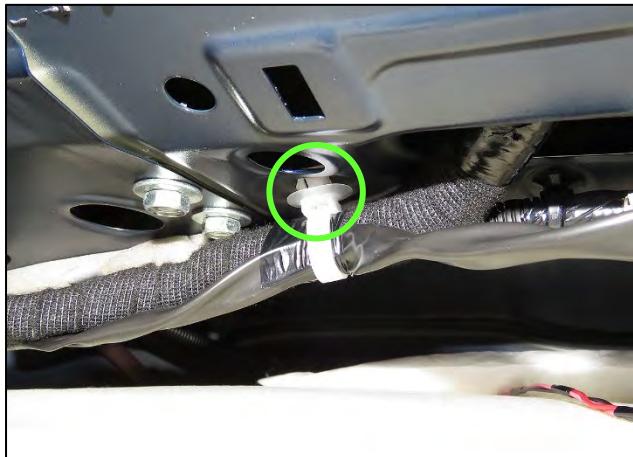
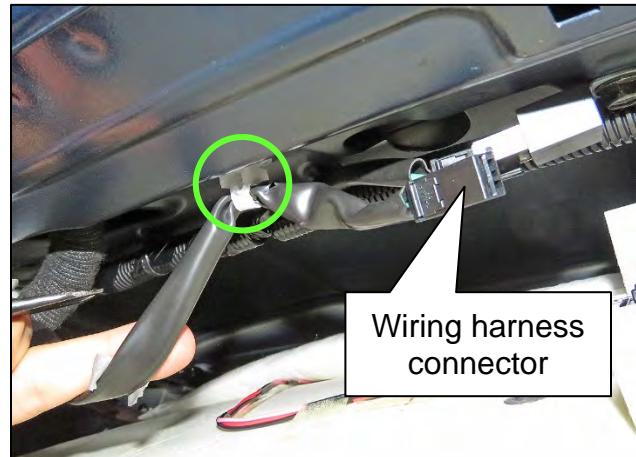
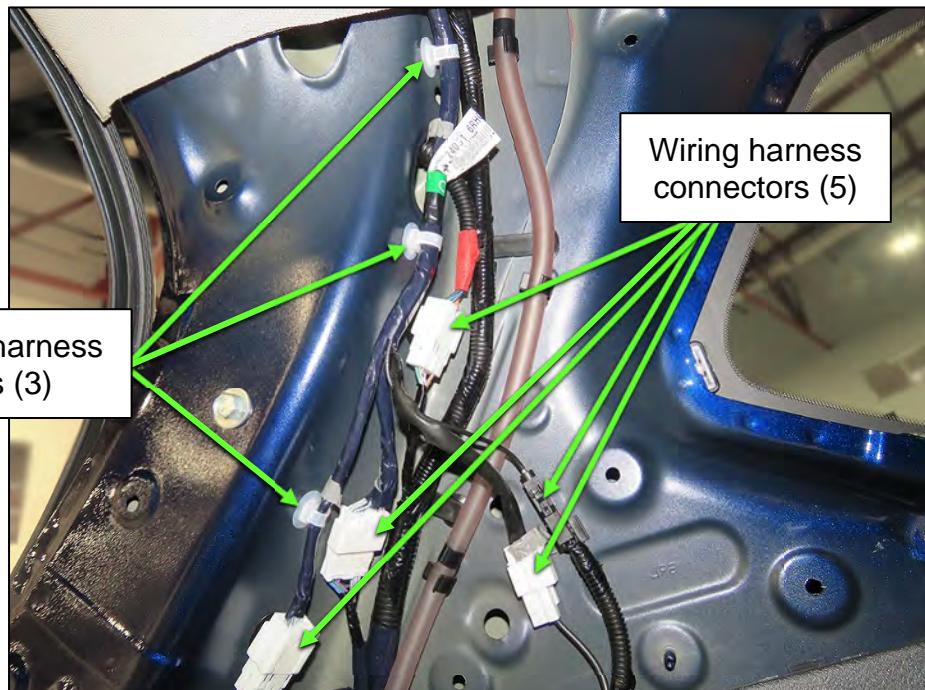
31. Reattach all wiring harness clips and all wiring harness connectors shown in Figure 22, Figure 23, and Figure 24.

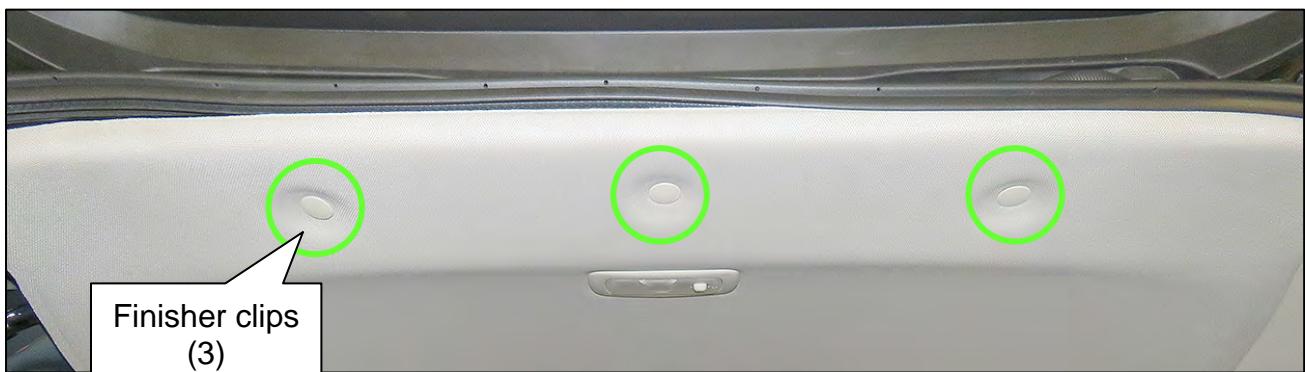
Figure 26

33. Reattach the rear of the headliner with three (3) finisher clips (Figure 26).

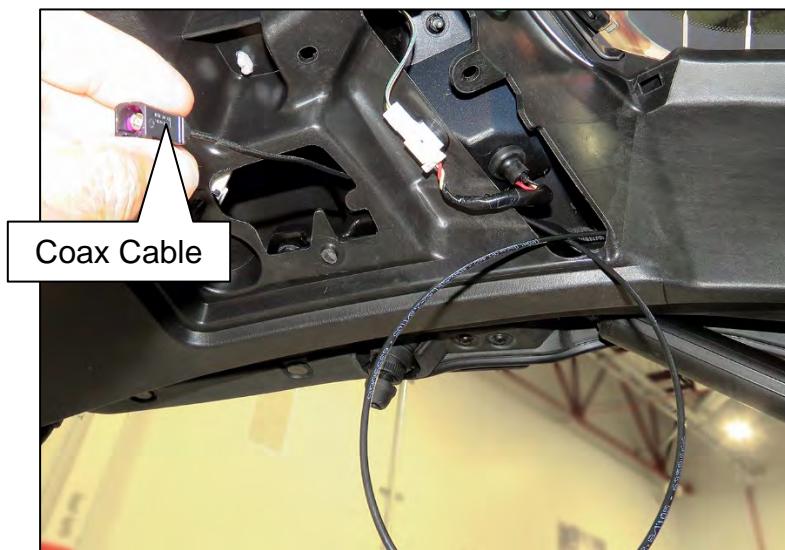
Figure 27

34. Route the Coax Cable through the Back Door to the next opening, as shown in Figure 27.

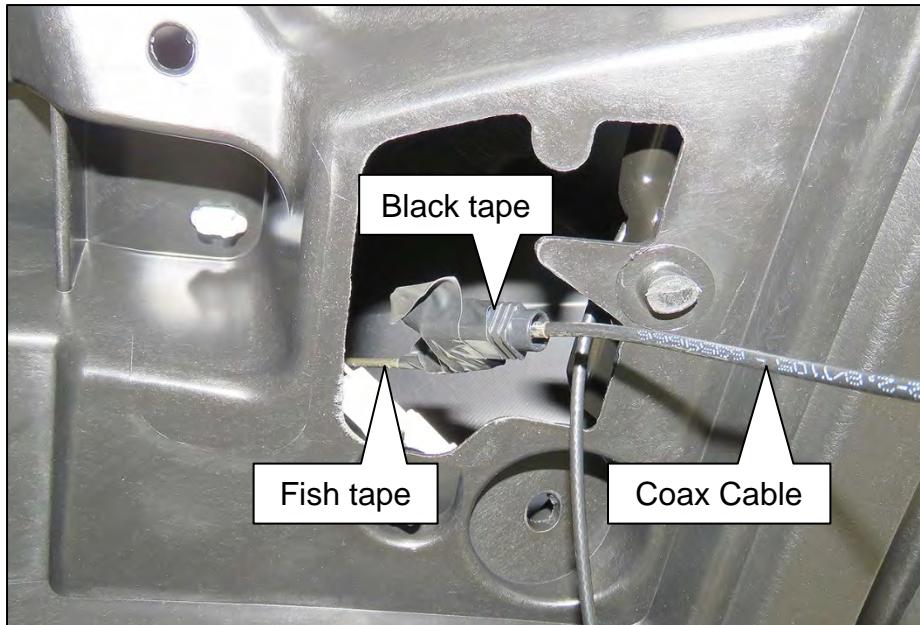
Figure 28

35. Insert the fish tape near the Rear View Camera and guide to the opening shown in Figure 28.
36. Attach the Coax Cable to the fish tape with black tape (Figure 28).
37. Gently draw the remainder of the Coax Cable slack through the back door.

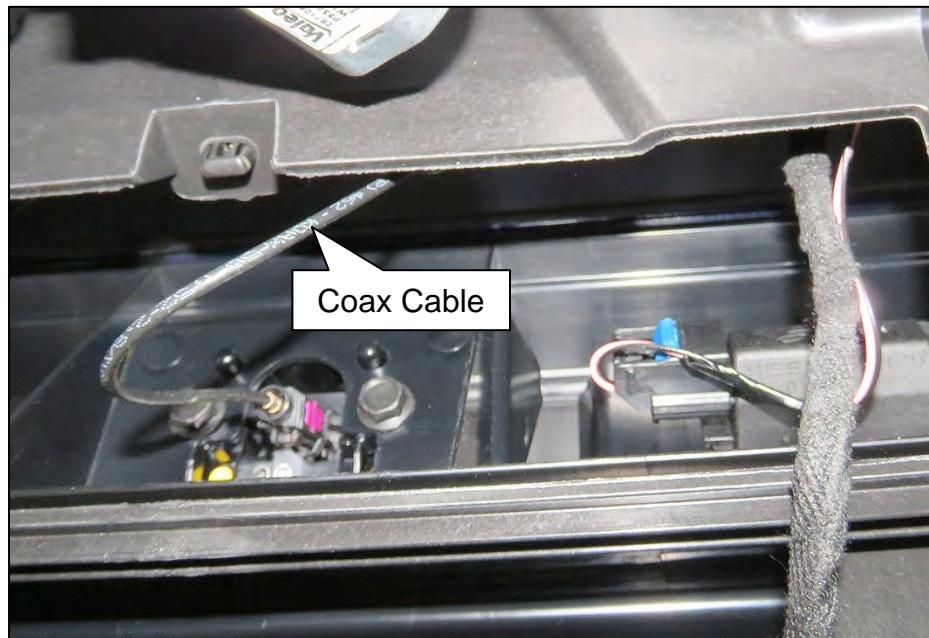
Figure 30

40. Tuck the Coax Cable harness into the cavity above the Rear View Camera, as shown in Figure 30.

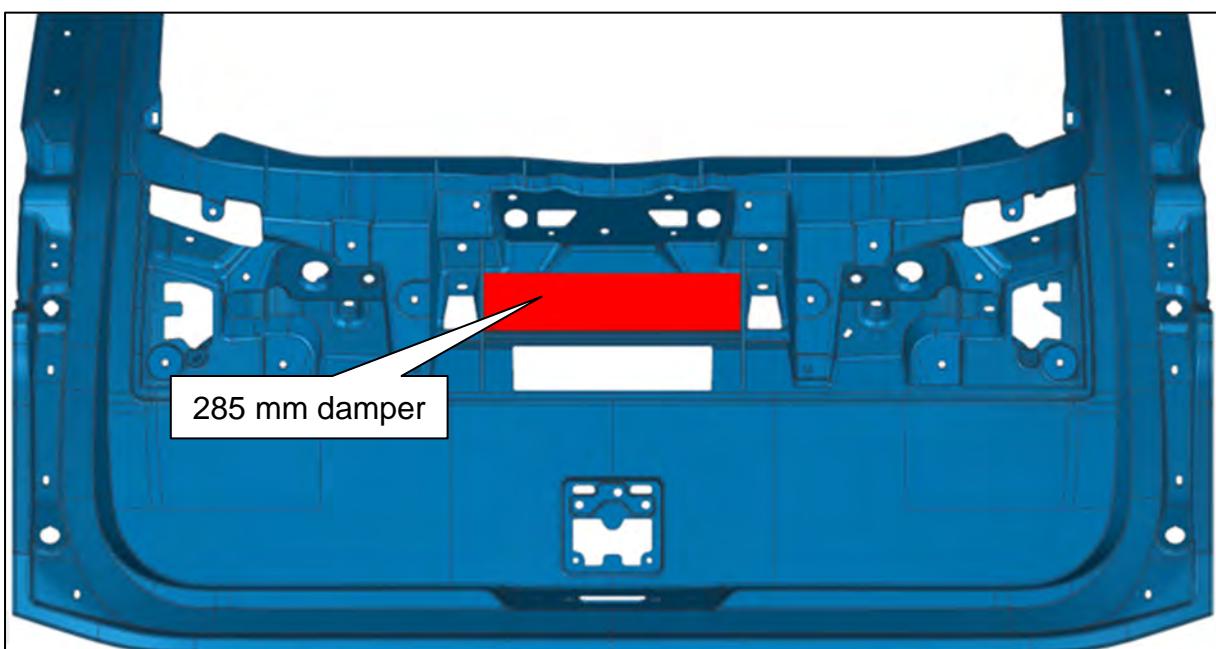
Figure 33

43. Clean the surfaces where the 285 mm and 115 mm Dampers will attach to the Rear Door with isopropyl alcohol.
44. Apply 285 mm Damper where shown in Figure 33.

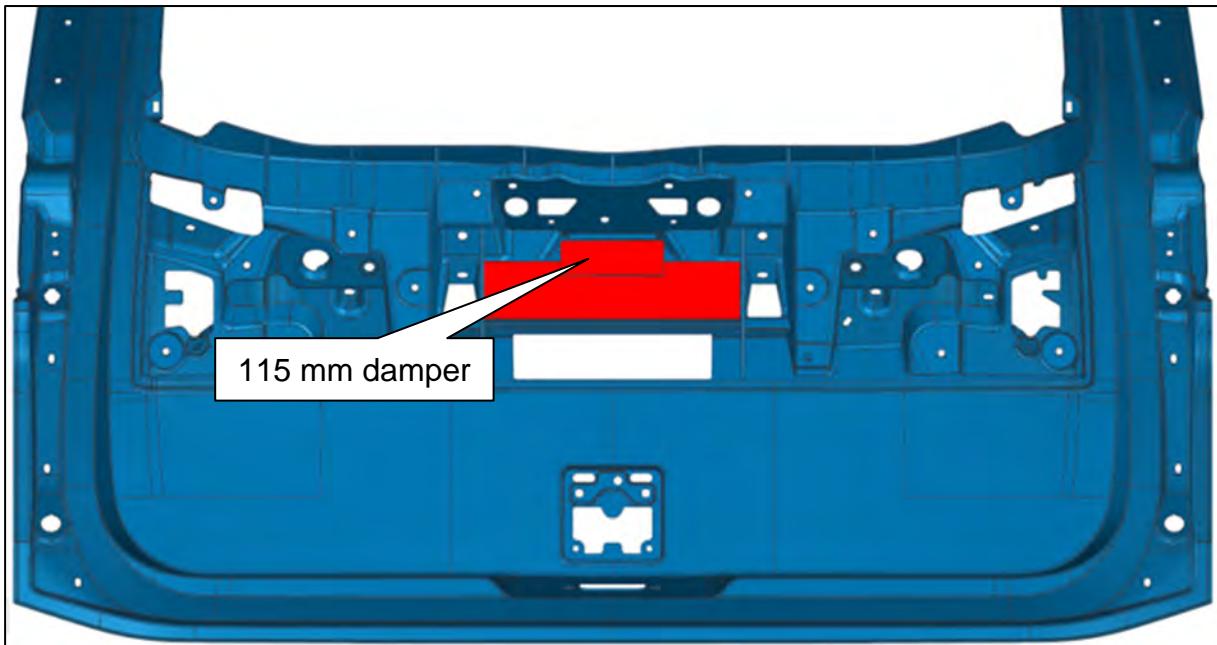
Figure 34

45. Apply the 115 mm Damper where shown in Figure 34.

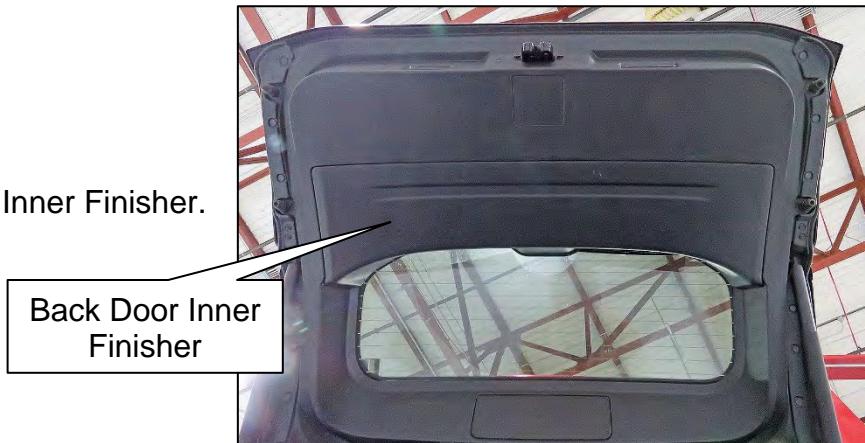
Figure 35

47. Measure 300 mm on the driver (LH) side of the Back Door (Approximately 12 inches) from where shown in Figure 35, and then place a mark on the underside edge of the Back Door with a black marker.

48. Measure 300 mm on the passenger (RH) side of the Back Door (Approximately 12 inches) from where shown in Figure 35, and then place a mark on the underside edge of the Back Door with a black marker.

49. Using a 6 mm (approximately  $\frac{1}{4}$  inch) drill bit, drill one (1) hole at each mark made in steps 47 and step 48. A total of two (2) holes shown in Figure 39.

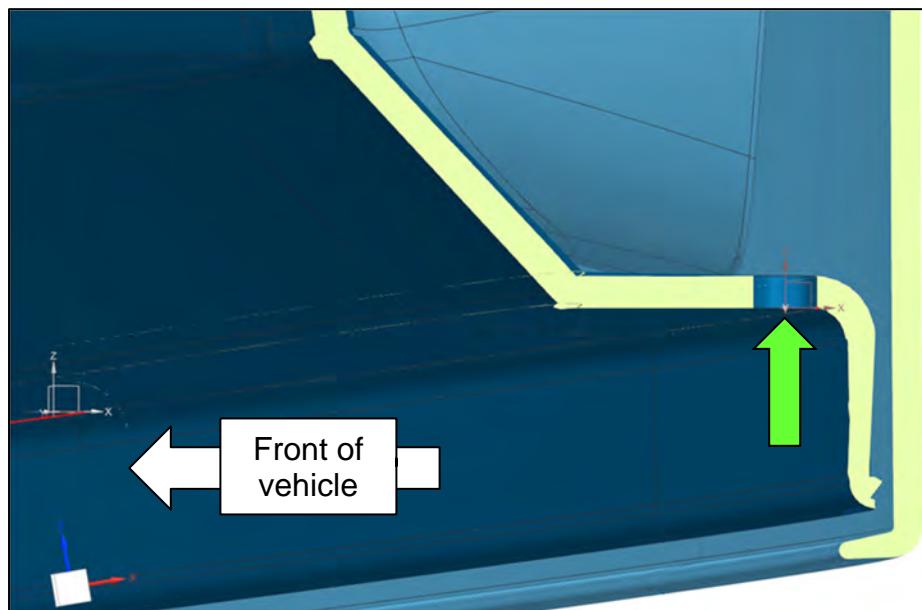
- Figure 36 illustrates the orientation of the underside edge of the Back Door when closed, and the angle that the drain hole will be drilled in the following steps.

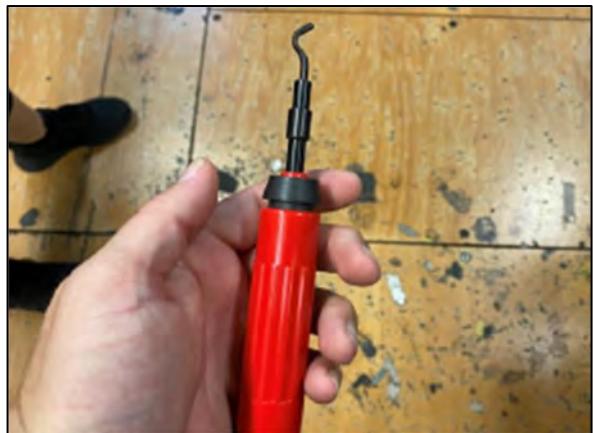
Figure 40

50. If needed, a deburring tool (Figure 40) can be used to remove any sharp edges from both drain holes (Figure 41).
