# Technical Service Bulletin

<b>Topic</b>	Air spring fault finding guidelines - 25MY
<b>Market area</b>	Bentley: worldwide (2WBE)
<b>Brand</b>	Bentley
<b>Transaction No.</b>	2076718/1
<b>Level</b>	EH
<b>Status</b>	Released for publishing
<b>Release date</b>	Mar 17, 2025

### 25MY Continental GT/GTC & Flying Spur

The front and/or rear suspension appears to have dropped.

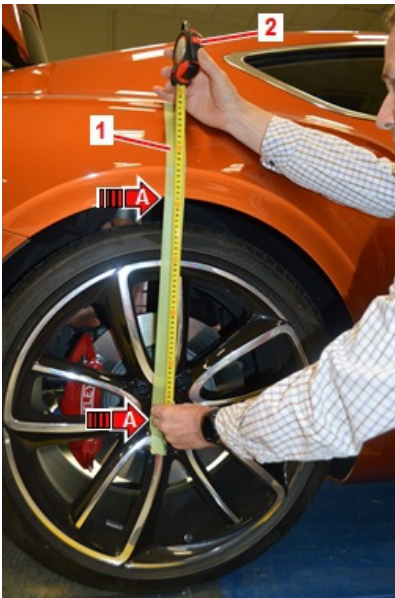
Figure 16

Apply strips of masking tape (1) from the centre of each wheel to the highest part of the wheel arch as shown, making sure the masking tape is applied 'taut'

Using a tape measure (2), measure and take note of the ride heights (A-A) at all four corners of the vehicle. See Figure 16.

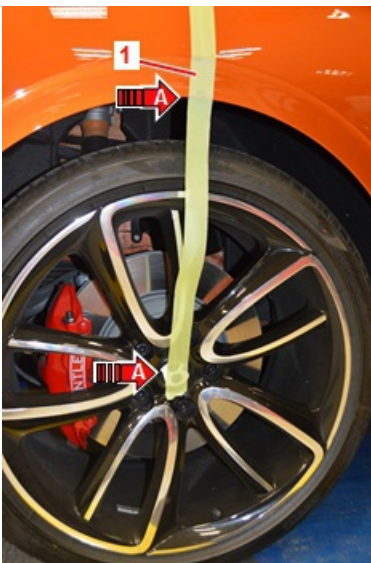
Figure 17

If there **IS** a difference in ride heights, and the strips of masking tape (1) have 'sagged' (shown in Figure 17), then refer to the following leak finding procedures below.

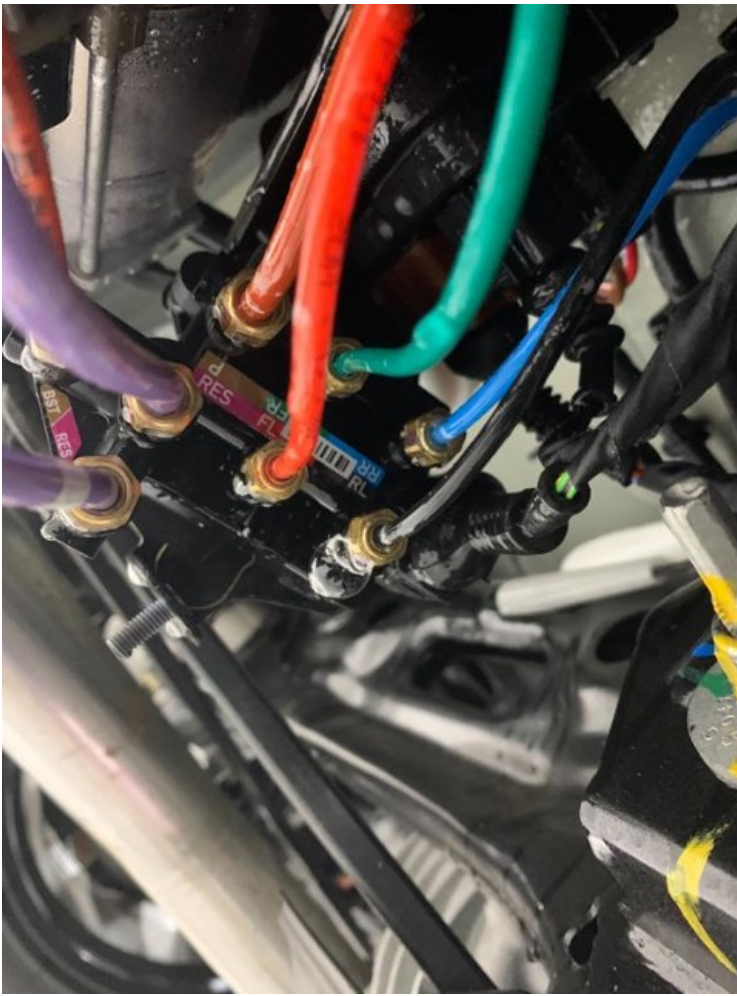
Figure 20

**VERY IMPORTANT:** In the event a leak is found at the air supply unit (Figure 20) a video and photographs of the leak is required to be attached to a new or existing DISS query

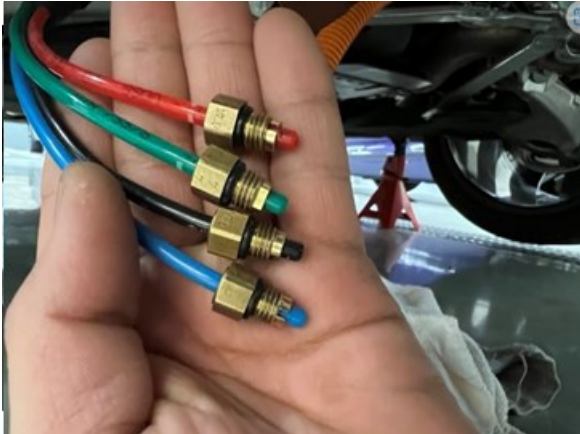
Figure 23

- Referring to Figures 23, 24 and 25, attach clear photographs of the components shown

**NOTICE**  
 In the event an air leak or any other issues were found at any of the afore mentioned locations the operative should attach clear photos or video (if requested) to a new or existing DISS query
