# Technical Service Bulletin

<b>Topic</b>	DTC P14AB00 and/or other related exhaust flap DTC's - Warning lamp evident within the DIP
<b>Market area</b>	Bentley: worldwide (2WBE),Hongkong-Macau (5HK)
<b>Brand</b>	Bentley
<b>Transaction No.</b>	2055664/2
<b>Level</b>	EH
<b>Status</b>	Released for publishing
<b>Release date</b>	Mar 3, 2025

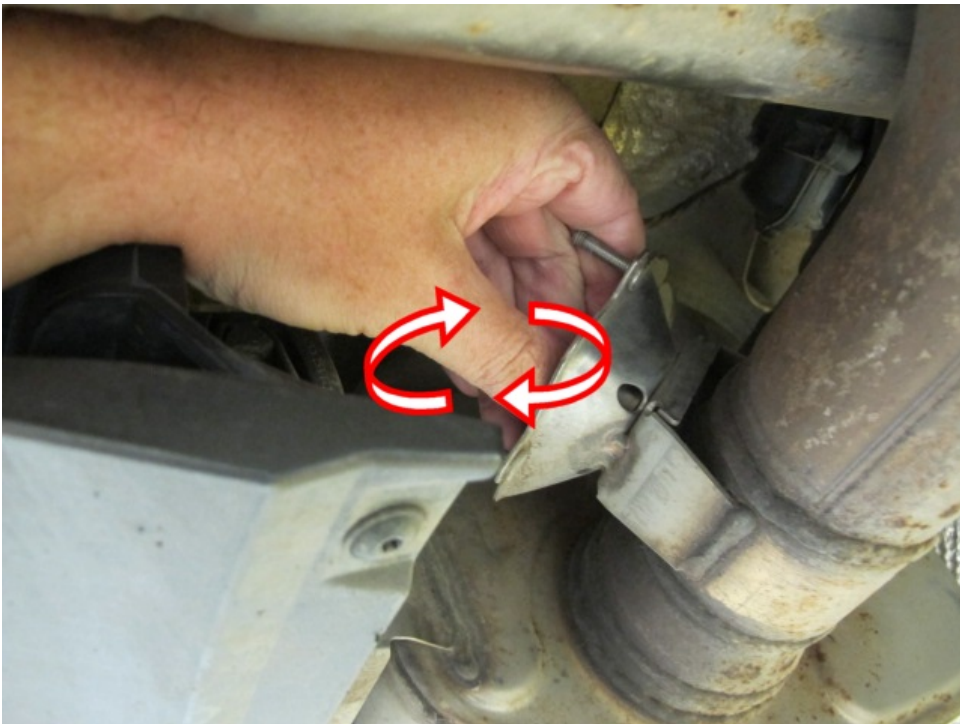
Figure 1

- Check and confirm the exhaust flap can be rotated by hand (clockwise and anti-clockwise) without the control unit fitted (Figure 1)

- Should no issue be evident with the exhaust flap and it can be freely rotated by hand - Replace the defective exhaust flap control unit Refer to Rep.Gr 26
