**SERVICE CAMPAIGN 75-05 LCI Leveling Pump Connection**  
**AFFECTED MODELS: 2025 VIEW & NAVION 524T**

## LCI Leveling Pump Connection

Field Service Campaign

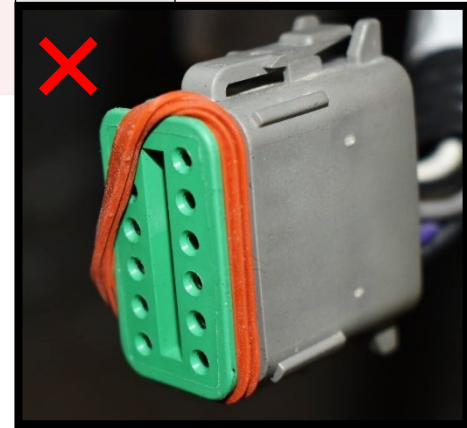
The LCI leveling pump connection may be missing the weather seal that protects the pin connections. If weather seal is missing, check for corrosion on the pins.

1. Ensure the vehicle is off. Visually examine the LCI leveling pump connection to determine if the weather seal that protects the pin connections is missing. Disconnect both connections to inspect. (See Figure 1 – Highlighted in Red)
2. If the weather seal is missing, or not properly placed, proceed to inspect the pins for any corrosion. The grommet is Orange. (See Figure 2 for example of how it is NOT supposed to be)

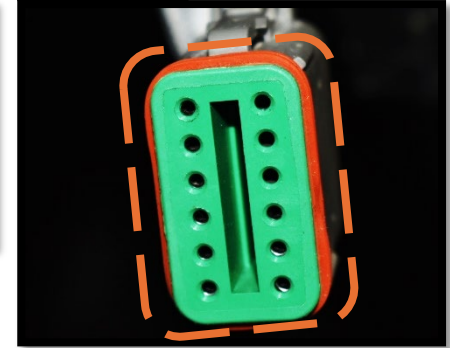
1. Ensure the Wedgelock is not loose in the connector (See Figure 5 – Green surface). If the Wedgelock is missing, replace it with the one provided in the parts Kit

1. Locate the weather seal supplied in the parts kit. (See Figure 4)
2. Carefully clean the surface of the connection to remove any dirt or debris.
3. Install the weather seal, pressing it firmly to ensure a proper fit. (See Figure 5 – Highlighted in Orange)

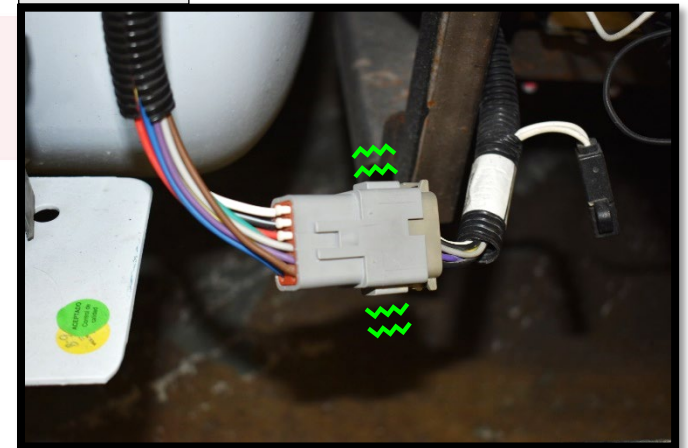
1. Reconnect the LCI leveling pump. You must hear a Clicking noise signifying proper reconnection. (See Figure 6 – Green Highlight shows where connection should be clicking together)
2. Turn on the system and verify that the leveling pump is functioning correctly without any issues.
3. Visually inspect the connection to ensure the weather seal grommet is in place and shows no signs of damage.
