MAS004653 RU 25-05

**RAPID UPDATE**

# Rapid Update 770 Grecale Folgore - Additional checks

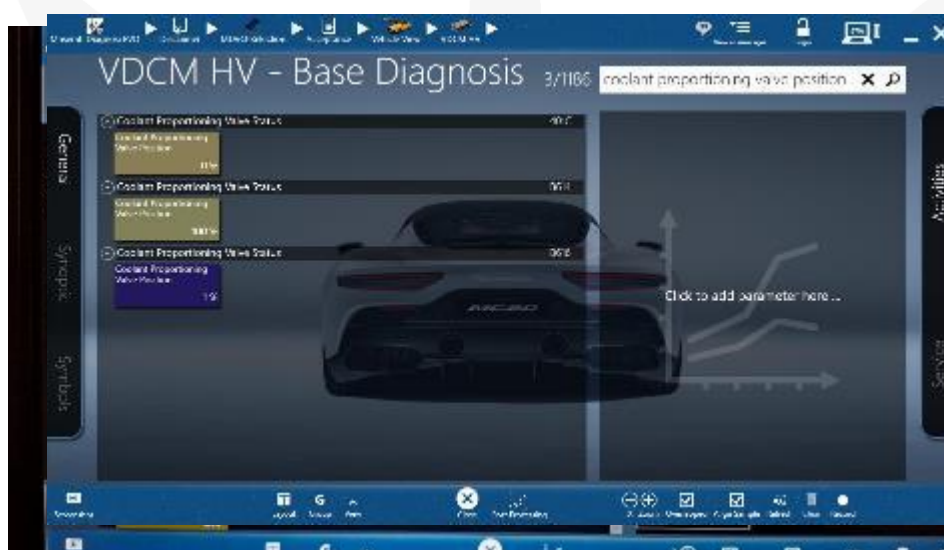
4. Select the "**VDCM HV – Base Diagnosis**" screen from the "**Vehicle View**" window
5. Enter the word "**Coolant**" in the search field **Proportioning Valve Position** "

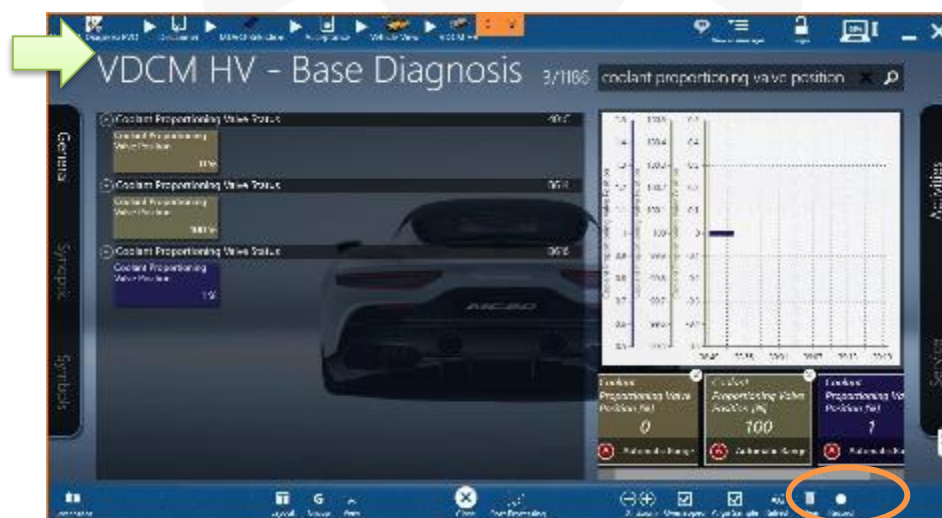
6. By using the mouse (or by holding down the single item) activate the window and insert the three required parameters in the display screen.
7. "**Coolant**" in the display screen. "**Proportioning Valve Position**" parameters 401C, B614, B616 of each individual valve.

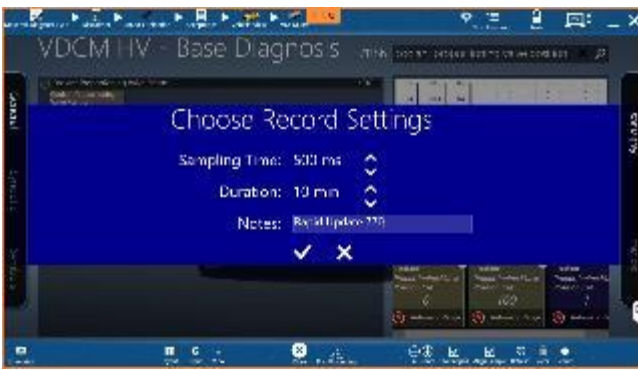
8. At this point select the "Record" button at the bottom right and enter the configuration shown in the following figure and start recording.

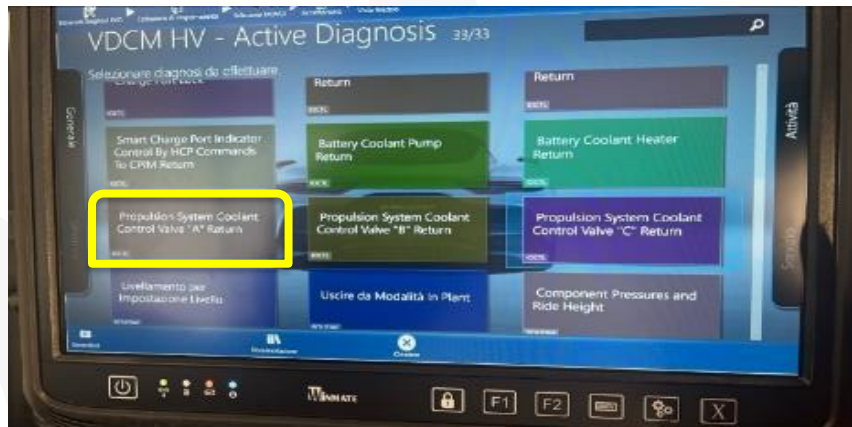
9. Select the "Vehicle View" window again to access the Active Diagnostics screen. Here select the "**Propulsion System Coolant Control Valve "A" Return**" command.

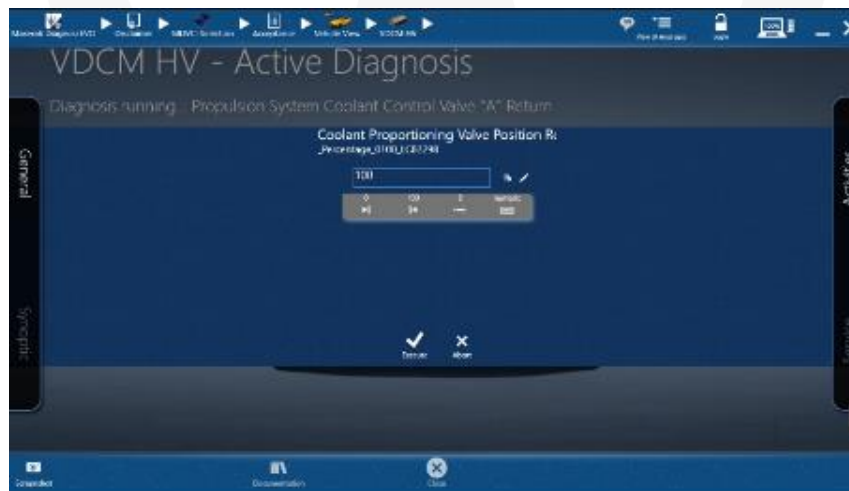
10. Enter the value "**100**" in the screen and click on the "**EXECUTE**" button

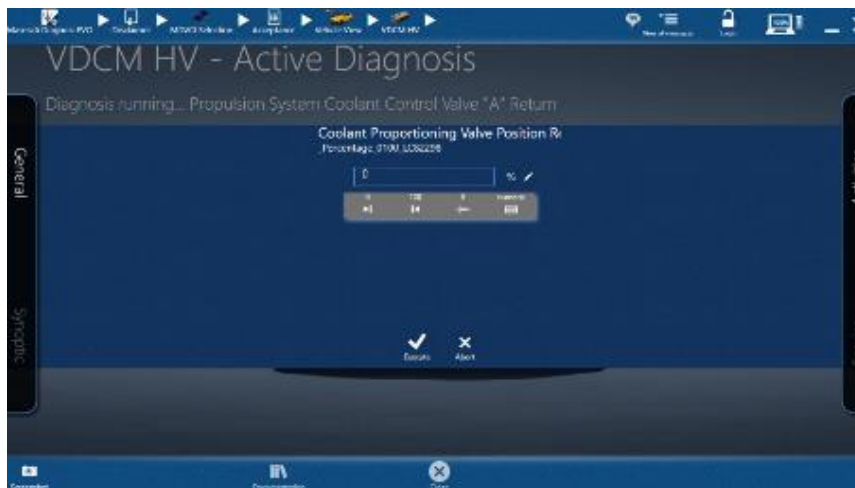
11. Wait 20 seconds.
12. **Propulsion System Coolant Control Valve "A" Return** again and enter the value "**0**" (zero) and click on the "**EXECUTE**" button

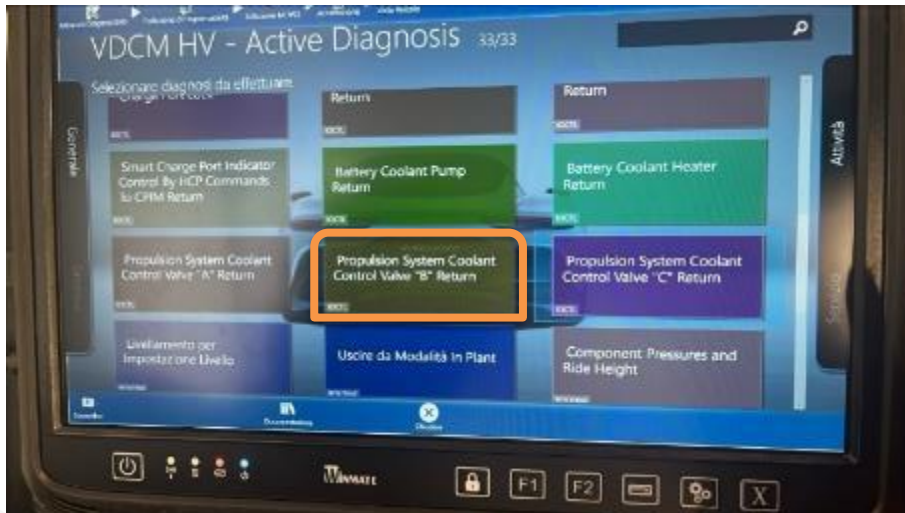
- Repeat the procedure seen for valve A also for valve B by selecting **Propulsion System Coolant Control Valve “B” Return** ”.

- Perform the procedure for entering the values 100 and 0 as explained from step 10 to step 13 of this bulletin 5 times , taking care to wait at least 20 seconds between one command and the next.
- Wait 20 seconds before proceeding with valve C.

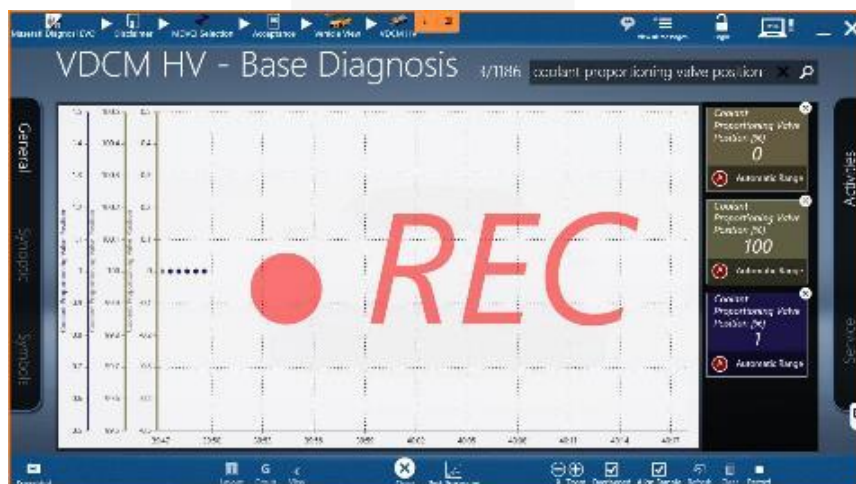
- Perform the procedure for entering the values 100 and 0 as explained from step 10 to step 13 .
- At this point return to the recording screen and stop recording by clicking the “Record” button again and save the file.

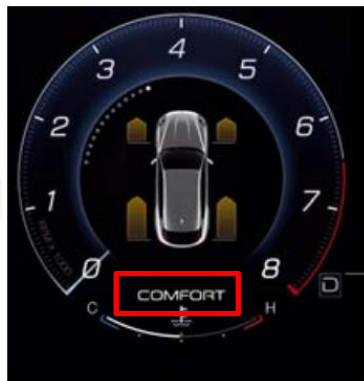
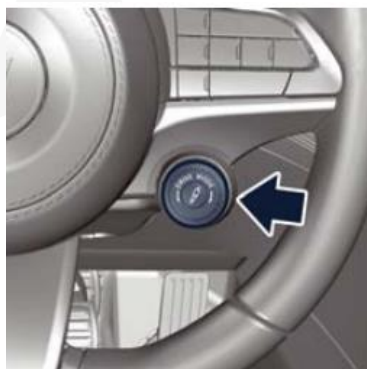
1. Always check ModisCS+ to see if the vehicle is involved in this action and if it has not been previously performed.
2. Start the Engine and make sure "Comfort" mode is activated via the instrument cluster (IPC) display using the selector located on the steering wheel.

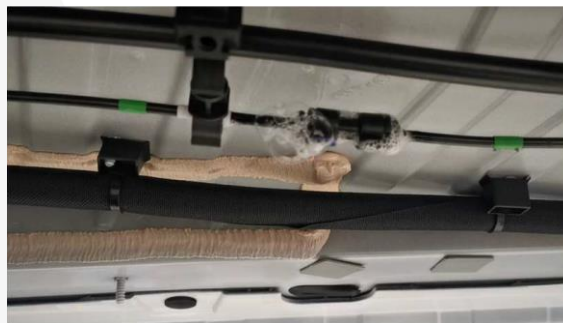
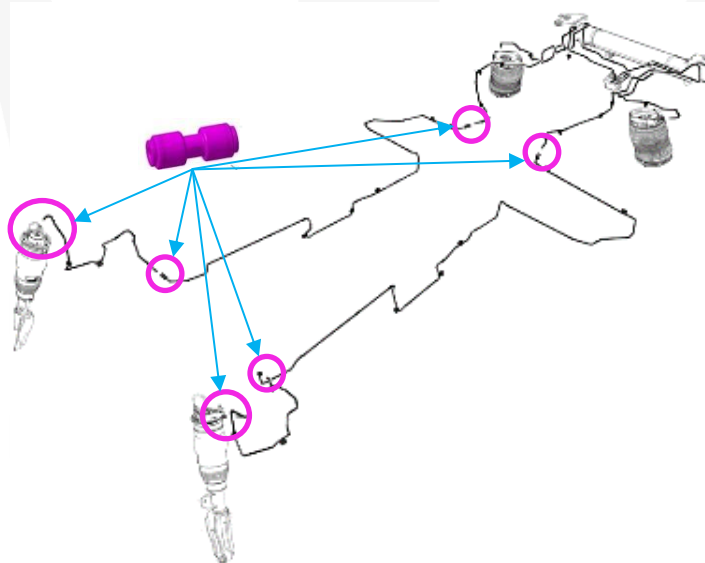
1. Check all the connections (1) between the section of all tubes of the circuit with the gas leak detector liquid or equivalent and check for air leaks.

2. If no leaks are evident, reassemble the disassembled parts following the reverse procedure, no further action is needed.
3. If, on the other hand, air leaks are evident from the areas of the sections, the two components of the section (part with male end and part with female end) of the single offending section must be replaced, following the dedicated workshop procedure.
4. The intervention can be considered complete.

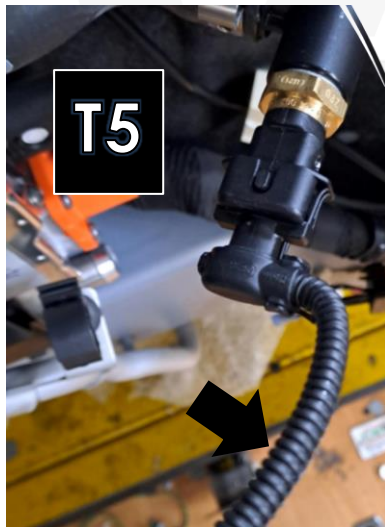
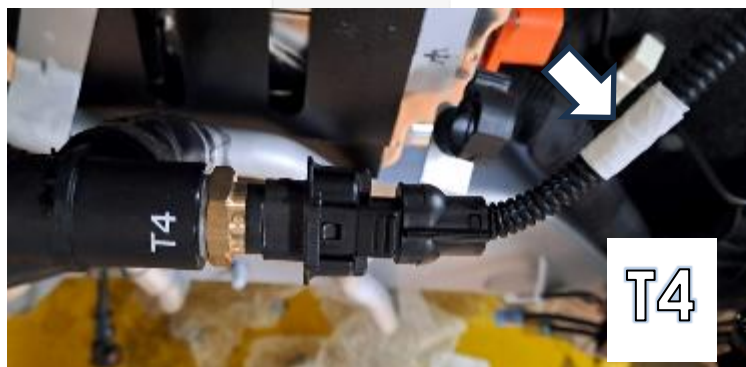
**Note:** each component indicates the type of sensor mounted and possibly the color of the tape on the wiring to which it is to be coupled. In particular, the **T4** sensor is connected to a connector with a **white** tape while on the **T6** wiring, there is a blue tape and the word "**blue**" on the connector. As for the **T5**, however, this is **black** and must be connected to the **wiring without taping**.

3. If a different situation is found (mismatch of the color of the tape and the indication on the sensor) **the exchange must be carried out and the correct match must be restored.**
