GENERAL MOTORS  
DCS7185  
URGENT - DISTRIBUTE IMMEDIATELY

Subject: N242483540 - Service Update  
Transmission Shifting Issues With DTC P2732

Models: 2024 Chevrolet Silverado 1500  
2024 GMC Sierra 1500

### N242483540 Transmission Shifting Issues with DTC P2732

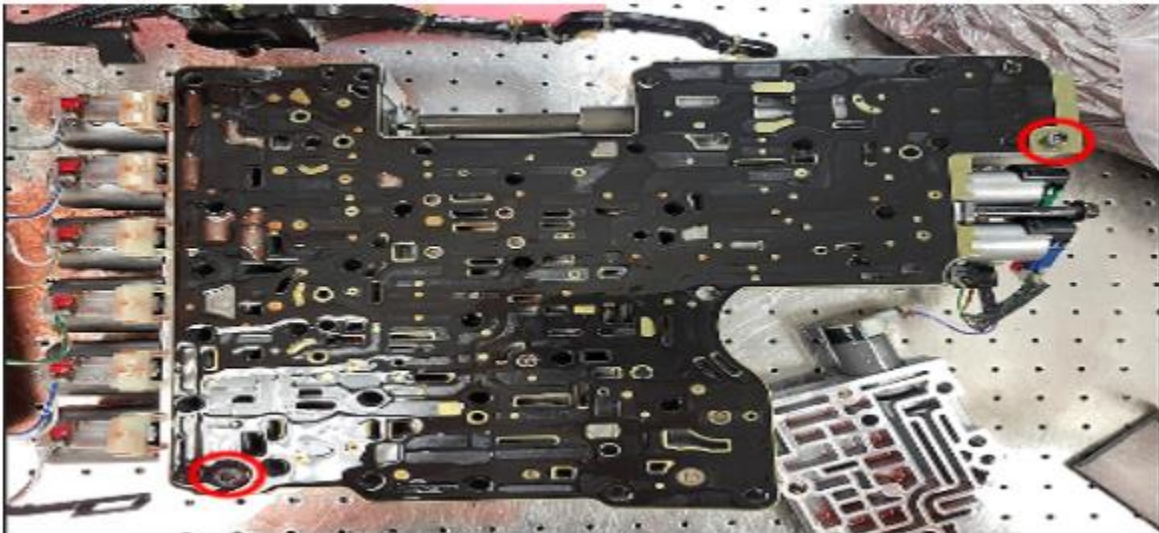
6804467

**NOTE:** There are check balls beneath the spacer plate that may fall out if the Solenoid Body is tilted.

13. Remove the two bolts securing the Solenoid Body Spacer Plate as indicated above.
14. Remove and discard the Solenoid Body Spacer Plate.

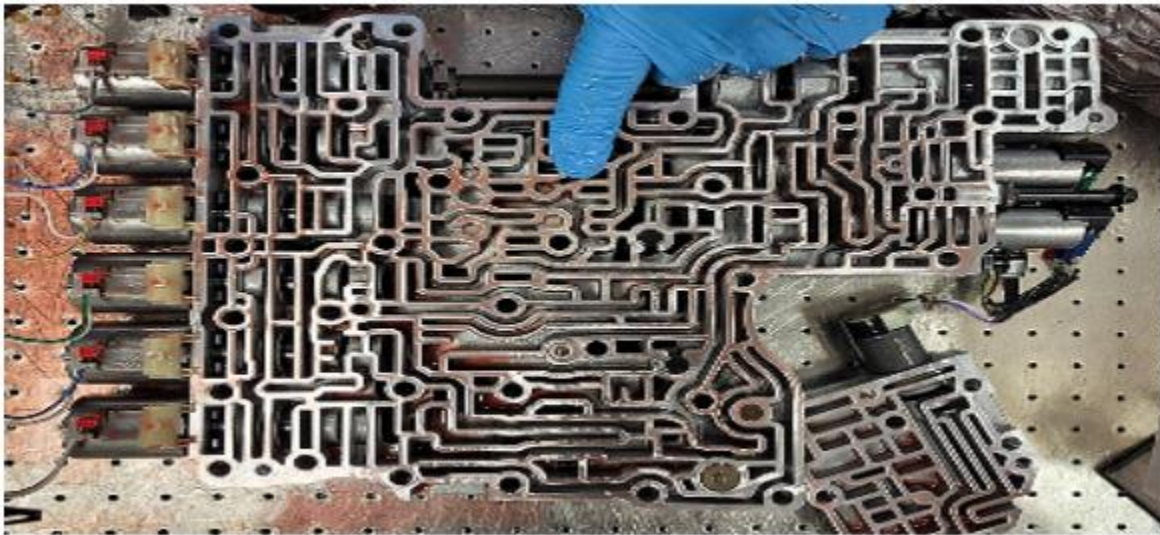
6804538

**NOTE:** The parts section indicates ordering 5 check balls. Replacement of the undersized check ball is all that is required, the extra check balls are included in the event that some are misplaced or damaged during replacement.

15. Utilizing a pick or equivalent tool, remove the undersized check ball from the check ball seat and discard. Use care not to damage the Solenoid Body surface.
16. Install a NEW check ball into the Solenoid Body.
17. Ensure all Solenoid Body components are in their correct position prior to installing the new Spacer Plate.

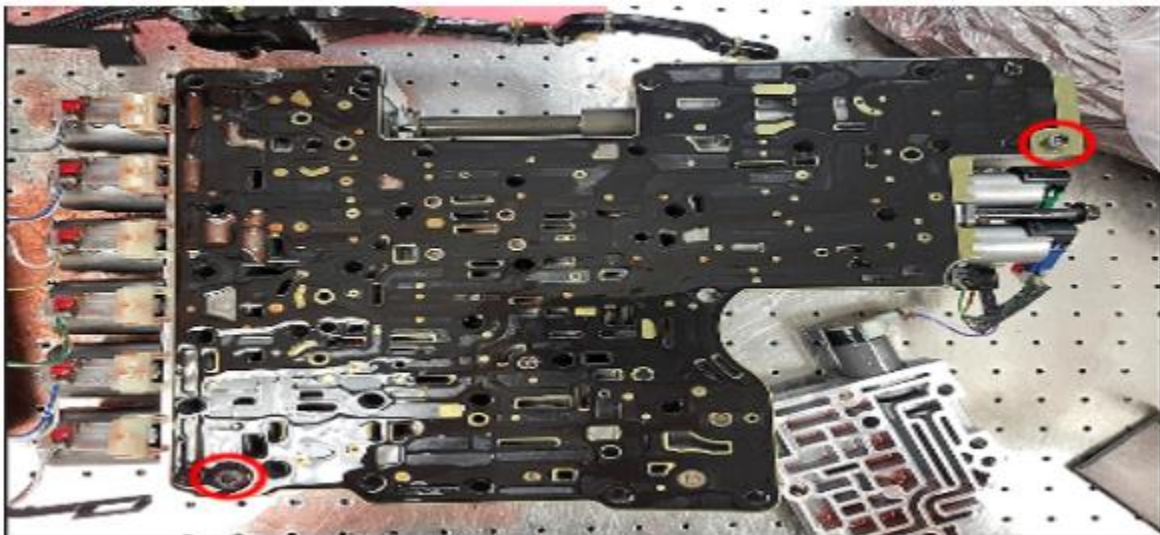
6804467

18. Install the NEW Solenoid Body Spacer Plate and tighten the two fasteners to 9Nm (80 lb-in).
