Technical Service Bulletin

Subject: CHECK ENGINE LIGHT ON WITH DTC P0126:00	Bulletin No.: 01-003/25
	Last Issued : 03/13/2025

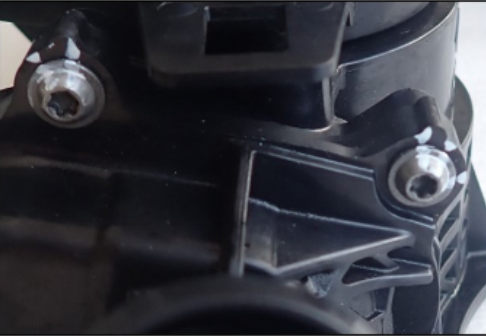
Marking Example 1: Draw lines over the screws and the thermostat cover as shown above.

a. Mark the four (4) screws and the respective holes before loosening them to ensure that the screws are placed in their original holes when reinstalling.

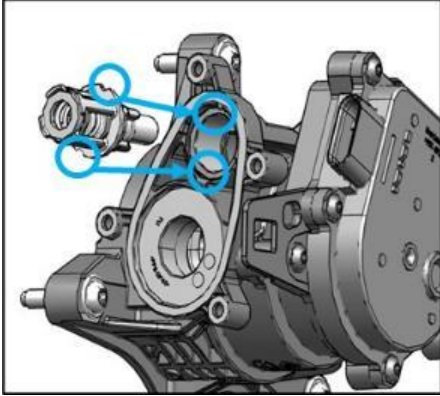
- b. When installing the thermostat, push it firmly until it makes a clicking noise to ensure it has been installed properly.

- Insert the thermostat so that its notch matches the protruding area in the hole.
- Add 1-2 drops of coolant as necessary to the O-ring to help slide it into the thermostat housing.

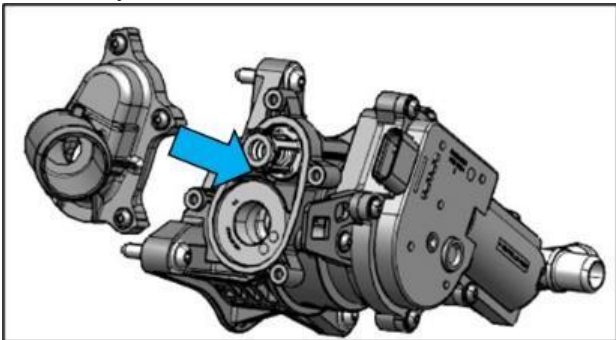
5. Install the new thermostat cover and the thermostat cover gasket (included in the thermostat set) to the coolant control valve body.

a. Ensure that the thermostat cover gasket is inserted correctly in thermostat cover slot.

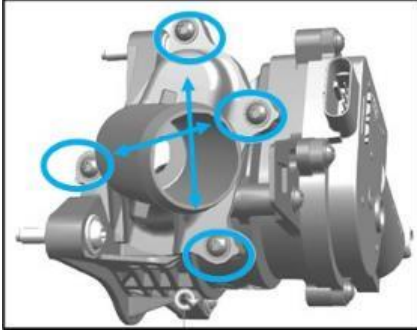
c. Tighten the screws in a criss-cross pattern.

Tightening torque: Tighten screws to 26 in. lbs (3 Nm), then repeat tightening to 44 in. lbs (5 Nm).
