Technical Service Bulletin

Subject: CREAK OR SQUEAK NOISE FROM LOWER CONTROL ARM AT FRONT SUSPENSION WHEN TRAVELING OVER A BUMP WHILE TURNING AT LOW-SPEED	Bulletin No.: 02-001/25
	Last Issued : 03/11/2025

2024 CX-90 with VINS lower than JM3KK*****126418 (produced before August 2, 2023)

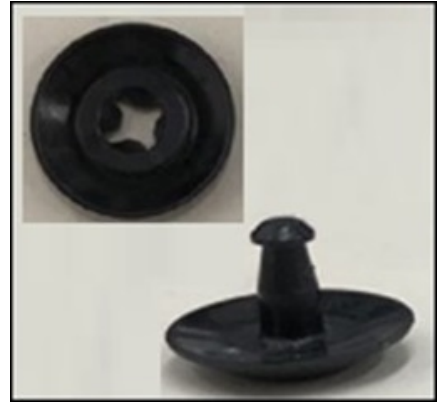
Female Rivet
Male Rivet
(3 each for one side)

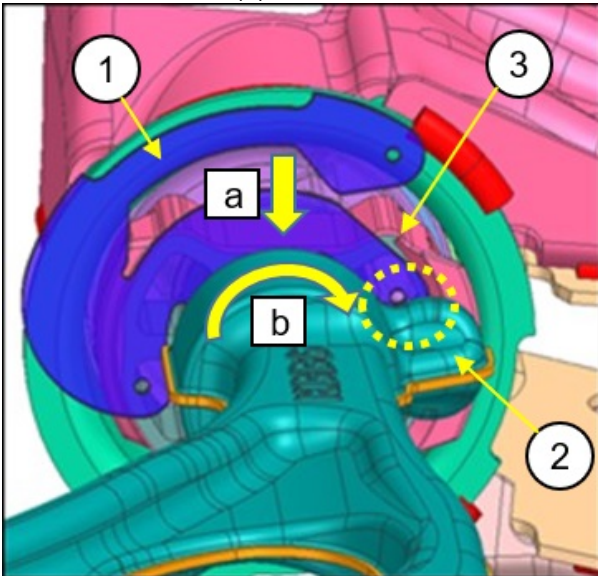
- 1) Insert the dust cover A (1) into the gap between the lower arm and the stopper rubber (3) in the direction of arrow (a).
- 2) Insert the dust cover A (1) under the protrusion (2) of the lower arm while rotating it in the direction of the arrow (b).

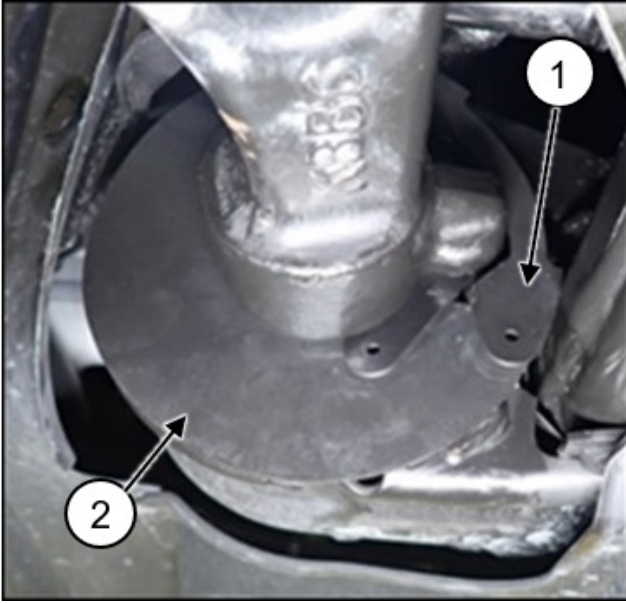
b. Install Dust Cover B (2) so that Dust Cover A (1) is on the vehicle front as shown.

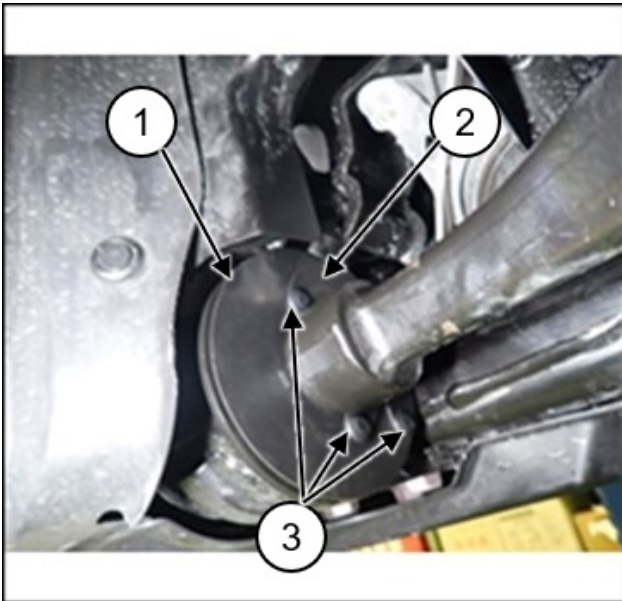
Images of the completed repair

- (1) Dust Cover A
- (2) Dust Cover B
- (3) Rivets

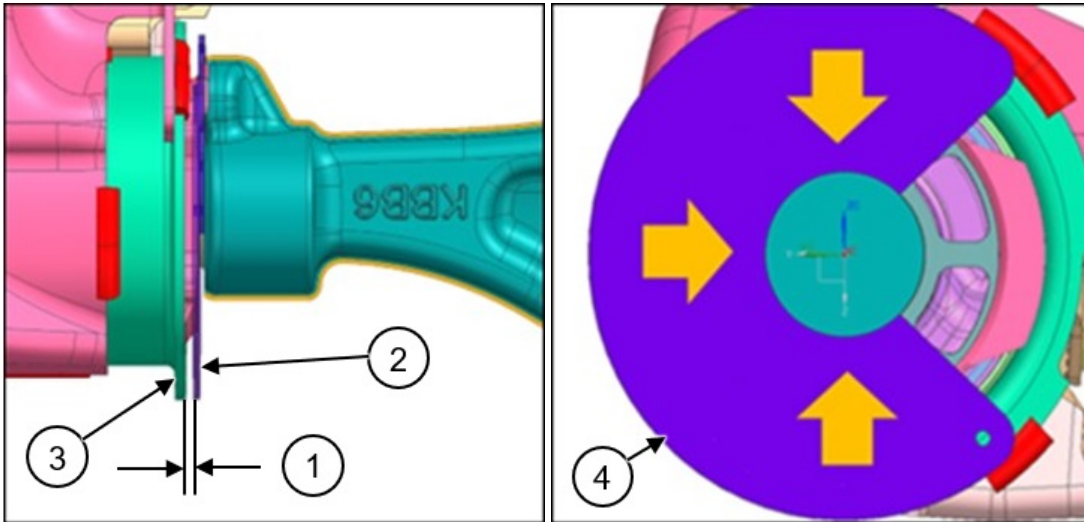
- Ensure the space (1) of 3-5 mm {0.1-0.2 in.} between the dust cover (2) and the bracket (3).
- If the space (1) is wider than 10 mm {0.4 in.}, the mounting position may be incorrect.
- If the space (1) is wider than 5 mm {0.2 in.}, push the dust cover B (4) into the direction of the shaft (yellow arrows) and adjust the gap.
