# Technical Service Bulletin

Topic	V8 Kovomo - Bentayga - Water pump drive gear cover (Deletion)
Market area	Australia E04 Bentley rest Asia and Australia (6E04),China 723 Volkswagen (Anhui) Automotive CO (6723),China 796 VW Import Comp. Ltd (Vico), Beijing (6796),Germany E02 Bentley rest Europe (6E02),Japan E03 Bentley Japan (6E03),Korea, (South) E08 Bentley South Korea (6E08),United Arab Emirates E06 Bentley Middle East and Africa (6E06),United Kingdom E01 Bentley UK (6E01),United States E05 Bentley USA and rest America (6E05)
Brand	Bentley
Transaction No.	2065918/5
Level	EH
Status	Released for publishing
Release date	Mar 4, 2025

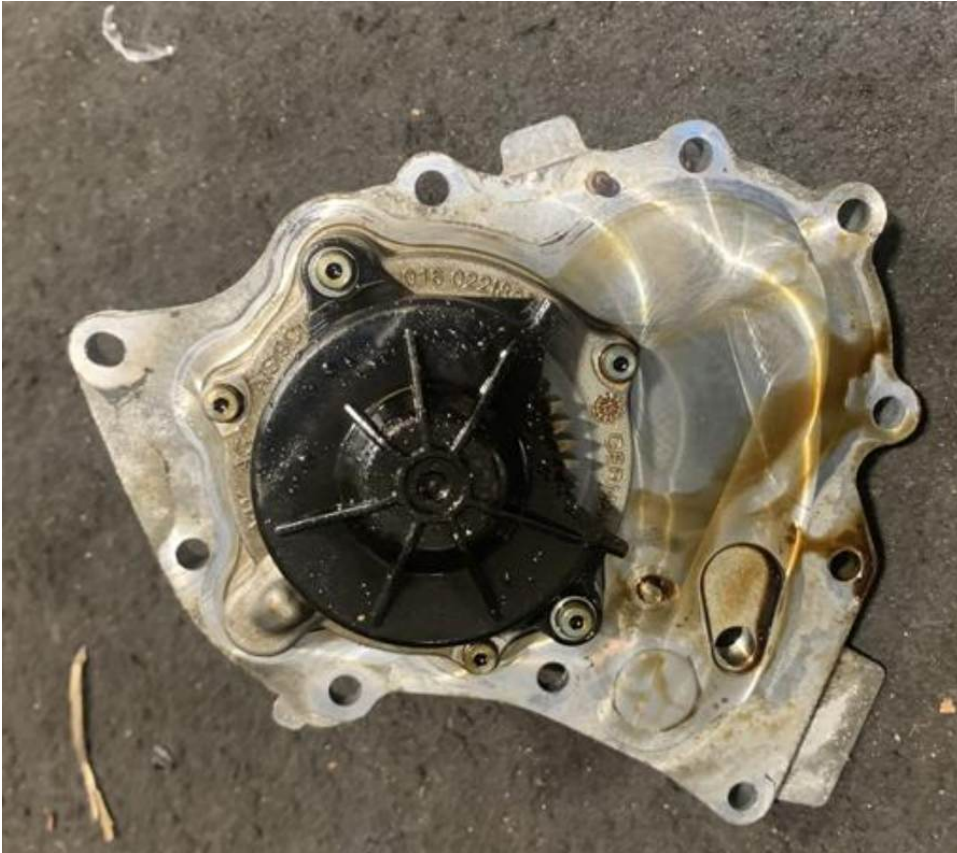
Figure 1

The original water pump has a cover fitted directly over the top of the water pump drive gear (Figure 1)

**The cover is no longer fitted on replacement water pumps, the cover is not required and MUST not be transferred to the new water pump**

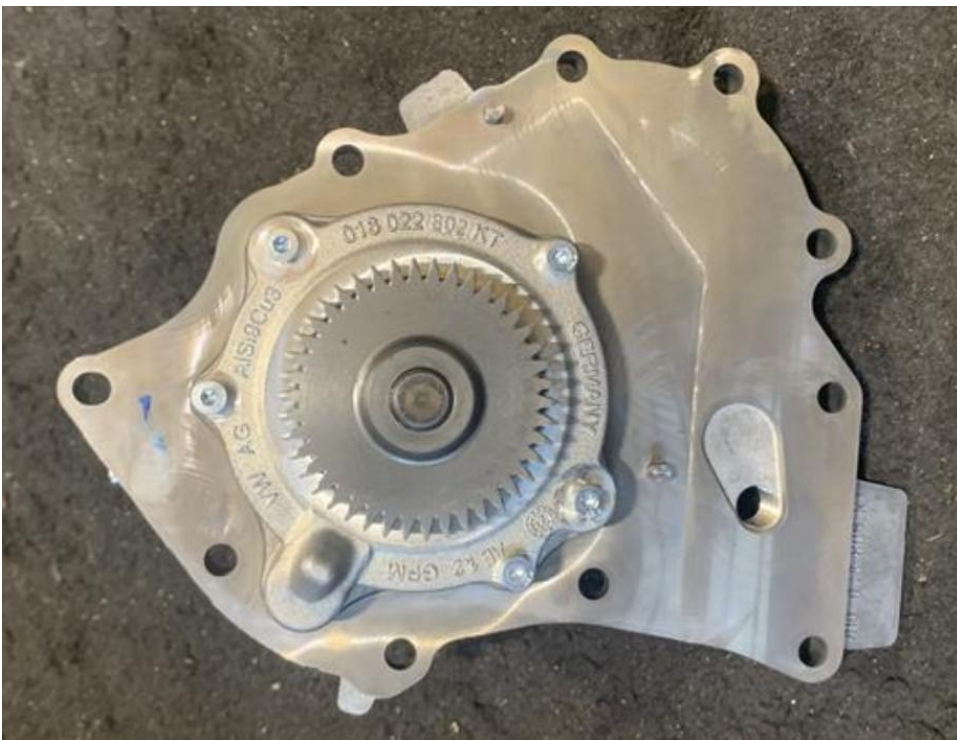
Figure 2

However the replacement water pump does not have a cover fitted (Figure 2)

**The operative should fit the new water pump without the cover as shown in Figure 2**
