Applicable Vehicles					
Model	Year	Eng. Code	Trans. Code	VIN Range From	VIN Range To
ID.4	2021-2025	All	All	All	All

Revision Table			
Instance Number	Published Date	Version Number	Reason For Update
2071473/3	3/24/25	87-24-02	Clarify step 16 by reinstalling the condenser cap.
2071473/2	12/9/24	87-24-02	Update to labor operation number and update model year applicability.
2071473/1	4/2/24	87-24-02	Original publication.

Debris can be dispersed throughout the refrigerant circuit after A/C component damage. In order to maintain A/C operating efficiency, it is important to flush the refrigerant circuit after A/C component repairs.

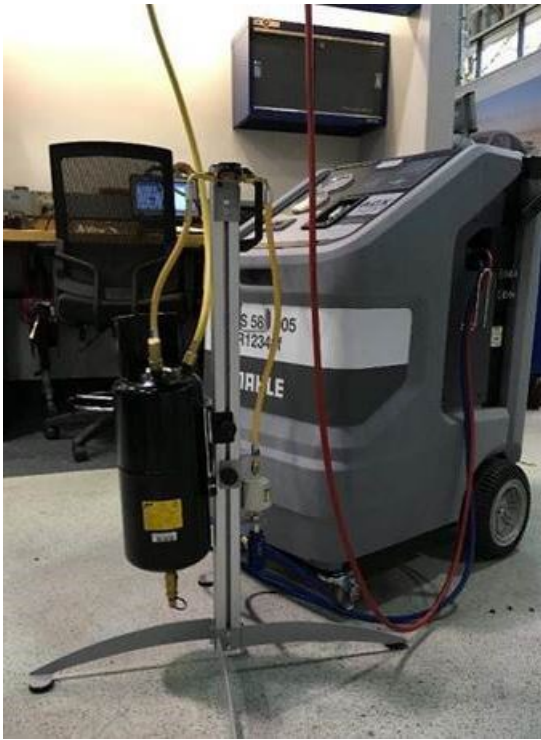
Figure 1. VAS581005 Air Conditioning Service System with Flushing Device.

Use an approved R1234yf servicing machine and the R1234yf Flush Kit RTI360831840 (Figure 1).

Used for effective refrigerant handling and air conditioning circuit flushing after air conditioning component failure.

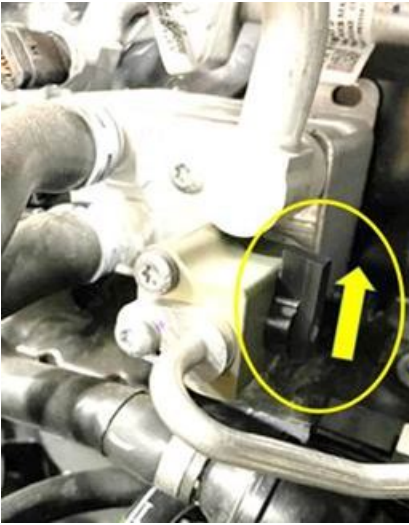
Figure 16. Installation of A/C Line connection block adaptor VAS 6338/80.

At this time place the bypass adaptor in the closed position as shown in Figure 16.

18. Remove expansion valve -**N636**- and install adaptor VAS 6338/80 (Figure 16)

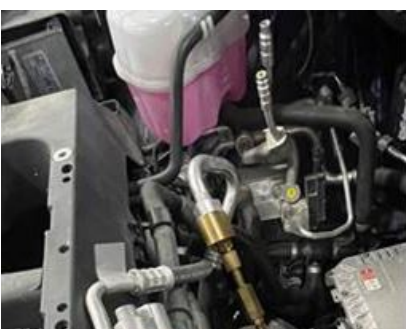
Figure 18. Installation of VAS 6338/3 and 6338/12.

This connection strategy allows for a system flush *in the opposite* direction of the normal refrigerant flow.

20. Disconnect A/C compressor hoses from the compressor.

Install flush adaptor VAS 6338/3 on the high side compressor hose.

Install flush adaptor VAS 6338/12 on low side compressor hose.

Attach high side A/C Recovery machine hose with VAS 6338/48 fitting to low side compressor hose adaptor VAS 6338/12.

Attach the Yellow recovery tank hose to high side adaptor VAS 6338/3. (Figure 18)
