STAR ONLINE PUBLICATION

Case Number: S2508000027

Symptom/Vehicle Issue: Massage Seat, Seat Lumbar, and Seat Bolsters Inoperative

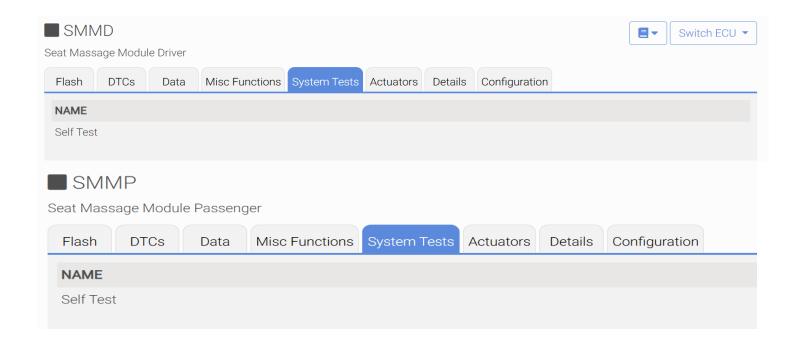
Customer Complaint/Technician Observation: Owner complains that the seat massager is not working. The technician identified the seat operations for the above seat functions do not operate. Vehicle is setting Diagnostic Trouble Code B1D60-00 Front Seat Identification Circuit.

Discussion: If the condition of the above seat malfunction with the DTC B1D60-00 setting, use the wiTECH scan tool to perform the Seat Massager Module Driver (SMMD) and Seat Massager Module Passenger (SMMP) self-test to complete. No parts required.
