BEST PRACTICES – BRAKE JUDDER/VIBRATION

- There have been several FRED submissions for a customer allegation of brake judder/vibration.
- If a customer is alleging that there is brake judder/vibration, the supporting evidence must be clear.
- Please take videos of the brake rotors being measured for lateral runout.
- Proceed to disassemble the brake components from the vehicle and take photos of the rotors and pads (both front and back surfaces, as shown on the previous slide).
- Please also take photos of the hub flange mating surfaces.
- Once the photos are taken, It is important that the submission attachments are clear, as this will justify the gateway for approval based on evidence of a manufacturing defect.

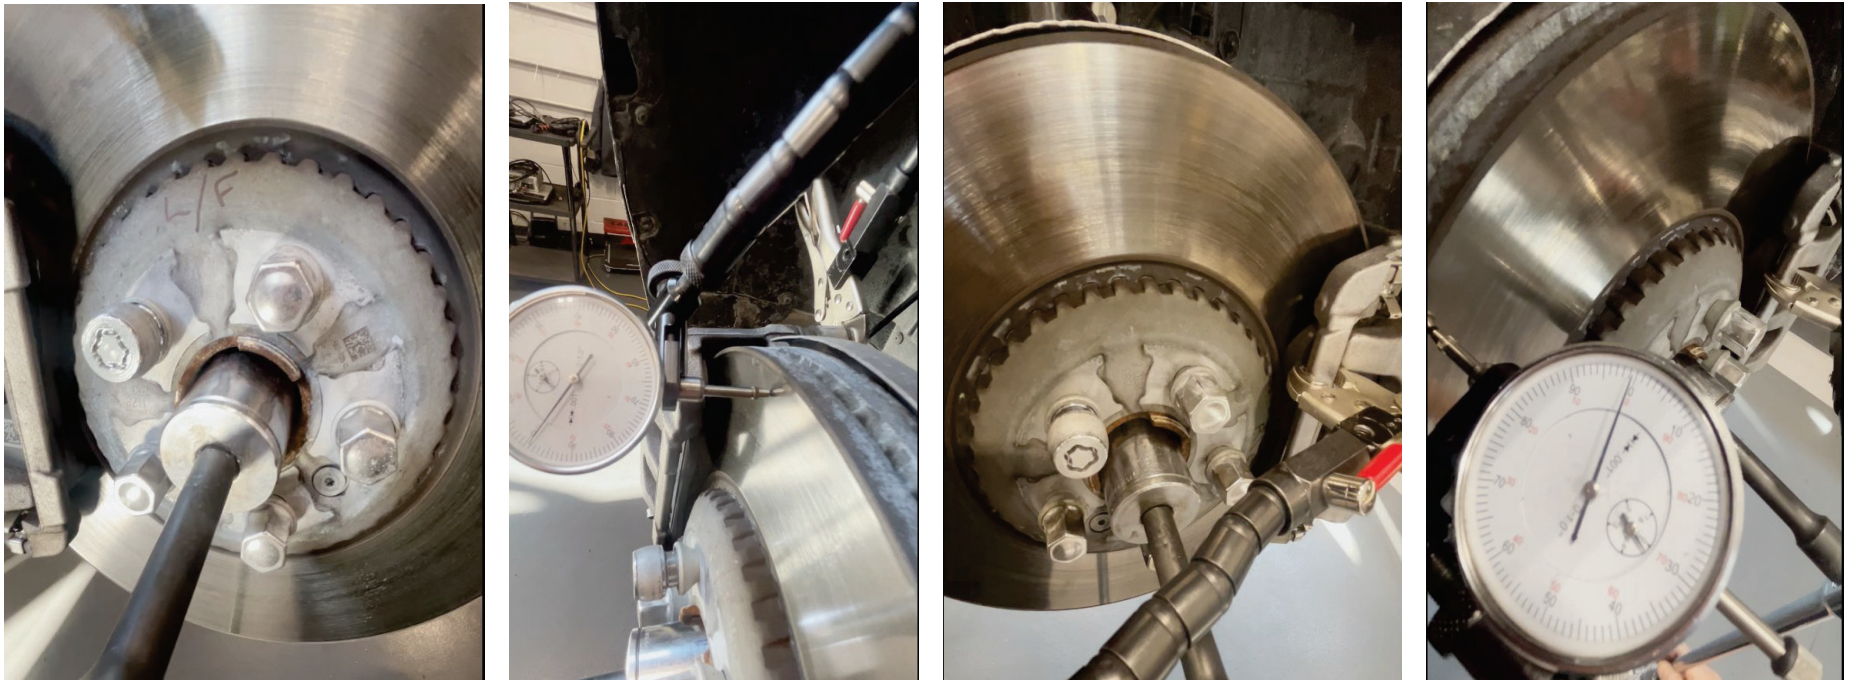
Step 1. Videos of the brake rotors being measured for lateral runout
