Title: Alternate Entrance Door Skirt Light Non-Functioning Repair

Applies To: Next Gen Bus

- Due to an incorrect power source signal, the left Alternate Entrance Door Skirt light only comes ON when the Right Entrance Door is opened.

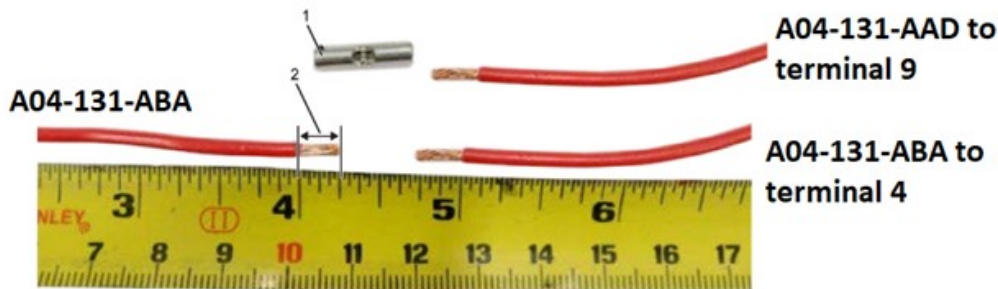
Figure: Insulation Stripped 1/4 inch

5. Locate the A04-131-ABA wire from terminal 4 on the Center Chassis/IP connector. Cut the wire approximately 10.5" or 270 mm from the connector body and strip the insulation back ¼" on both ends of the cut wire.

1. Crimp splice
2. Insulation stripped back 1/4 inch

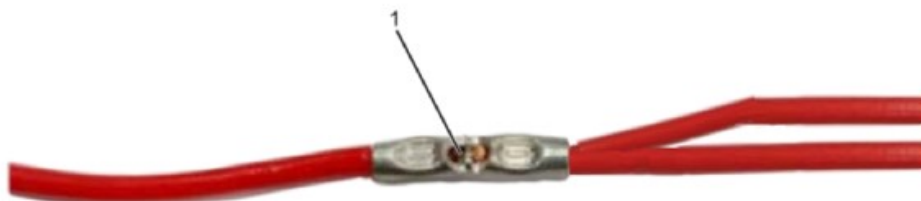
Figure: Crimp Splice Crimped on Both Wires

NOTE: Do not use pre-insulated crimp splices (1) as they can attract corrosion and moisture. Always use non-insulated crimp splices (1) and dual wall heat shrink.

1. Wire stop

6. Slide a 2-inch piece of heat shrink tube over the cut wires. Twist together the stripped ends of the A04-131-AAD wire from terminal 9 and A04-131- ABA wire from terminal 4. Splice them together with solder, followed by heating the shrink tube to cover the splice joint. Using a barrel style crimp splice of appropriate size for the wire, insert both ends of the wires into the crimp splice until conductor hits the wire stop.

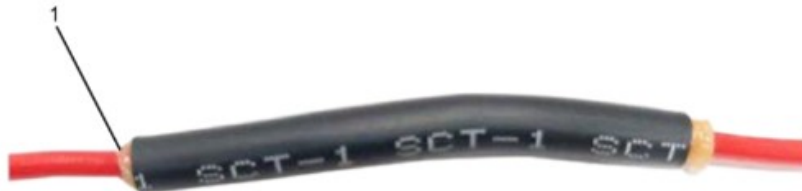
Figure: Dual Wall Heat Shrink Sleeve Over Splice

9. Slide the heat shrink over the splice and apply sufficient heat using a heat gun to shrink the tubing over the splice and wires (1). The adhesive should start to seep out of the ends, completely sealing the repaired area.

1. Adhesive on both sides
