Body Symptom - Green Discoloration on Door Seals: Clean the Door Seals (SY 05/25)

Model Line: **Taycan (Y1A / Y1B / Y1C)**

Model Year: **As of 2022**

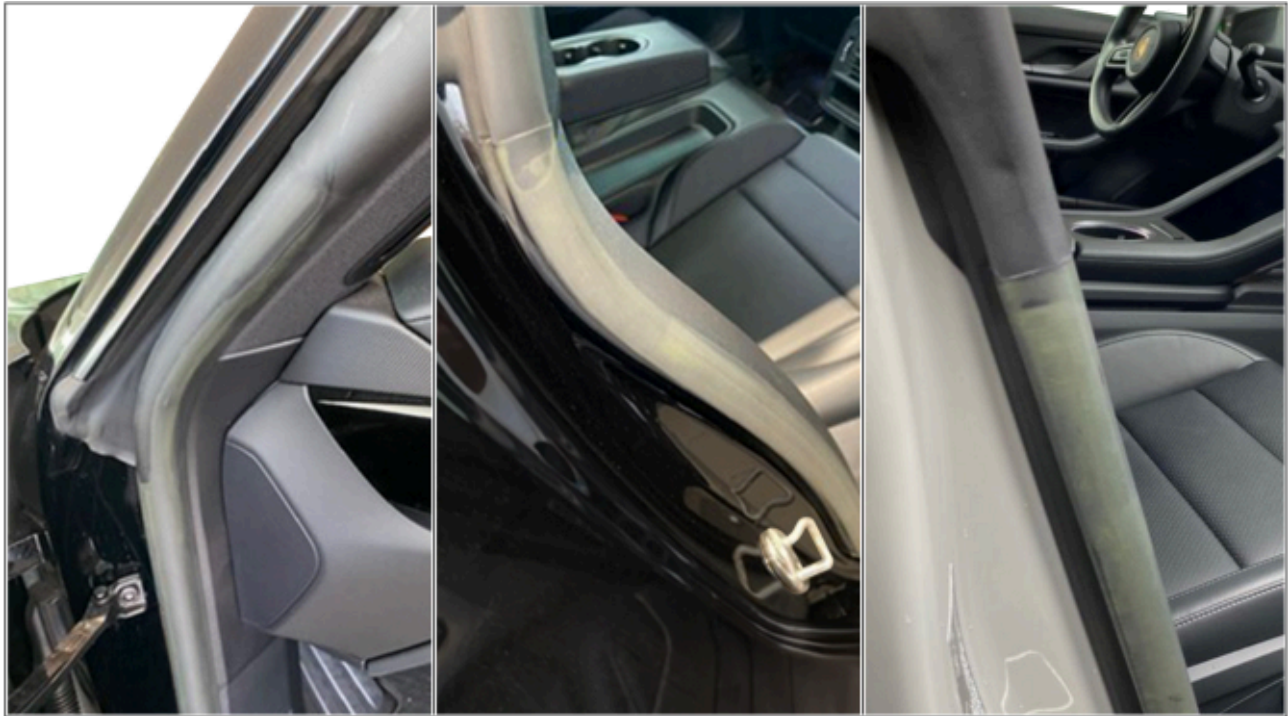
Example of door seal discoloration

Cause: Over time, the surface of the door seal can turn green.

Replacing the affected door seal is not expedient for this complaint and does not provide any remedy, because this is not a defect in the door seal.

If there is a customer complaint, clean the door seals on all four doors.

Commercially available vehicle interior cleaners have been seen to be suitable, which do not attack seal materials and paintwork.

So-called dirt eraser sponges have proven useful for the application and effective cleaning.
