Coolant Loss in the Body Front Section/Engine Compartment Area - Locate and Eliminate Cause of Coolant Loss (60/22)

Model Line: **Macan (95B)**

Concerns: **Coolant leak on coolant regulator housing or coolant pump**

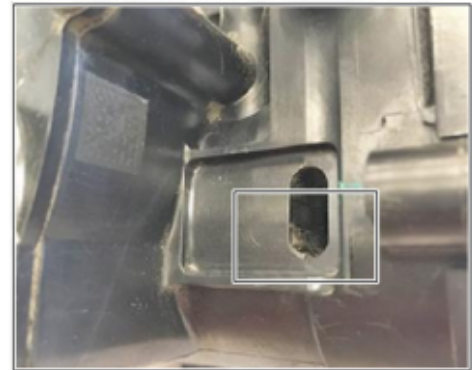
If only **slight traces of coolant** (dry white deposits) are visible **on the components and there is no specific customer complaint, replacing components is generally not justified.**

Example 1: Slight traces of coolant using the type of coolant regulator without a leakage tank as an example ⇒ *Slight traces of coolant (old type of coolant regulator without a leakage tank).*

Slight traces of coolant (old type of coolant regulator without a leakage tank)

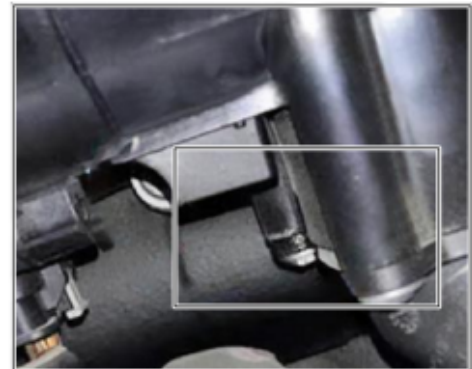
Example 2: Slight traces of coolant using the type of coolant regulator with a leakage tank as an example ⇒ *Slight traces of coolant (current type of coolant regulator with a leakage tank).*

Slight traces of coolant (current type of coolant regulator with a leakage tank)

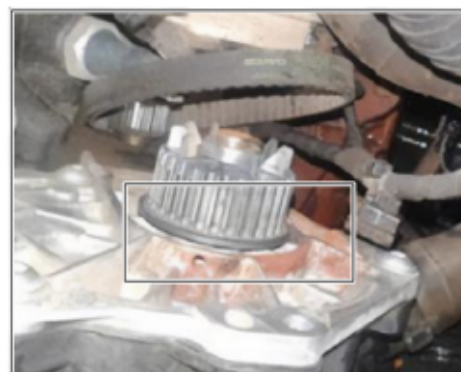
Unambiguous loss of coolant at the coolant pump close to the radial shaft seal ring ⇒ *Leaks on the coolant pump close to the radial shaft seal ring*. There is a leak in the coolant pump and **not** in the coolant regulator. Replace the coolant pump if the customer complains. ⇒ *Workshop Manual '195019 Removing and install coolant pump (R4)'*

*Leaks on the coolant pump close
to the radial shaft seal ring*
