Paint Stains Under Rapgard

Service Category Vehicle Exterior

Section Paint/Coatings

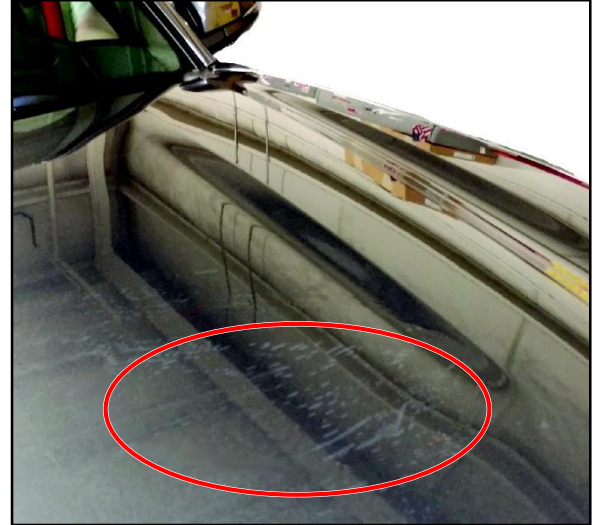
Figure 1.

Some 2010 – 2026 model year Lexus vehicles may exhibit paint stains after the removal of Rapgard™. The paint stains may appear to be under the clear coat but are usually under wrinkles in the Rapgard™. The wrinkles may trap water and cause the paint to stain from the trapped moisture, especially on horizontal surfaces such as the hood, roof, and trunk. Follow the Repair Procedure in this bulletin to address this condition.

1. Confirm the condition exists.
AFTER Rappard™ removal, does the vehicle exhibit paint stains as shown?
 - **YES** — Continue to step 2.
 - **NO** — This bulletin does NOT apply. Continue diagnosis using the applicable Repair Manual.

2. Using aluminum foil or a damp cloth, cover ANY plastic and/or rubber parts located near the stain.
3. With an infrared lamp or heat gun, apply heat to the stain for 5 – 10 minutes at 158°F – 176°F (70°C – 80°C).

Do NOT allow the surface temperature to become higher than 176°F (80°C). Measure the temperature with a thermometer.

4. Wait AT LEAST 5 minutes AFTER heat application, then examine the area and determine if the stain has been removed.
