Service Bulletin

Bulletin No.: 19-NA-255

Subject: Wax Coating on Frame Peeling, Metal Shows Corrosion/Rusting

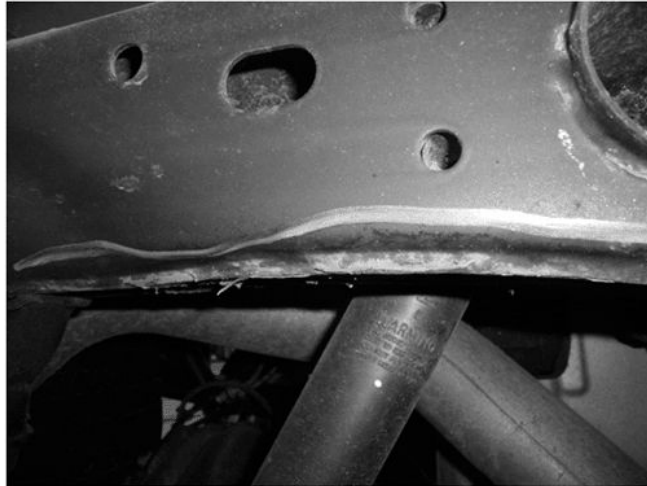
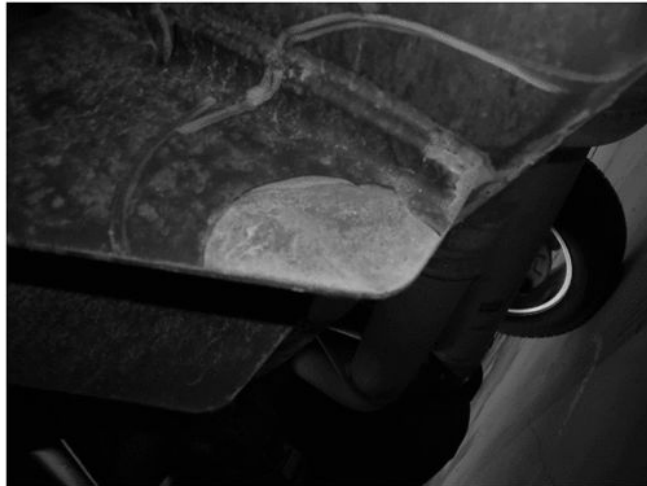
2708906

<p>Involved Region or Country</p>	<p>North America, Europe, Middle East, Israel, Palestine, Chile, Columbia, Ecuador, Paraguay, Peru, Uruguay, Japan, S Korea, China, Taiwan, Thailand, Africa and Egypt, Russia, Uzbekistan, S. Africa</p>
<p>Condition</p>	<p>Some customers may comment that areas of the frame wax coating are peeling off and rust/corrosion is visible on the metal in these areas. Several examples of this condition are shown in each group of graphics below.</p> <p>Truck Example Photos</p>

<p>Cause</p>	<p>The cause of this condition may be that the frame supplier may not have properly prepped the metal before the wax coating was applied.</p>
<p>Correction</p>	<p>Note: A combination of specialized metal coating products manufactured by Lloyds and Daubert have been found to be the most suitable products to provide corrosion control and protection to address this type of repair. Our recommendation is to prep the metal surface using *Lloyd's Pure Prep™ Metal Surface Preparation P/N 25418, then topcoat with both *Lloyds Kryptonite™ Metal Treatment* - P/N 36500 High Temp Satin Black 455 ml (16 oz), and *Daubert Non-Rust® P/N X-121B One Coat Rust Preventative Coating. It is strongly recommended they be applied according to the manufacturer's procedures.</p> <p>*We believe this source and their products to be reliable. There may be additional manufacturers of such products/materials. General Motors does not endorse, indicate any preference for, or assume any responsibility for the products or material from this firm or for any such items that may be available from other sources.</p> <p>Prep the frame and apply the Lloyds and Daubert coatings following the steps in the Service Procedure below:</p>

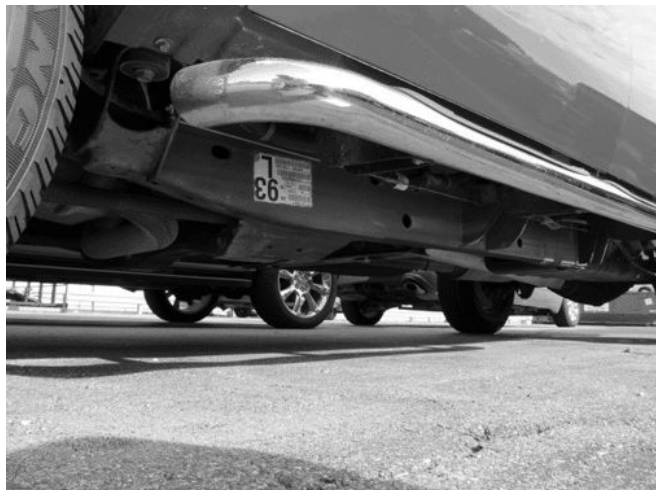
2708909

Note: The graphics below show the bed and/or cab removed from the vehicle. These pictures are provided for reference only. Bed and/or Cab removal are not necessary. Dealers should only repair the locations that show the condition. The following procedure should be utilized to return the truck to a factory look.

1. Raise and suitably support the vehicle. Refer to *Lifting and Jacking the Vehicle*.

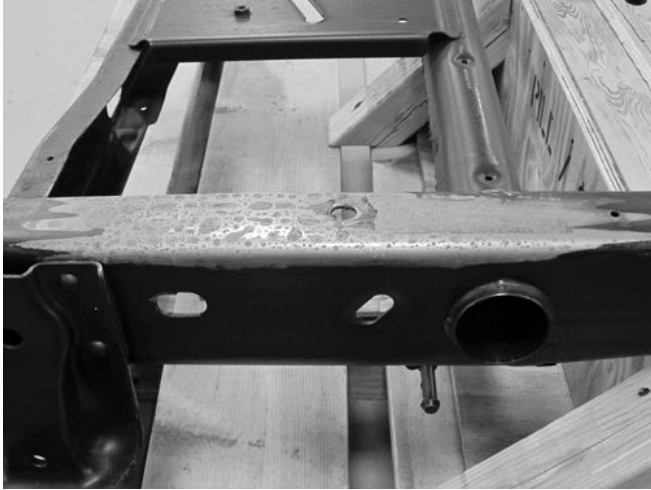
3611133

5. Using a rag and wax/grease removing solvent, remove the wax coating and any grease, oil, or undercoating from the truck frame in the affected repair area. The graphic above shows an example of a small portion of the wax coating removed.

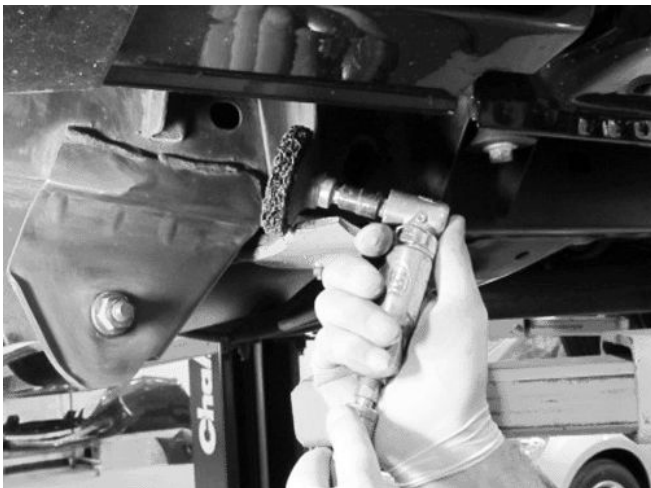
2708911

Important: Lloyds Kryptonite is designed to apply directly onto brown rust or clean surfaces; however any loose flakes/scale of rust need to be removed prior to application.

6. Any loose rust or loose flakes should be scraped, wire brushed or ground off.
7. Remove any residual wax, oil or rust by wiping the frame down with a towel or Scotch-Brite™ (3M) pad soaked with wax/grease remover.

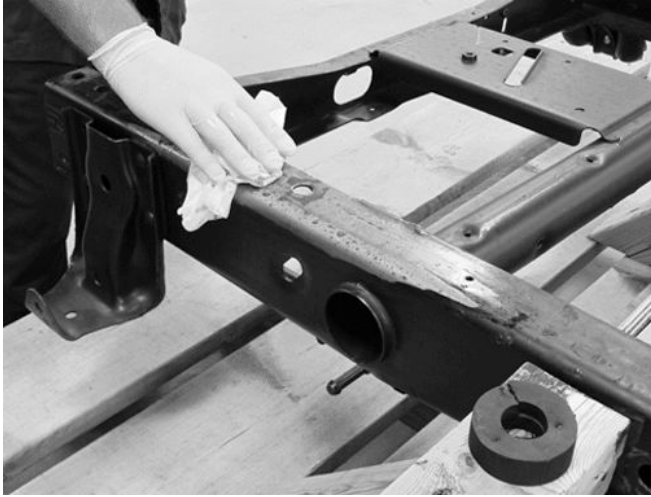
3611135

8. Using Lloyd's Pure Prep™ Metal Surface Preparation P/N 25418 (10 fluid ounce bottle), or equivalent, saturate a towel or Scotch-Brite™ (3M) pad with the pre-diluted solution and scrub the area well, rendering a foaming of the Pure Prep.™ This will greatly improve adhesion and corrosion resistance in the repair areas.

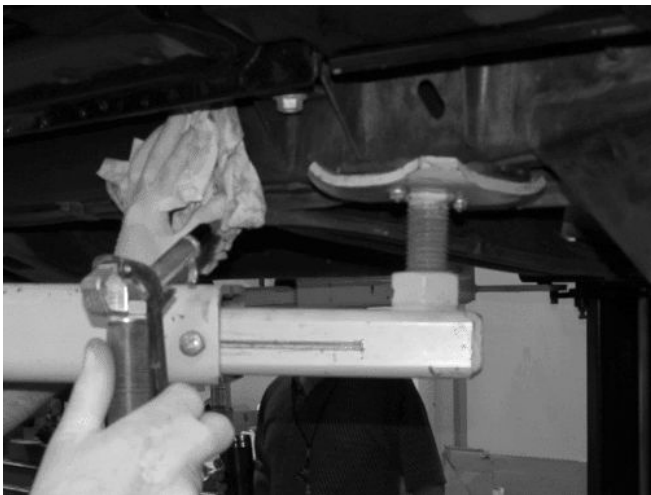
2708913

Important: The frame must be dry and free of wax/oily substances prior to application of the new coating.

9. Using a water dampened clean towel, remove any residue and dry the affected area. Dry the repair area completely using an air hose to blow dry the frame.
10. Check the repair area for phosphate treatment by wiping it to see if any corrosion residue can be picked up. Correctly treated areas will not have any residue on the surface.

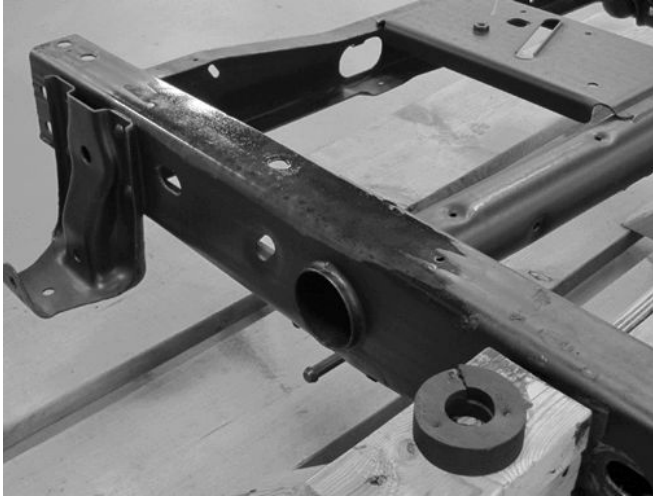
3611138

Note: For application of the Lloyds Kryptonite P/N 36500, it can be sprayed, rolled, dipped or painted.

11. To retain corrosion protection, apply a light coat of Lloyds Kryptonite™ Metal Treatment* - P/N 36500 High Temp Satin Black 455 ml (16 oz), or equivalent, to all rusted and bare areas of the frame where the wax coating was removed. This first coat should flash in approximately 3-5 minutes.
12. Apply a second coat of Lloyds Kryptonite. This can be a heavy coat; double and triple passes with this product, over a light first coat, are not a problem.

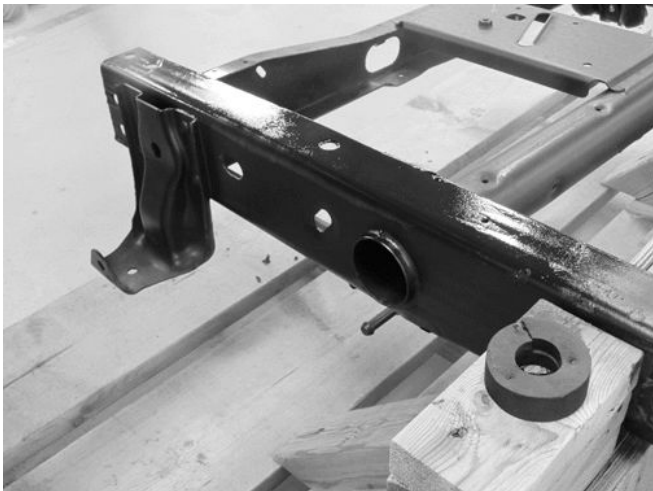
3611142

13. We suggest top coating the Lloyds Kryptonite with Daubert Nox-Rust® P/N X-121B “One Coat Rust Preventative Coating” (aerosol), or equivalent.

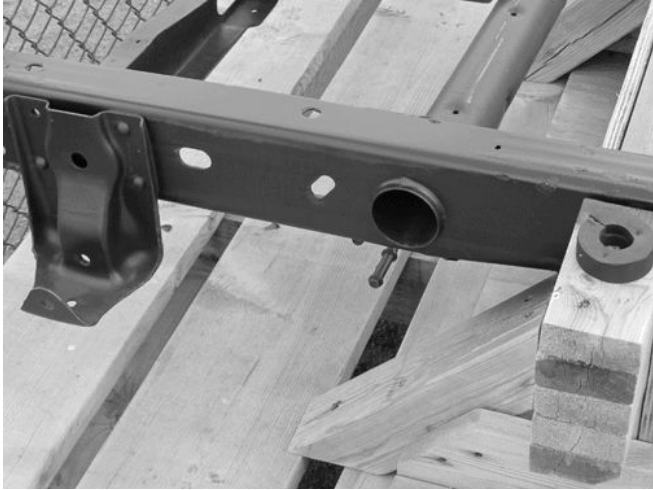
3611143

Note: As shown in the graphic below, besides adding a corrosion resistant layer, it dries to firm, wax-like film which will more closely resemble the appearance of the unrepaired areas of the frame.
