# HYUNDAI

GROUP <b>BODY ELECTRICAL</b>	NUMBER <b>25-BE-006H</b>
DATE <b>MARCH 2025</b>	MODEL(S) <b>PALISADE (LX2)</b>

**SUBJECT:** TWISTED SEAT BELT REPLACEMENT  
(WARRANTY EXTENSION TXX1)

**Description:** Certain 2020 - 2024MY vehicles may experience seat belts that are twisted due to excessive space in the D-ring.

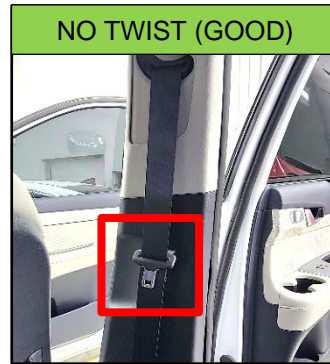
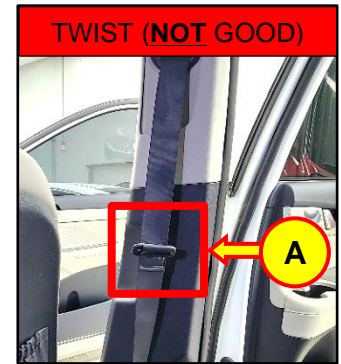
First-row Seat Belt

1. Inspect the seat belts for rows 1 – 3 for twists (A):
  - If a twist is **NOT** present any of the rows, this TSB does **NOT** apply.
  - If a twist is present, then proceed to the respective section to replace the seat belt(s).

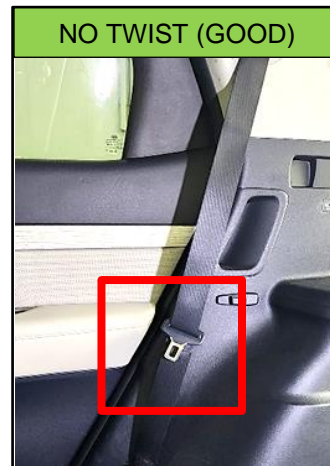
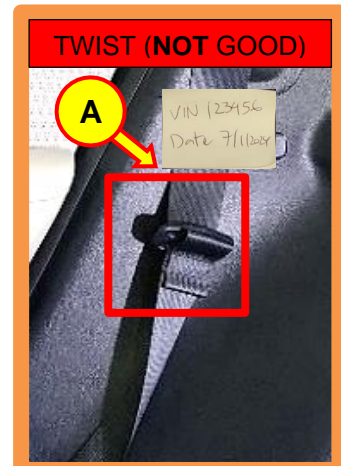
Second-row Seat Belt

Using STUI, take a photo of the twisted seat belt with the last 6 digits of the VIN and the date of repair on a piece of paper.

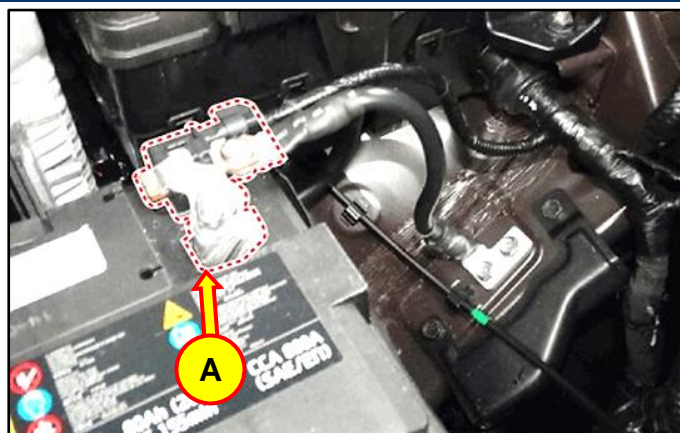
1. Disconnect the negative (–) battery terminal (A).

lb-ft	6.5
lb-in	78
N.m	8.8

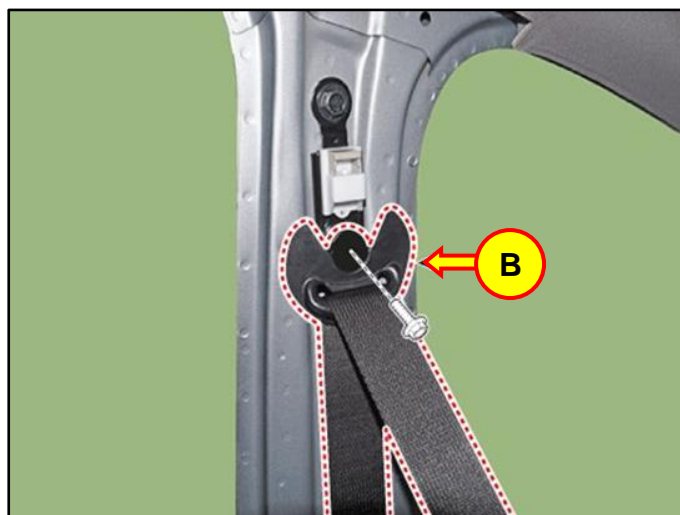
Remove the mounting bolt then remove the front seat belt upper anchor (B).

lb-ft	35
N.m	47

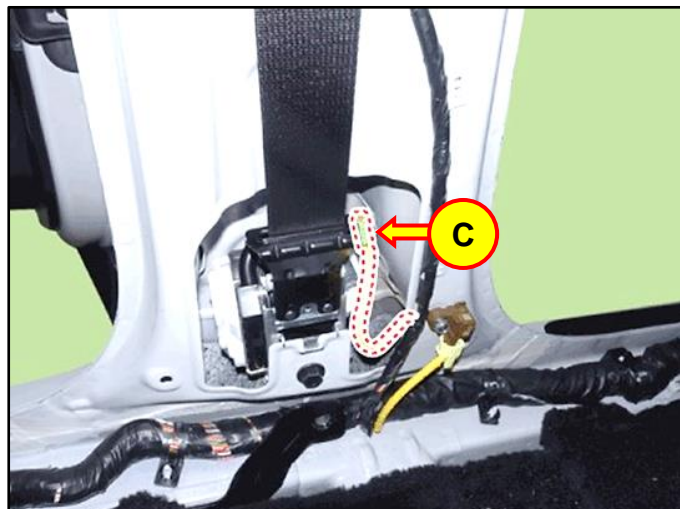
3. Press the lock pin then separate the front seat belt pretensioner connector (C).

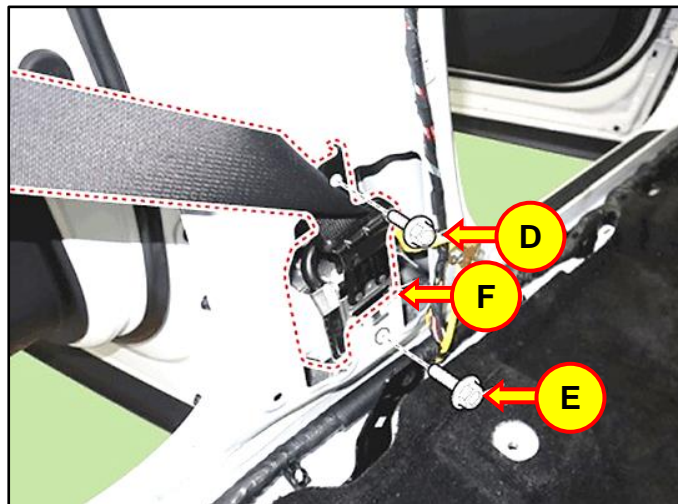
4. Remove the mounting bolts (D & E).

lb-ft	7.3
lb-in	87
N.m	9.8

lb-ft	35
N.m	47

Remove and replace the first-row seat belt (F) with the supplied first-row seat belt.

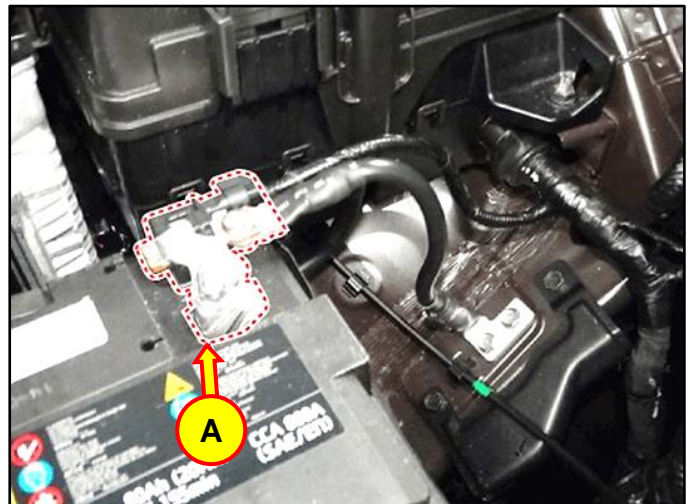
Disconnect the negative (–) battery terminal (A).

lb-ft	6.5
lb-in	78
N.m	8.8

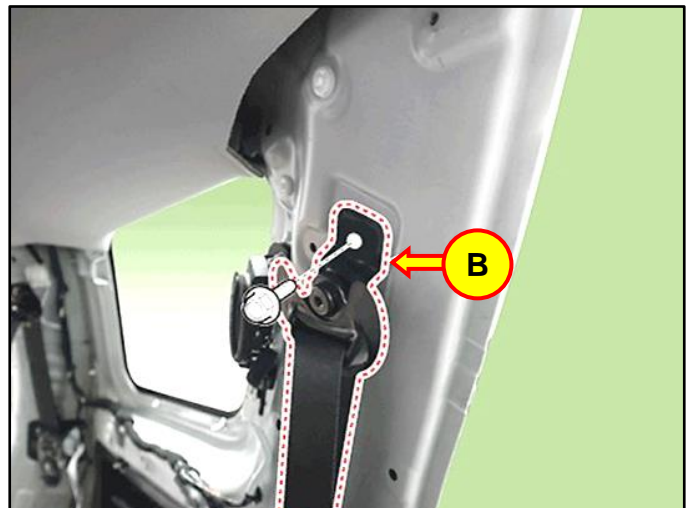
2. Refer to the shop manual to remove the luggage side trim (B).

Separate the second-row seat belt upper anchor.

lb-ft	35
N.m	47

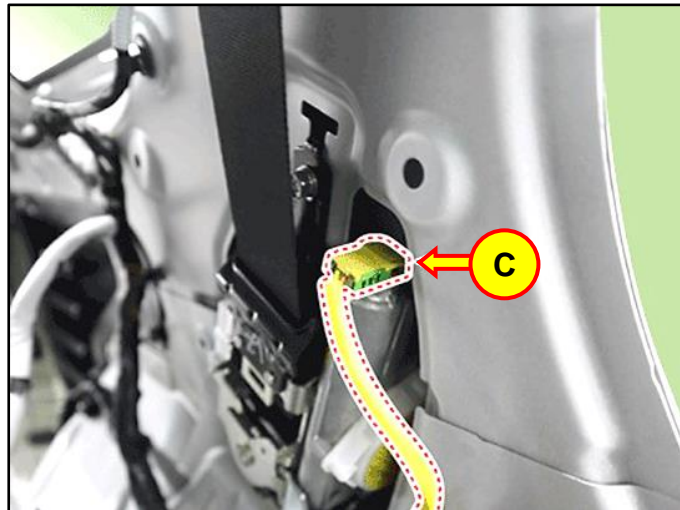
3. Press the lock pin then separate the second-row seat belt connector (C).

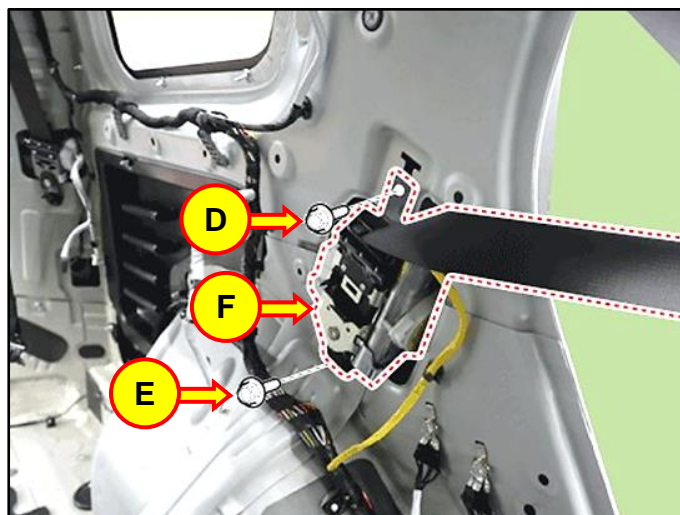
4. Remove the mounting bolts (D & E).

lb-ft	7.3
lb-in	87
N.m	9.8

lb-ft	35
N.m	47

Remove and replace the second-row seat belt (F) with the supplied second-row seat belt.

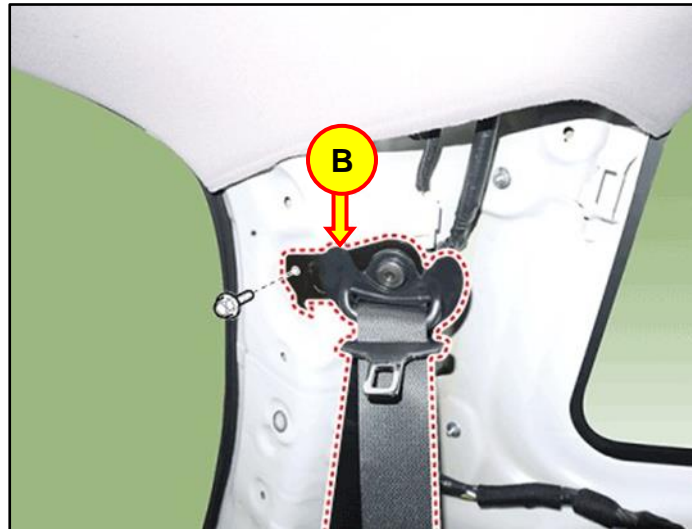
Separate the third-row seat belt upper anchor (B).

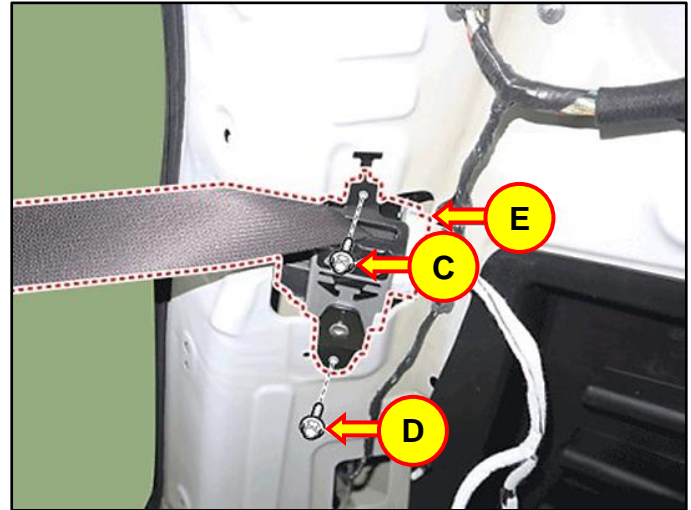
3. Remove the mounting bolts (C & D).

lb-ft	7.3
lb-in	87
N.m	9.8

lb-ft	35
N.m	47

Remove and replace the third-row seat belt (E) with the supplied third-row seat belt.
