Vehicle with atypical reduced heat output

| Topic number | LI83.20-P-051802 |
| Function group | 83.20 - Heating |

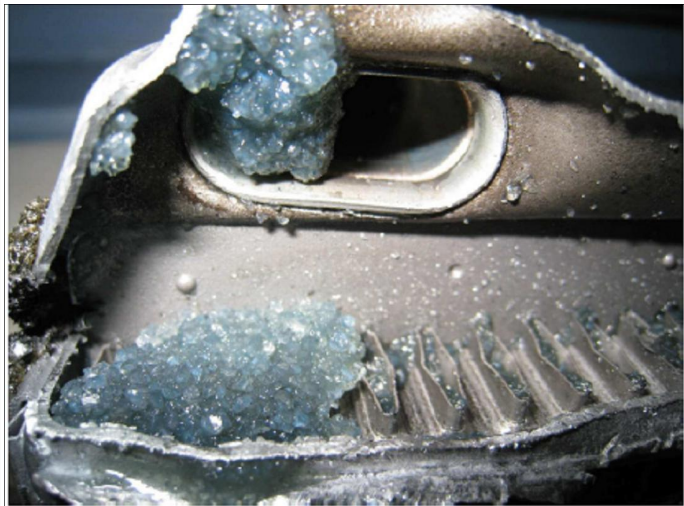
Silicate granulate may have escaped from a damaged bag in the expansion reservoir (not visible), reducing the coolant flow in the heater heat exchanger (see picture).

| Attachments | |
|---|---|
| <a href="#">Silikagel im Heizungswaermetauscher.jpg</a> | Silica gel in heater heat exchanger |

With the aforementioned complaint, make sure that the cooling circuit is inspected for silicate residues after all standard tests are completed.

The silicate residues tend to accumulate upstream of the shutoff valve for the heater hot water pulsed valve.

If there are silicate residues in the coolant, the engine must be flushed thoroughly.

To make sure that all silicate residues are removed from the cooling circuit, the following parts must also be replaced (cleaning of these components is not sufficient):

Coolant expansion reservoir, radiator, oil/water heat exchanger (oil cooler), heater valve, heat exchanger of heater, coolant and, if installed, the electric water pump for the residual heat utilization system.
