SIB 64 05 25  
HVAC FLAP LINKAGE NOT FULLY CONNECTED

2025-04-09

E-Series	Model Description	Production Date
G45	X3 Sports Activity Vehicle	Vehicles produced up to January 2025

# G45 HVAC: Air Vent Flaps/Kinematic & Stepper Motor Master Info.

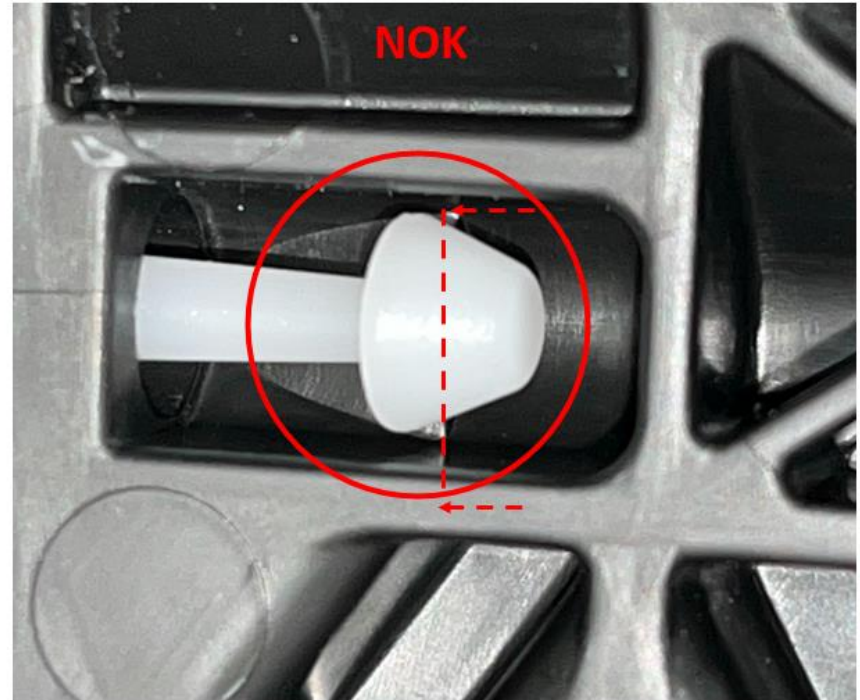
**NOK part – Push pin mushroom head NOT over the flap ramp (not snapped)**
