Technical Service Bulletin (TSB)
Engine Coolant Leak From Thermostatic Valve Gasket

| REFERENCE: | TSB: 07-002-25 GROUP: 07 - Cooling | Date: | April 15, 2025 | REVISION: | — |
| CAUSE: | Leaking thermostatic valve gasket | | | | |

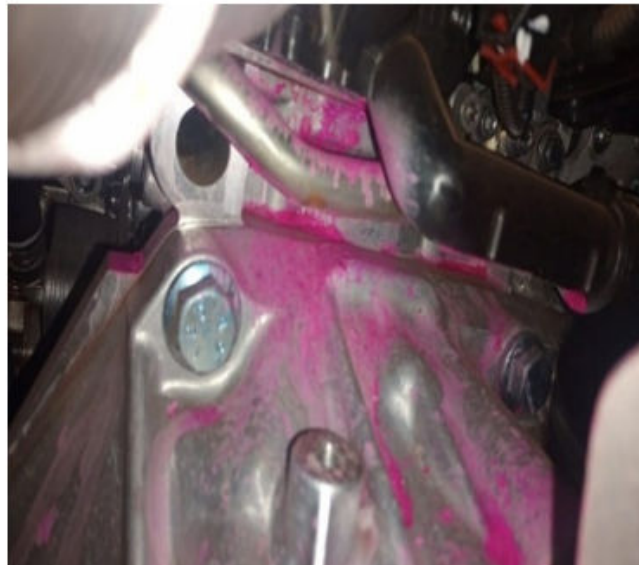
Fig. 2
Coolant Leak

4. Was there a coolant leak found [Fig. 2](#)?

- YES>>> Proceed to [Step 1](#) of the Repair Procedure.
 - NO>>> Use Inspection LOP (07-40-10-91) to close the active RSU and proceed to [Step 5](#).
5. If equipped, install the under engine protection cover. Refer to the detailed service procedures available in DealerCONNECT/Service Library under: Service Info> 7055B54 - Under Engine Protection - Removal/Installation.
