Technical Service Bulletin (TSB)
Rear Door Belt Molding Loose

REFERENCE:	TSB: 23-017-25 GROUP: 23 - Body	Date:	April 17, 2025	REVISION:	—
VEHICLES AFFECTED:	2022 - 2024 (B1) Jeep Renegade This bulletin applies to vehicles built on or before May 30, 2024 (MDH 0530XX).	MARKET APPLICABILITY:			
		<input type="checkbox"/> NA <input type="checkbox"/> MEA <input type="checkbox"/> EE <input type="checkbox"/> IAP <input checked="" type="checkbox"/> SA <input type="checkbox"/> CH			
CUSTOMER SYMPTOM:	Customers may experience the following: <ul style="list-style-type: none"> The weather stripping (belt molding) on the rear doors is loose or detaching. 				
CAUSE:	Manufacturing issue

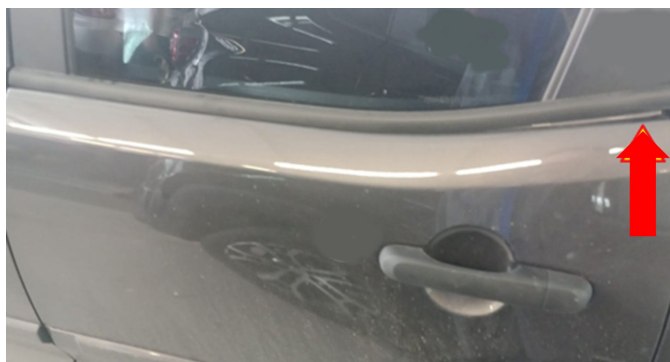
1. Verify the door sill molding (weatherstrip, door window belt molding) on the rear doors (right/left) is loose or detaching [Fig. 1](#).

Fig. 1
Loose Or Detaching Molding

2. Was the door sill molding (weatherstrip, door window belt molding) on the rear doors (right/left) loose or detaching [Fig. 1](#)?
 - YES >>> Proceed to [Step 1](#) of the Repair Procedure.
 - NO >>> This bulletin does not apply.

This bulletin involves possibly replacing one or both of the rear door sill moldings (belt moldings).

1. Replace one or both rear door sill moldings as required. Refer to the detailed service procedures available in DealerCONNECT/Service Library under: Service Info> 7010D26 - Pestana (externa) do vidro da porta lateral (uma) - remocao/recolocacao.
