Maserati

Grecale: Air Suspension System Diagnosis

DATE: April 4, 2025

This Technical bulletin serves as a guide and provides additional diagnostic info for possible Air suspension issues on Grecale equipped with Air Suspension System.

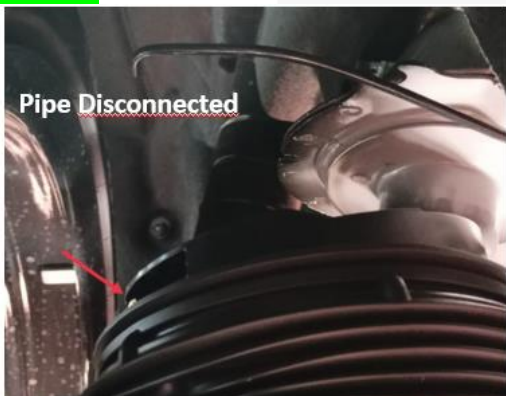
Area 2 - Rear axle

Example of incorrect installation of air suspension system lines on rear axle

The insertion of the pipes into the fittings is correct if only the outermost reference marking (in relation to the pipe) is visible.

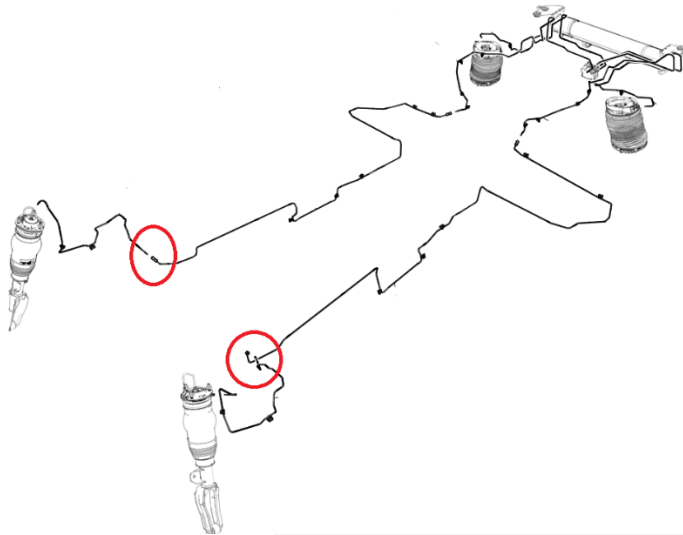
Grecale BEV pipe junction area (checks to be carried out without removing the HV battery)

The insertion of the pipes into the fittings is correct if only the outermost reference marking (in relation to the pipe) is visible.

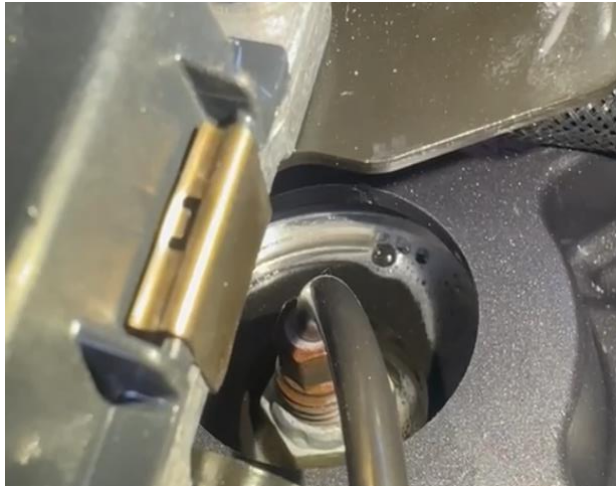
Area 5 - Shock absorber top mount upper part check

It is normal for bubbles to form in the zone shown in the picture above because the liquid slowly replaces the air in the top mount seat (releasing bubbles at a low frequency compatible with the progressive filling of the seat).

Refer to the image above and the videos attached to this bulletin for cases of "Confirmed leaks" and "Normal operation" (in which case bubbles can still be observed but do not indicate an objective problem).

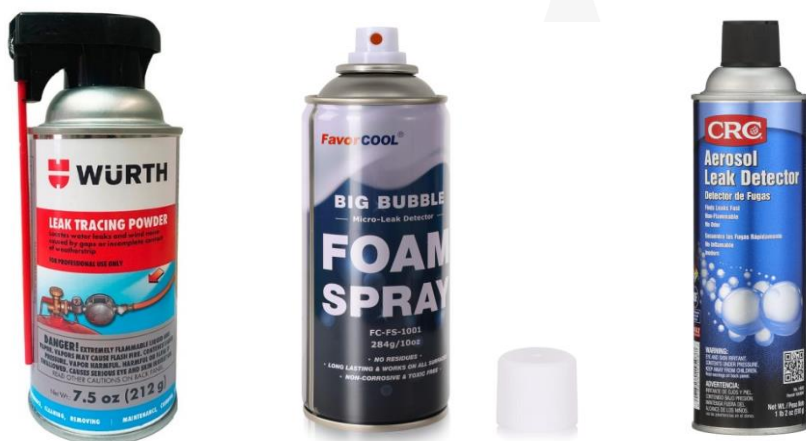
EXAMPLES:

Products to be used when inspecting for any leakage in the air suspension system.

- LEAK TRACING POWDER OR EQUIVALENT
