Summary of communications for **CSC-2501: Model I Battery Ground**

## **Customer Satisfaction Campaign CSC-2501**

# CUSTOMER SATISFACTION CAMPAIGN

### 12 VDC GROUND INSTALLATION

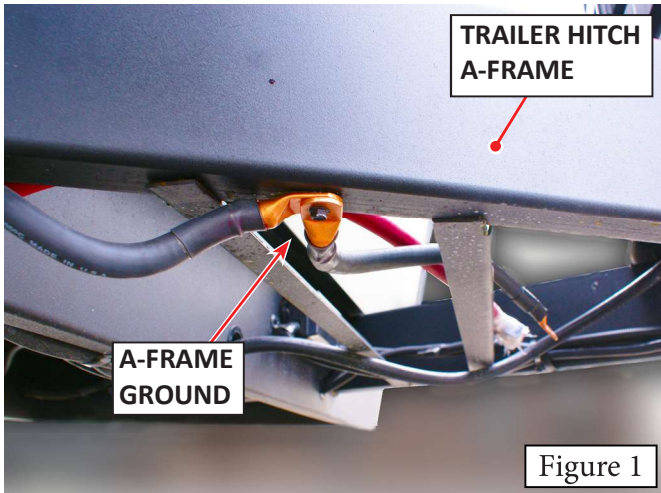
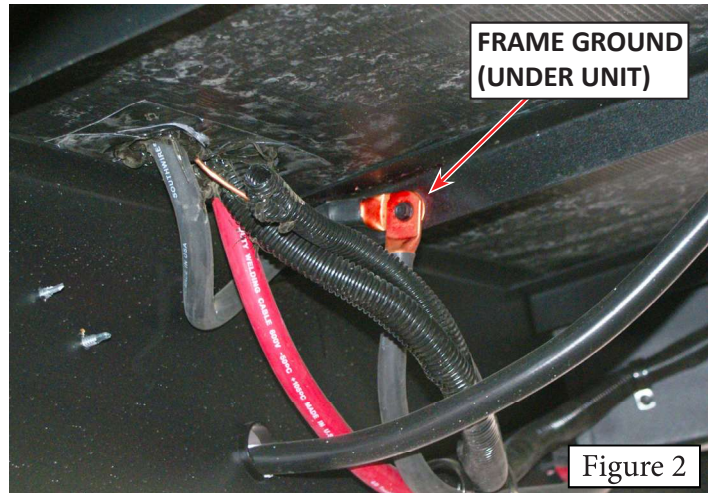
1. **READ AND UNDERSTAND ALL INSTRUCTIONS PRIOR TO BEGINNING WORK.**
2. **Determine the location you want to install the chassis ground; either at the front A-frame (Figure 1) or under the unit on the frame rail (Figure 2). NOTE: These pics show the installed ground for clarity and to help you determine which location is best for you. Either location provides the same chassis ground.**

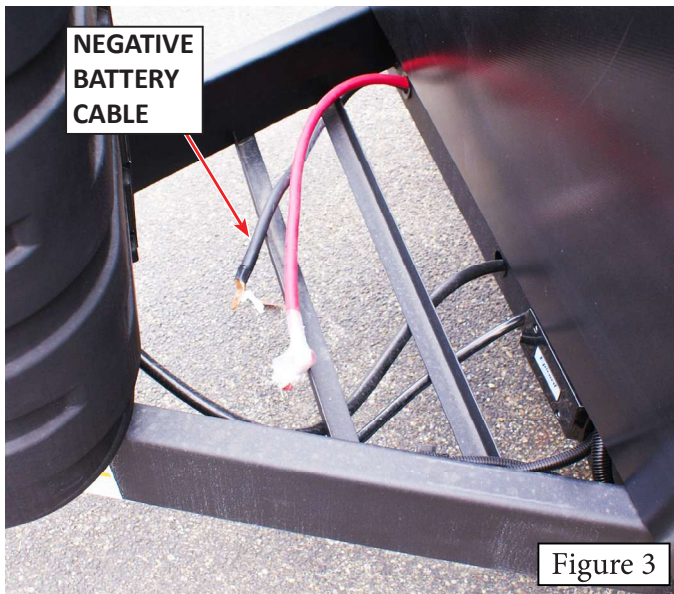
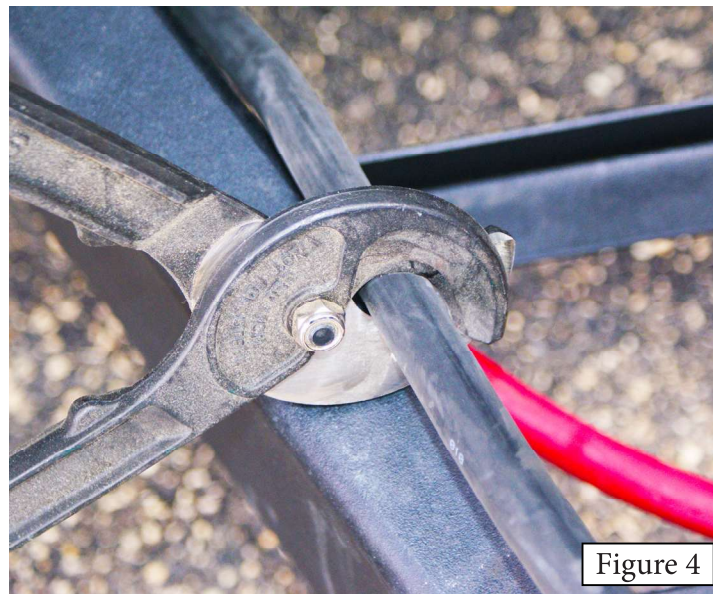
3. **Locate the 4/0 guage black NEGATIVE (-) battery cable at the battery connection location (Figure 3).**
4. **Use the large cable cutters to cut the 4/0 black NEGATIVE (-) cable at the location where you want to ground to the chassis (Figure 4).**

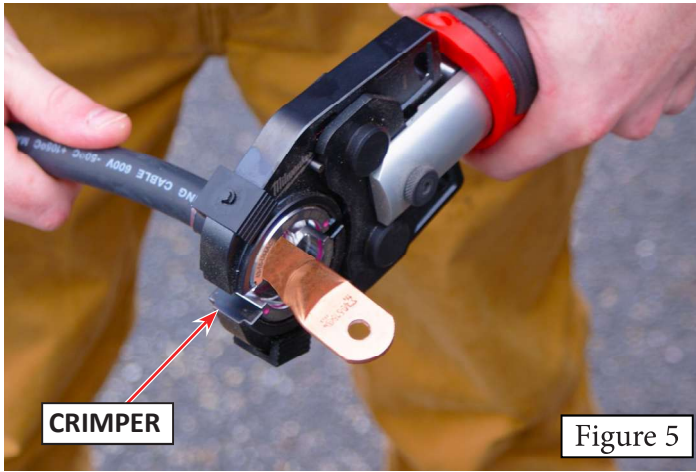
Figure 5

- Strip approximately 1" of insulation from the two ends of the ground cable and install 4/0 terminal ends on each. Crimp them securely using a power crimper or equivalent (Figure 5). Wrap electrical tape around the terminals to insulate.
- Use a power grinder with a T-29 aluminum grinding disc to remove the paint from the area where you are going to install the ground on the frame (Figure 6).

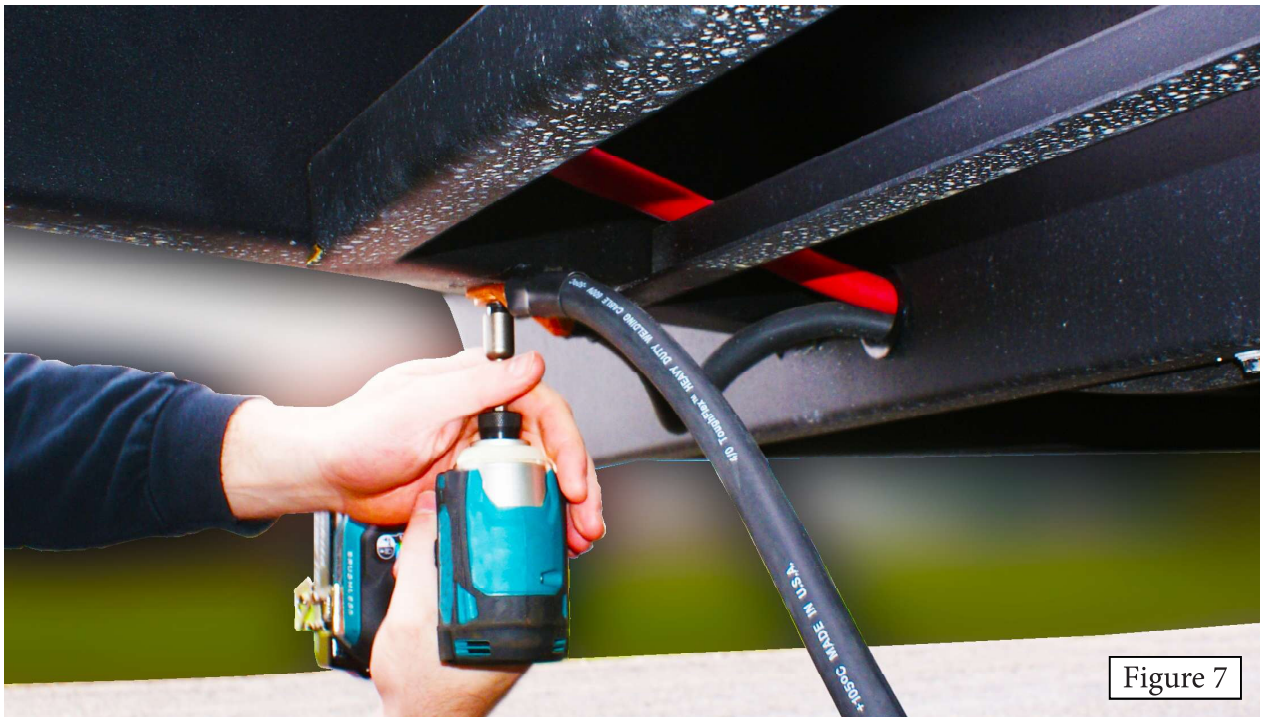
Figure 7

- Use a drill and a 3/8" socket driver to install the ground cables on the frame with a 3/8" X 1" self drilling screw (Figure 7).

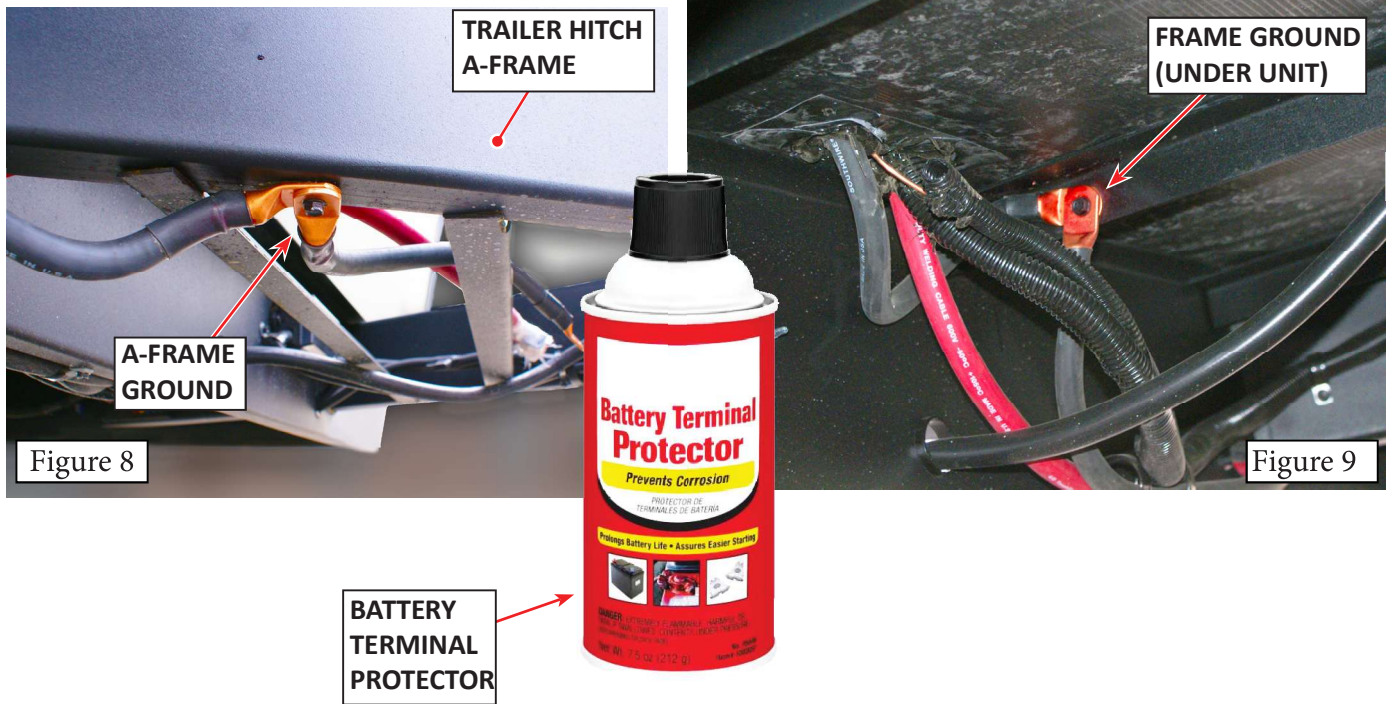
8. Once the ground connection cables are installed, coat the connection and the frame area around the new ground connection with a battery terminal protector spray (NOTE the red coating on the grounded terminal connections - Figure 8 or Figure 9).
9. Installation complete. Figure 8 shows ground on front hitch A-frame; Figure 9 shows ground to frame rail under unit.

1. The full 17 digit VIN;
2. The Retail Name if retail sold;
3. Dealer Name;
4. Dealer Address;
5. Dealer Phone Number;
6. Dealer Hourly Labor Rate;
7. Work Order detailing the work performed and labor time, and
8. A photograph of the completed repair similar to Figure 8 or Figure 9 on page 6.
