SIB 64 05 25

HVAC FLAP LINKAGE NOT FULLY CONNECTED

MODEL

| E-Series | Model Description | Production Date |
|---|---|---|
| G45 | X3 Sports Activity Vehicle | Vehicles produced up to January 2025 |

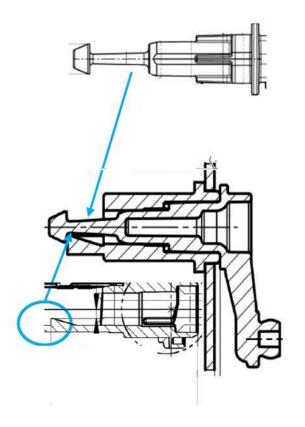
BV64 02 25 G45 Flap Linkage

There is a push-in end on the linkage that can be reinserted into the flap and fully seated.

Check that the linkage has not come loose from the HVAC flap for the zone that is malfunctioning.

There is a white plastic mechanism that connects the black linkage arm and the HVAC flap assembly.

To test if the mechanism is fully seated into the HVAC flap assembly, perform a wiggle test of the white plastic (in/out). Here you can see the white plastic mechanism has backed out of the HVAC case and is not locked into the flap.

Check that the linkage has not come loose from the flap in the heating, ventilation, and air conditioning (HVAC) system.

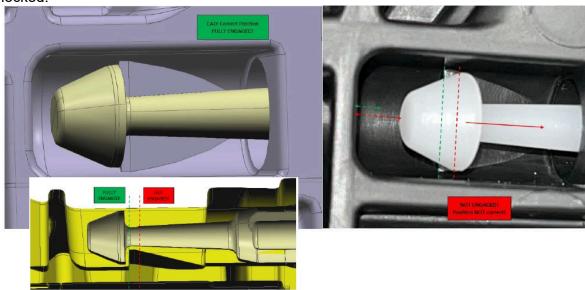
If using a borescope to inspect if the flap is fully locked into the linkage, you can see the White plastic mechanism push pin mushroom shaped end must engage into the flap by being pushed in until it fully goes past the plastic flap ramp. The pictures below show fully locked in vs not fully locked.

There is a push in end on the linkage that can be reinserted into the HVAC flap and fully seated. The white plastic mechanism push pin can be reinserted into the HVAC flap and fully seated.

Make sure to push in until you can feel the white plastic mechanism push pin mushroom shaped end engage into the flap ramp.

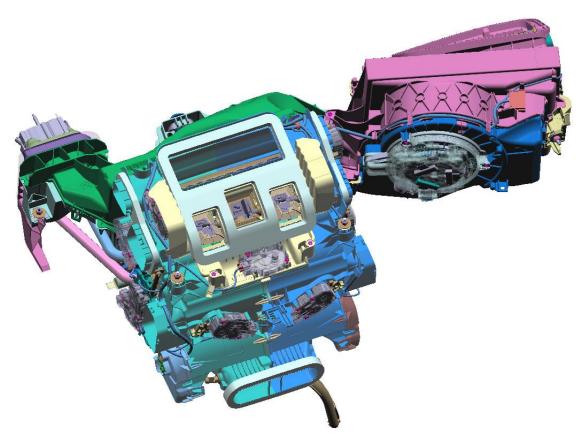
G45 HVAC: Complete Assembly Overview

- OVERVIEW CHART
- Air Vent Flaps/Kinematic (+ push pin) Detailed Information
- Stepper Motor Control Detailed Information

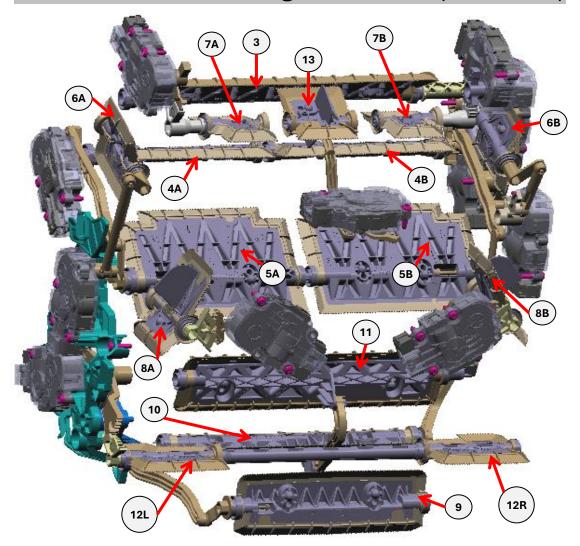
FLAPS / Kinematic Diagram Details (Overview)

Please reference the FLAP diagram & STEPPER MOTOR control locations diagrams on the following pages.

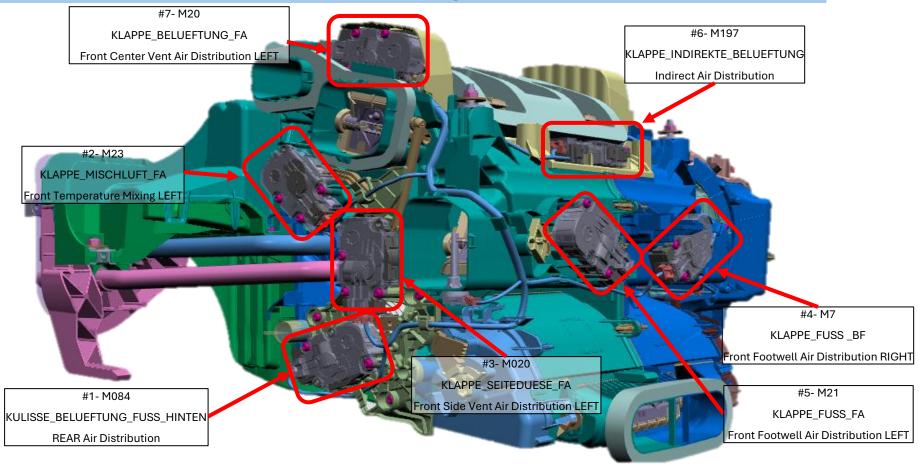
Stepper Motor Control Locations Diagram (OVERVIEW)

(LHD: Left Side VIEW)

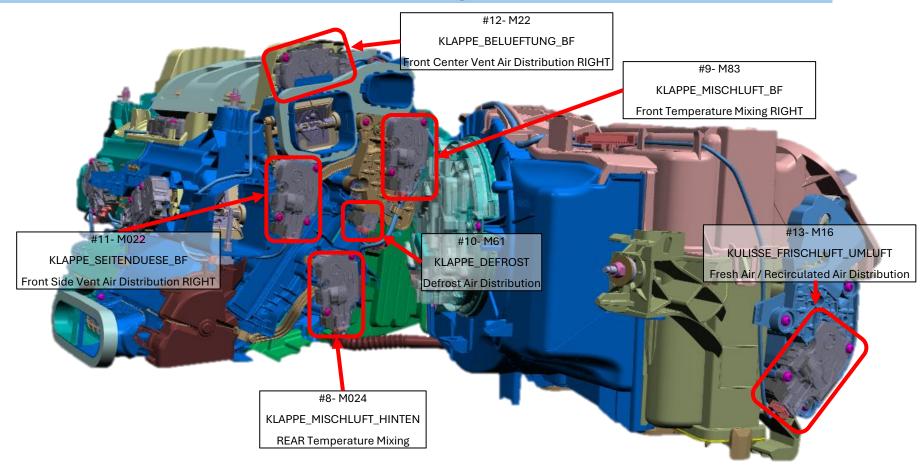
Stepper Motor Control Locations Diagram (OVERVIEW)

(LHD: Right Side VIEW)

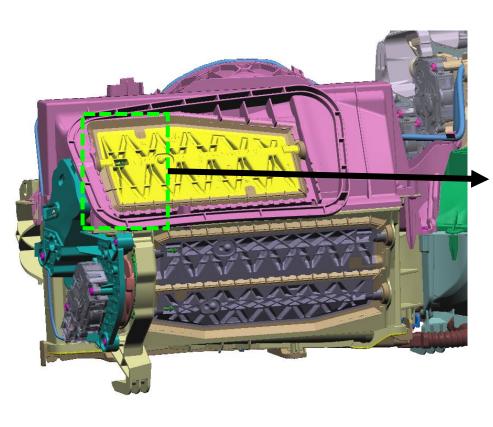
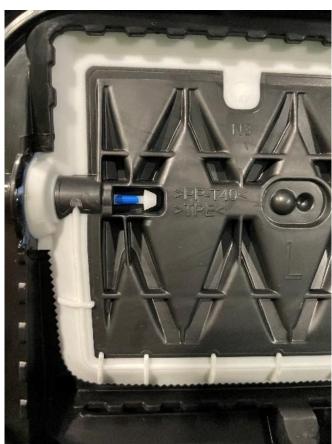
FLAP #1: Fresh Air Flap

| AIR VENT <u>FLAPS</u> | | | STEPPER MOTOR CONTROL INFORMATION | | |
|---|--|--|---|---|---|
| 1 | Fresh Air Flap | Easily Visible: Just inside of HVAC | 13 | M 16 (Shared) ◀··· | Fresh Air / Recirculated Air Distribution |

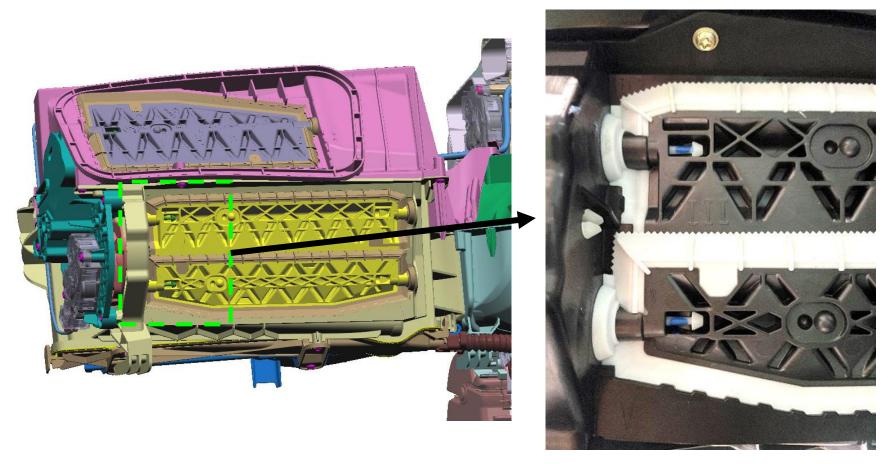
FLAP #2: Recirculated Air Flaps x2 (connected)

| AIR VENT <u>FLAPS</u> | | | STEPPER MOTOR CONTROL INFORMATION | | |
|---|--|--|---|---|---|
| 2 | Recirculated Air Flaps x2 (connected) | Easily Visible: Just inside of HVAC | 13 | M 16 (Shared) ◀ | Fresh Air / Recirculated Air Distribution |

TWO Push Pins!

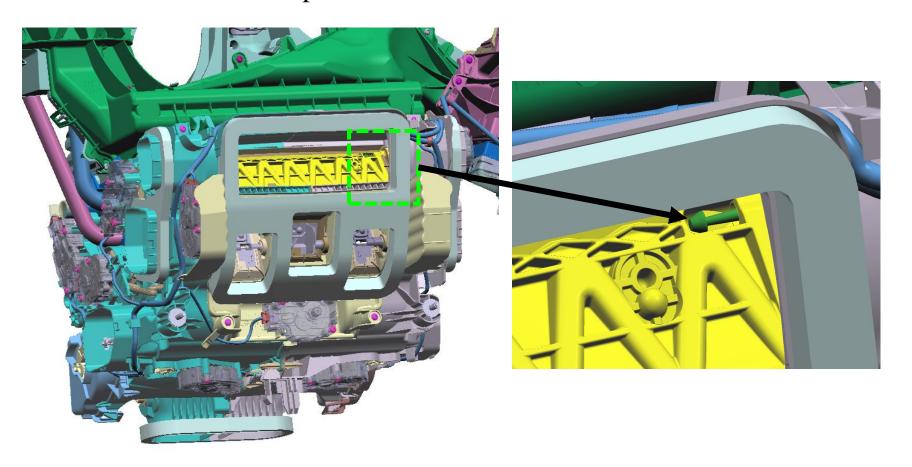
FLAP #3: Defrost Air Flap

| AIR VENT <u>FLAPS</u> | | | STEPPER MOTOR CONTROL INFORMATION | | |
|---|--|--|---|---|---|
| 3 | Defrost Air Flap | Easily Visible: Just inside of HVAC | 10 | M 61 | Defrost Air Distribution |

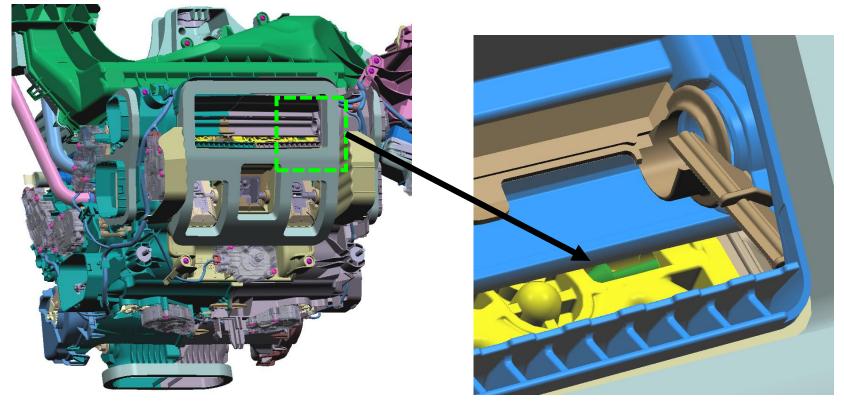
FLAP #4A/4B: Front Cold Temp. Mixing Flap Right (Mirrored Right to Left)

| AIR VENT <u>FLAPS</u> | | | STEPPER MOTOR CONTROL INFORMATION | | |
|---|--|--|---|---|---|
| 4 A | Front Cold Temp. Mixing Flap LEFT | Difficult: Bororscope through open Flap #3 | 2 | → M 23 (Shared) | Front Temperature Mixing LEFT |
| 4 B | Front Cold Temp. Mixing Flap RIGHT | Difficult: Bororscope through open Flap #3 | 9 | M 83 (Shared) ◆: | Front Temperature Mixing RIGHT |

4B shown. #3 Defrost Air Flap removed from CAD image for easier visibility

TWO Push Pins (one on LEFT side flap & one on RIGHT side flap)!

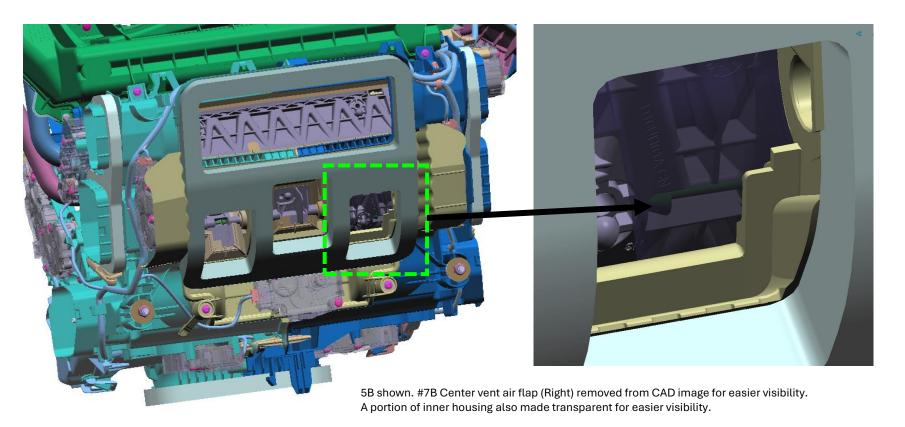
FLAP #5A/5B: Front Warm Temp. Mixing Flap Right (Mirrored Right to Left)

| AIR VENT <u>FLAPS</u> | | | STEPPER MOTOR CONTROL INFORMATION | | |
|---|--|--|---|---|---|
| 5 A | Front Warm Temp. Mixing Flap LEFT | Difficult: Bororscope through open Flaps #7 | 2 | → M 23 (Shared) | Front Temperature Mixing LEFT |
| 5 B | Front Warm Temp. Mixing Flap RIGHT | Difficult: Bororscope through open Flaps #7 | 9 | M 83 (Shared) | Front Temperature Mixing RIGHT |

TWO Push Pins (one on LEFT side flap & one on RIGHT side flap)!

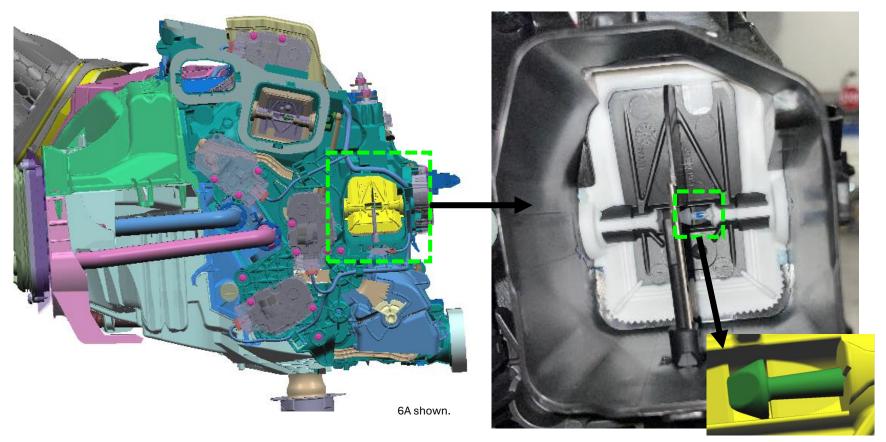
FLAP #6A/6B: Front Footwell Air Flap LEFT (Mirrored Left to Right)

TWO Push Pins (one on LEFT side flap & one on RIGHT side flap)!

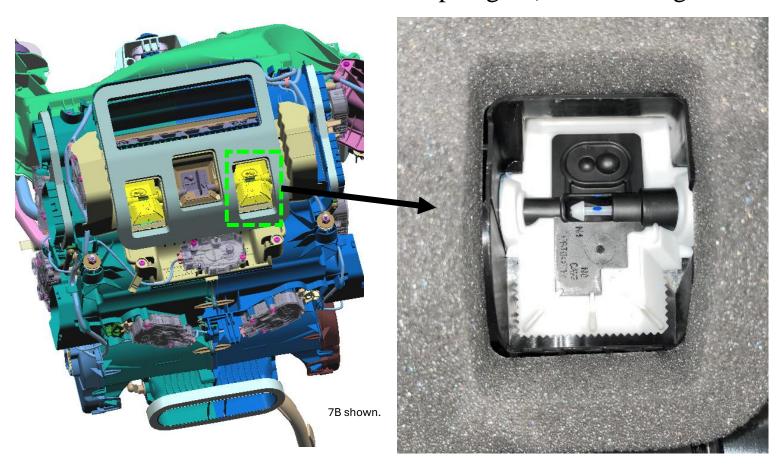
FLAP #7A/7B: Front Center Vent Air Flap Right (Mirrored Right to Left)

TWO Push Pins (one on LEFT side flap & one on RIGHT side flap)!

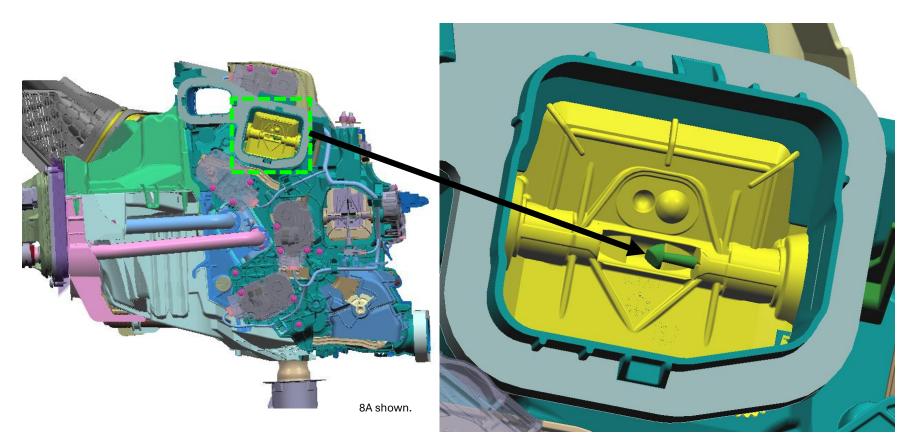
FLAP #8A/8B: Front Side Vent Air Flap LEFT (Mirrored Left to Right)

TWO Push Pins (one on LEFT side flap & one on RIGHT side flap)!

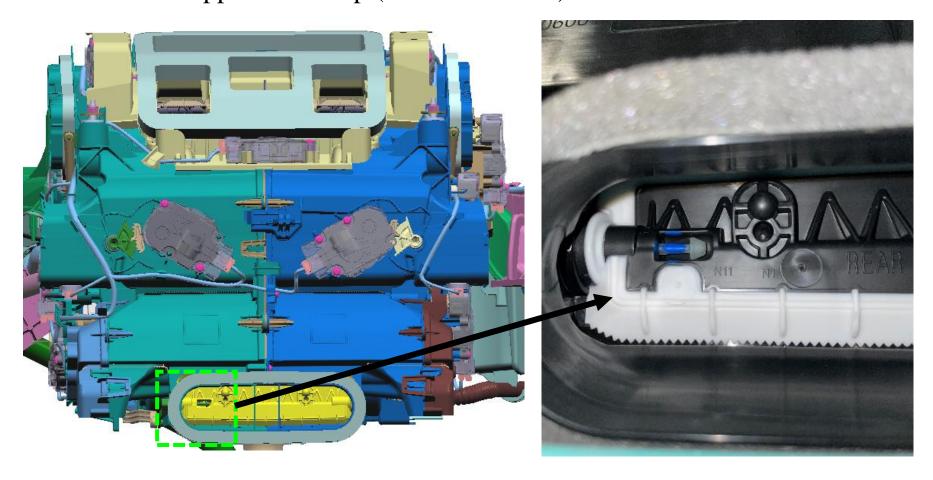
FLAP #9: Rear Upper Vent Flap (Center Console)

| AIR VENT <u>FLAPS</u> | | | STEPPER MOTOR CONTROL INFORMATION | | |
|---|--|--|---|---|---|
| 9 | Rear Upper Vent Flap (Center Console) | Easily Visible: Just inside of HVAC | 1 | M 084 (Shared) ◀·· | REAR Air Distribution |

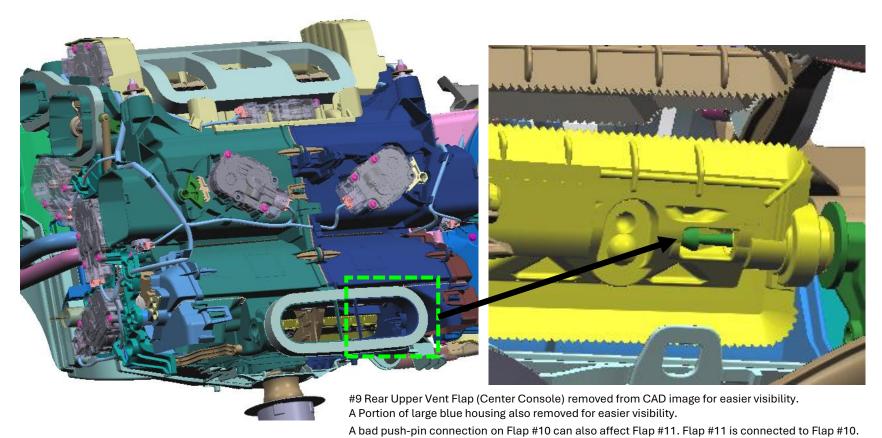
FLAP #10: Rear Cold Temp. Mixing Flap

| AIR VENT <u>FLAPS</u> | | | STEPPER MOTOR CONTROL INFORMATION | | |
|---|--|--|---|---|---|
| 10 | Rear Cold Temp. Mixing Flap | Difficult: Bororscope through open Flap #9 | 8 | : ► M 024 (Shared) | REAR Temperature Mixing |

ONE Push Pin (RIGHT side only)!

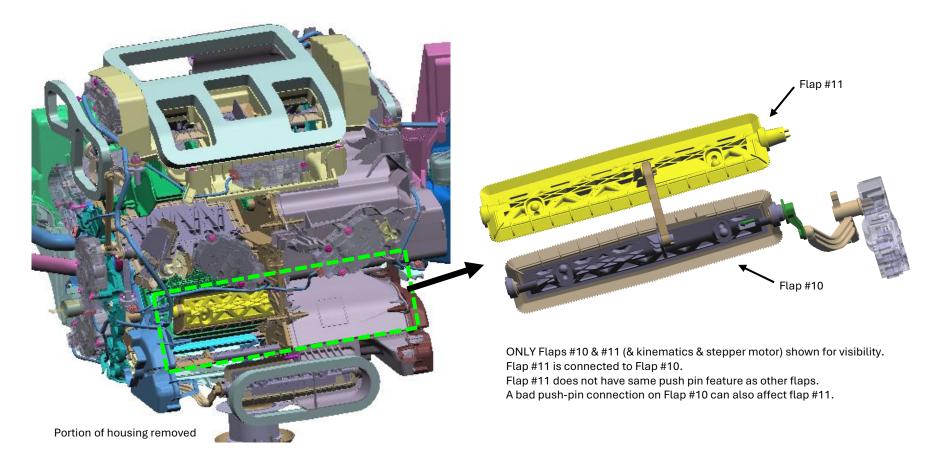
FLAP #11: Rear Warm Temp. Mixing Flap

NO Push Pin on Flap #11 (Please see Flap #10)!

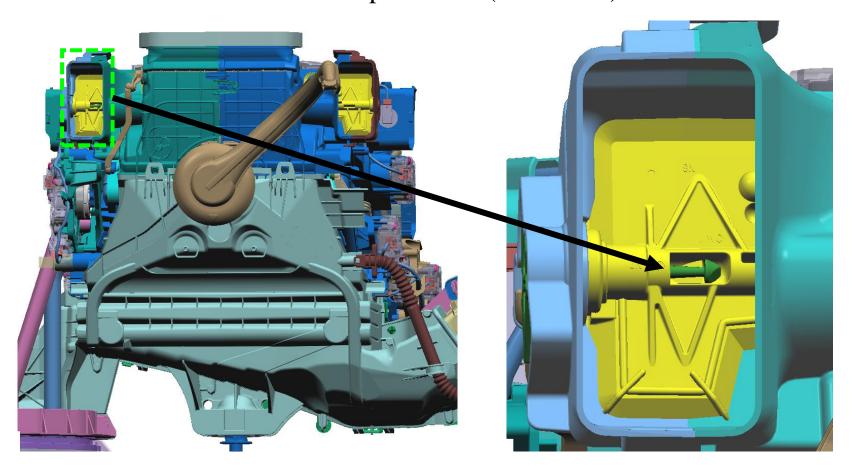
FLAP #12: Rear Footwell Air Flaps L/R x2 (connected)

ONE Push Pin (RIGHT side only)!

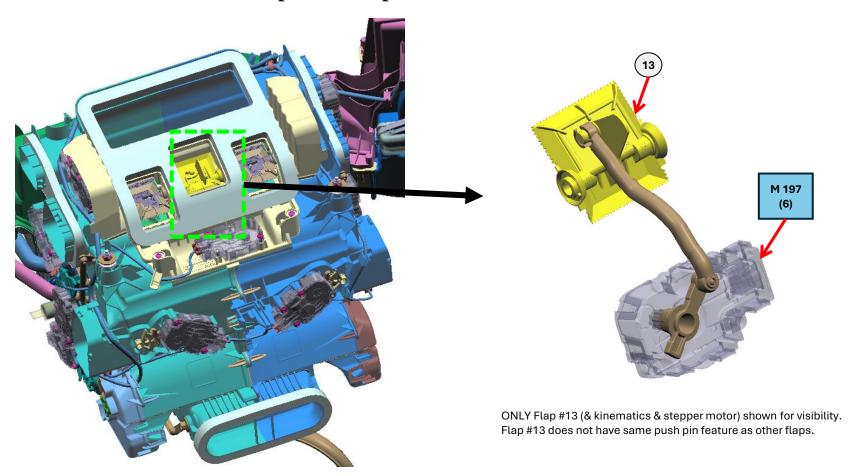
FLAP #13: Indirect Air Flap & Complete Kinematics Overview

| AIR VENT <u>FLAPS</u> | | | STEPPER MOTOR CONTROL INFORMATION | | |
|---|--|--|---|---|---|
| 13 | Indirect Air Flap | N/A: Different connection type (no push pin) | 6 | M 197 | Indirect Air Distribution |

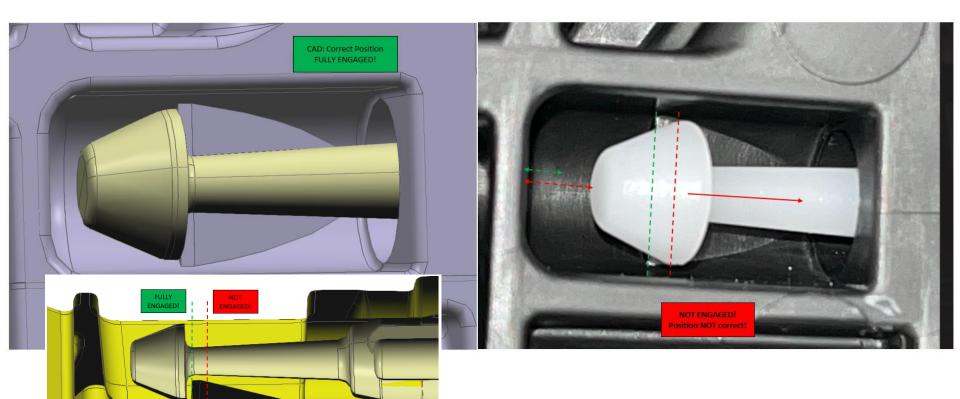
Push Pin Issue

The air flap linkage may not be fully locked into the air mixing flap.

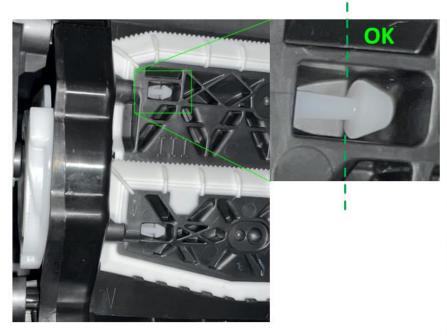
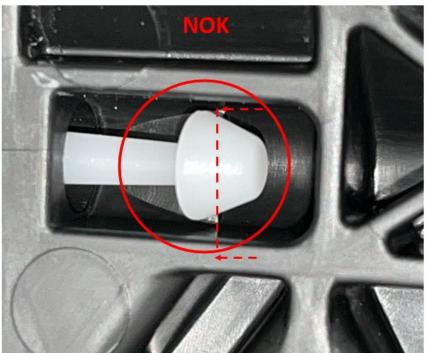
Push Pin Issue

OK part – Push pin mushroom head locked completely over the flap ramp

NOK part – Push pin mushroom head NOT over the flap ramp (not snapped)
