SIB 34 01 25

"SERVICE SOLUTION: Front Calipers Leaking" After sitting idle for long periods

2025-04-22

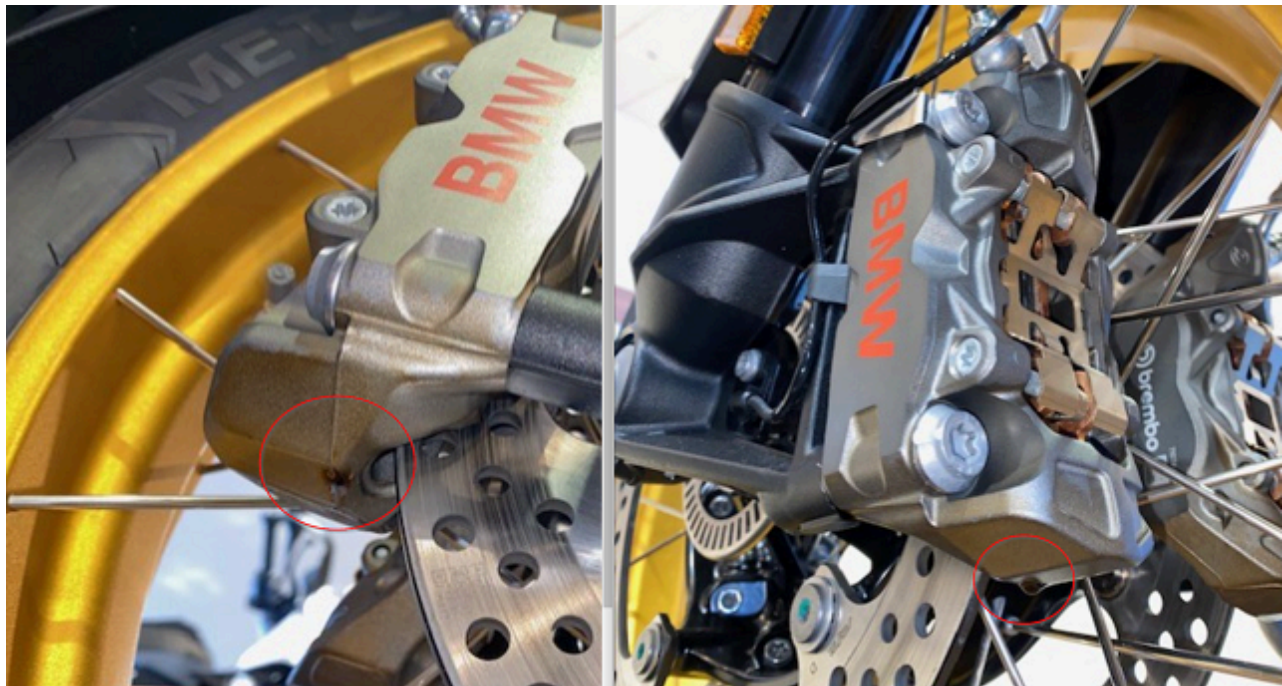
One or both of the front brake caliper/s are leaking after sitting idle for long periods of time. They only leak at low internal pressures.

**DO NOT REPLACE** the calipers.

The repair is to replace the Brake piston with seals set. Existing fluid residue on the caliper must be cleaned with a suitable cleaner. Check ETK for the correct part number.
