SIB 77 03 25

SERVICE SOLUTION: Vario cases cannot be removed or opened

Model	Model Description
KA1	R 1300 GS

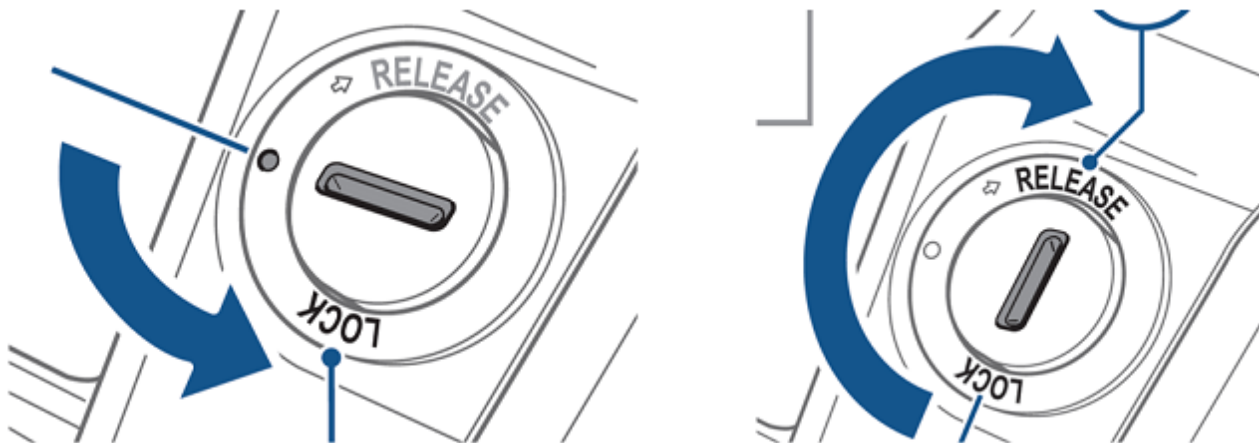
To be able to remove or open the case, the key must first be turned back in the "LOCK" direction until the end position.

Then, the key must be turned dynamically in the "RELEASE" direction all the way to the end position. The servomotor can be heard unlocking (see video attached in TIS with this Bulletin).

To remove the case, the key must then be held in this position (at the end position) until the release lever for the case has been raised.

It should be possible to open the case lid without holding the key in position and with little effort.
