STAR ONLINE PUBLICATION

Case Number: S2508000030

Symptom/Vehicle Issue: Fleet Vehicles Equipped With Tailgate Only Unlock/Lock Delivered With Interim Key Fobs With Incorrect Button Graphics

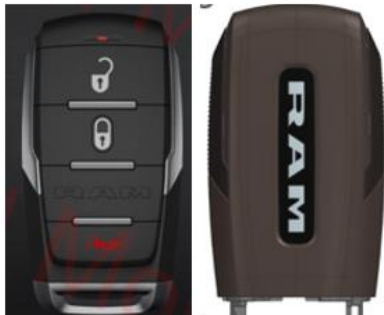
Interim Fob Graphics

1. Visual Inspection - Interim key fobs will have a the traditional Unlock, Lock, & Panic button graphics, reference images below.

ICA: Unlock, Lock, Panic

Production Key Kit PNs

2-Fob Key Kit PN 68731574AA
4-Fob Key Kit PN 68731649AA

Service Key Fob PN

68731649AA

Repair: When available the Tailgate Unlock, Lock fobs with the correct graphics will be provided to dealers and fleet customers through an RSU. When received follow standard fob programming procedures in Service Library to enable. 08 - Electrical / 8N - Power Systems / Power Locks / TRANSMITTER, Integrated Key FOB / Standard Procedure

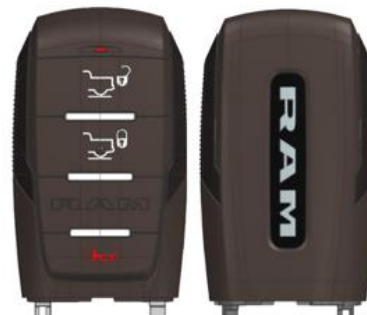
Design Intent Fob Graphics

PCA: Tailgate-Unlock, Tailgate-Lock, Panic

Production Key Kit PNs

2-Fob Key Kit PN 68710031AA
4-Fob Key Kit PN 68733054AA

Service Key Fob PN

68710035AA
