**Technical Service Bulletin (TSB)**  
**Air Conditioning Not Blowing Cold Air**

<b>REFERENCE:</b>	<b>TSB:</b> 24-002-25 <b>GROUP:</b> 24 - Heating and Air Conditioning	<b>Date:</b>	April 23, 2025	<b>REVISION:</b>	–
<b>VEHICLES AFFECTED:</b>	<b>2024 - 2025 (H6) Jeep Meridian</b> <b>2024 - 2025 (M6) Jeep Compass</b> This bulletin applies to vehicles built on or after April 08, 2024 (MDH 0408XX) and on or before March 08, 2025 (MDH 0308XX) equipped with the 2.0L I4 Turbo Diesel Engine w/ ESS (Sales Code EBS).	<b>MARKET APPLICABILITY:</b>			
		<input type="checkbox"/> NA		<input type="checkbox"/> MEA	
		<input type="checkbox"/> SA		<input checked="" type="checkbox"/> IAP	
		<input type="checkbox"/> EE		<input type="checkbox"/> CH	
<b>CUSTOMER SYMPTOM:</b>	<b>The customer may comment on the following:</b> <ul style="list-style-type: none"> <li>A/C provides insufficient cabin cooling.</li> <li>A/C is blowing warm air.</li> </ul>				
<b>CAUSE:</b>	A/C refrigerant leak

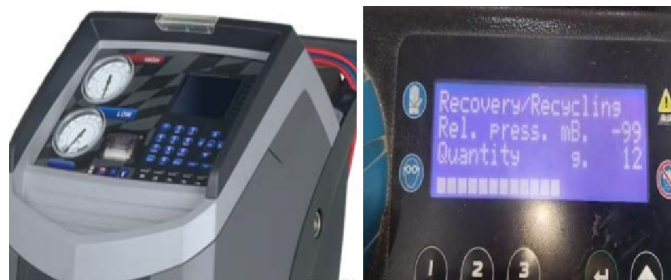
**Fig. 1**

Refrigerant Recovery/Recycling/Charging Station

1. Recover the A/C refrigerant using the Refrigerant Recovery/Recycling/Charging Station [Fig. 1](#). Refer to the detailed service procedures available in DealerCONNECT/Service Library under: Service Info> 24 - Heating and Air Conditioning / Plumbing / Standard Procedure.

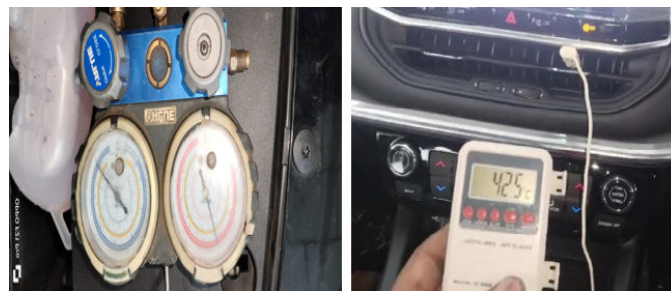
**Fig. 2**

A/C Vacuum Testing

2. Perform A/C vacuum testing cycle [Fig. 2](#). Refer to the detailed service procedures available in DealerCONNECT/Service Library under: Service Info> 24 - Heating and Air Conditioning / Plumbing / Standard Procedure.

3. Did the A/C vacuum testing cycle pass [Fig. 2](#)?
  - YES>>> This bulletin has been completed. Use Inspection LOP (24-45-22-94) to close the active RSU.
  - NO>>> Proceed to [Step 4](#).
4. Replace the A/C discharge line [Fig. 3](#). Refer to the detailed service procedures available in DealerCONNECT/Service Library under: 24 - Heating and Air Conditioning / Plumbing / Line, A/C Discharge / Removal and Installation.
