STAR ONLINE PUBLICATION

Case Number: S2323000067 Rev. A

Symptom/Vehicle Issue: Buzz Squeak Rattle (BSR) In The Door When Playing Music.

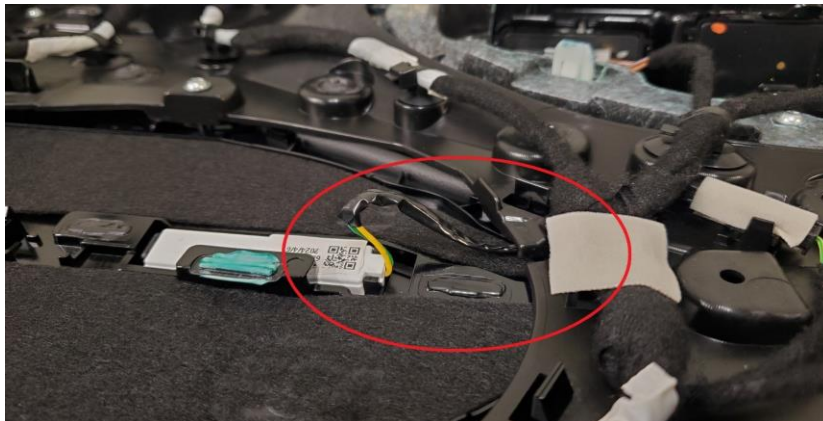
Wire loop should lay flat. Vibration buzz noise. Taping wire down resolved noise.

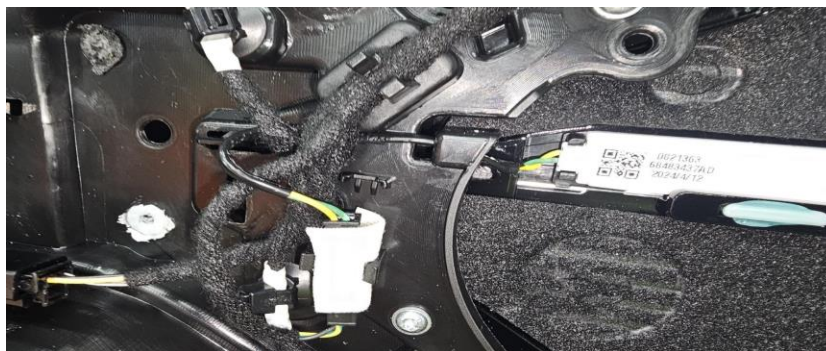
Correctly route wiring into molded wire channels.

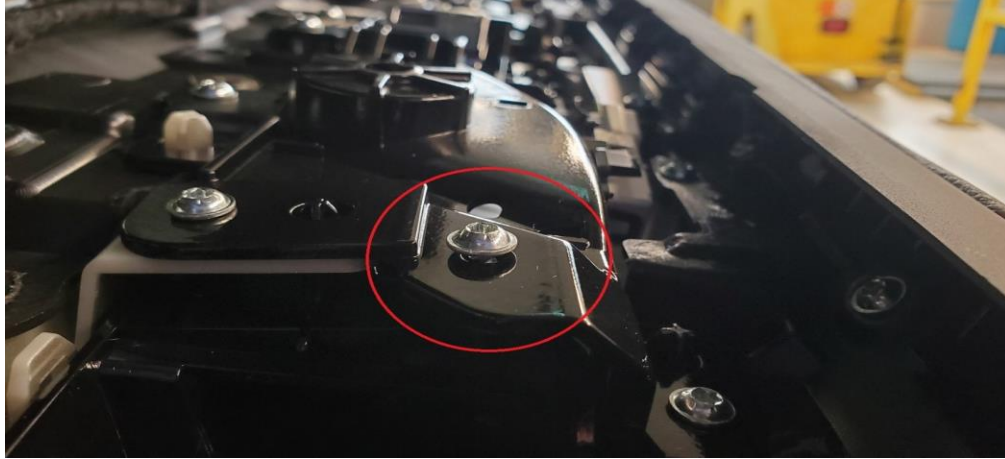
Inspect and check fastener installation.
