## SERVICE BULLETIN

**APPLICABILITY:** 2019-20MY Forester

**SUBJECT:** Power Rear Gate (PRG) Switch Trim- Design Change

**NUMBER:** 12-300-20R

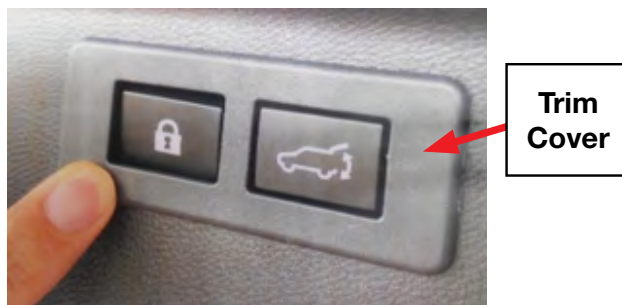
Here, the **LOCK** button is shown stuck below the surface of the switch trim cover.
