<b>HYUNDAI</b> <b>Technical Service Bulletin</b>	GROUP <b>ENGINE ELECTRICAL</b>	NUMBER <b>25-EE-002H</b>
	DATE <b>APRIL 2025</b>	MODEL(S) <b>SONATA (DN8/DN8A)</b>
<b>SUBJECT:</b> MULTI-FUSE REPLACEMENT & BLOWER WIRING REPAIR

**Description:** Certain Sonata (DN8) and Sonata (DN8A) vehicles may experience issues with the air conditioning due to damaged wiring in the engine room junction box. This bulletin provides instructions to replace the multi-fuse, reroute the damaged wiring using the blower wiring kit, and replace the fuse label.

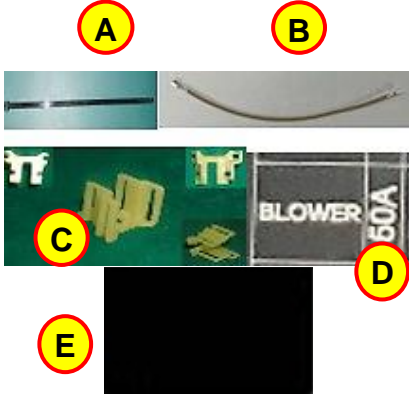
A. Band cable (qty: 2)
				B. Wiring terminal
				C. Retainer (relay unit) RBL04-02465
				D. Fuse label 50A
				E. Blank fuse label
